# Technical Service Information

## THM 200C

### LOCK-UP RIGHT ON TOP OF 2-3 SHIFT

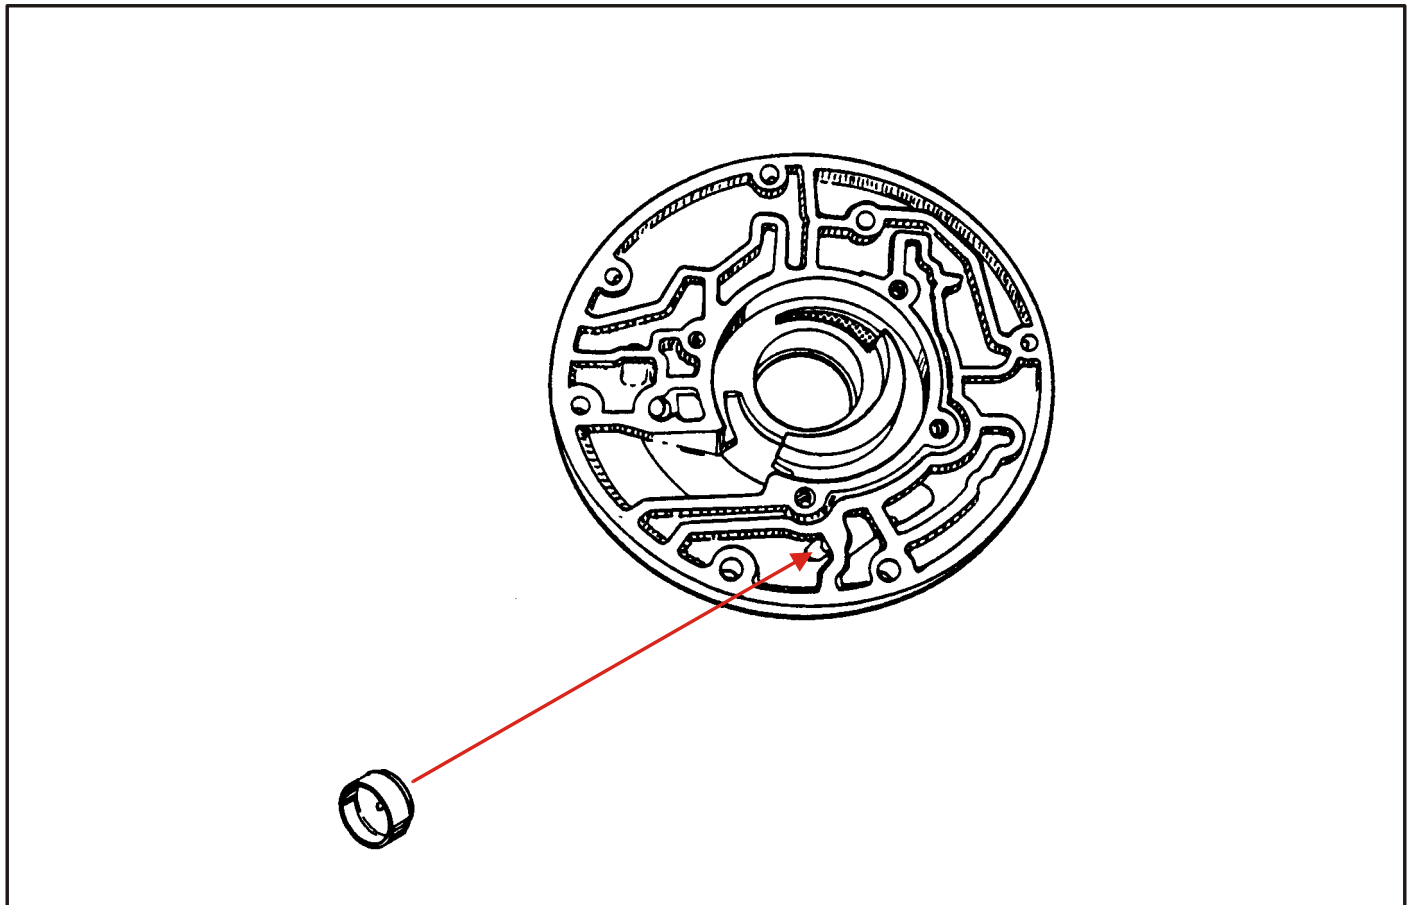
Figure 1

**COMPLAINT:** Converter clutch engages immediately after the 2-3 shift occurs.

The cause may be the orifice cup plug missing from the pump body (See Figure 1). If this cup plug is missing, direct clutch oil will overrun the solenoids ability to exhaust, and stroke the lock-up valve on the 2-3 shift. If the orifice is blocked, or a solid cup plug is installed, you will have NO lock-up

Install orifice cup plug in the pump body in the location shown in Figure 1. The cup plug is available under OEM part number 8630529.
