# Technical Service Information

## CHRYSLER A500/A518 NO SHIFT TO 4TH GEAR

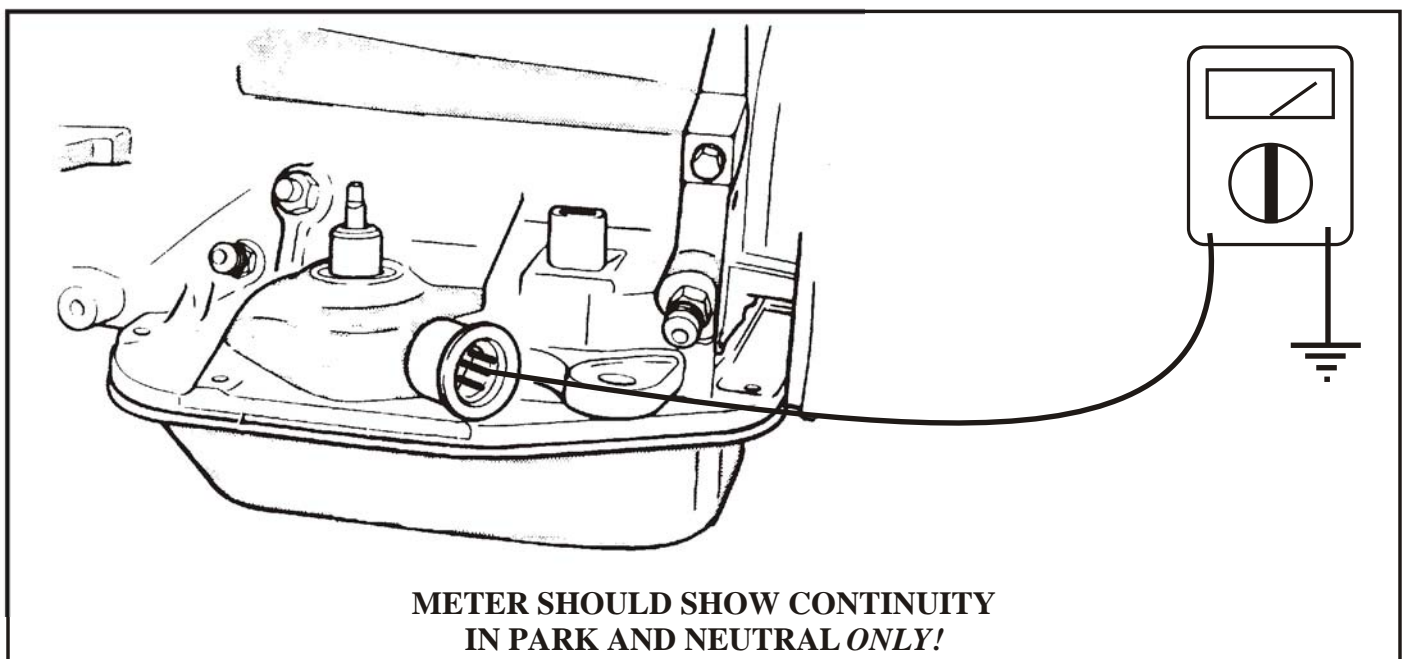
**CAUSE:** The cause may be, an internally grounded Park/Neutral switch, a grounded Park/Neutral switch wire, or an internally grounded Starter Relay. These can be easily detected, because the engine will start in ranges other than Park or Neutral. The center terminal of the Park/Neutral switch provides the ground for the starter solenoid circuit through the selector lever in Park and Neutral positions only. The computer monitors this ground circuit from the starter relay. If the Park/Neutral circuit is grounded while in the Drive position, the vehicle may exhibit a no 4th gear condition.

**CORRECTION:** Refer to Figure 1 for the location of the Park/Neutral switch. Disconnect the three pin harness connector from the switch, and see if the engine will start.

If the engine **will not** start, perform the switch test as shown in Figure 1, and replace the Park/Neutral switch as necessary. If the engine **does** start, locate the "Starter Relay", normally found on the "Firewall" or "Fender Well", depending on the model. Check for continuity to ground on the brown with yellow tracer wire on early models, or the black with white tracer wire on late models, and repair or replace as necessary.
