Technical Service Information

ACURA LEGEND WITH G4, L5 & PL5X TRANSAXLES GRINDING OR BIND IN REVERSE

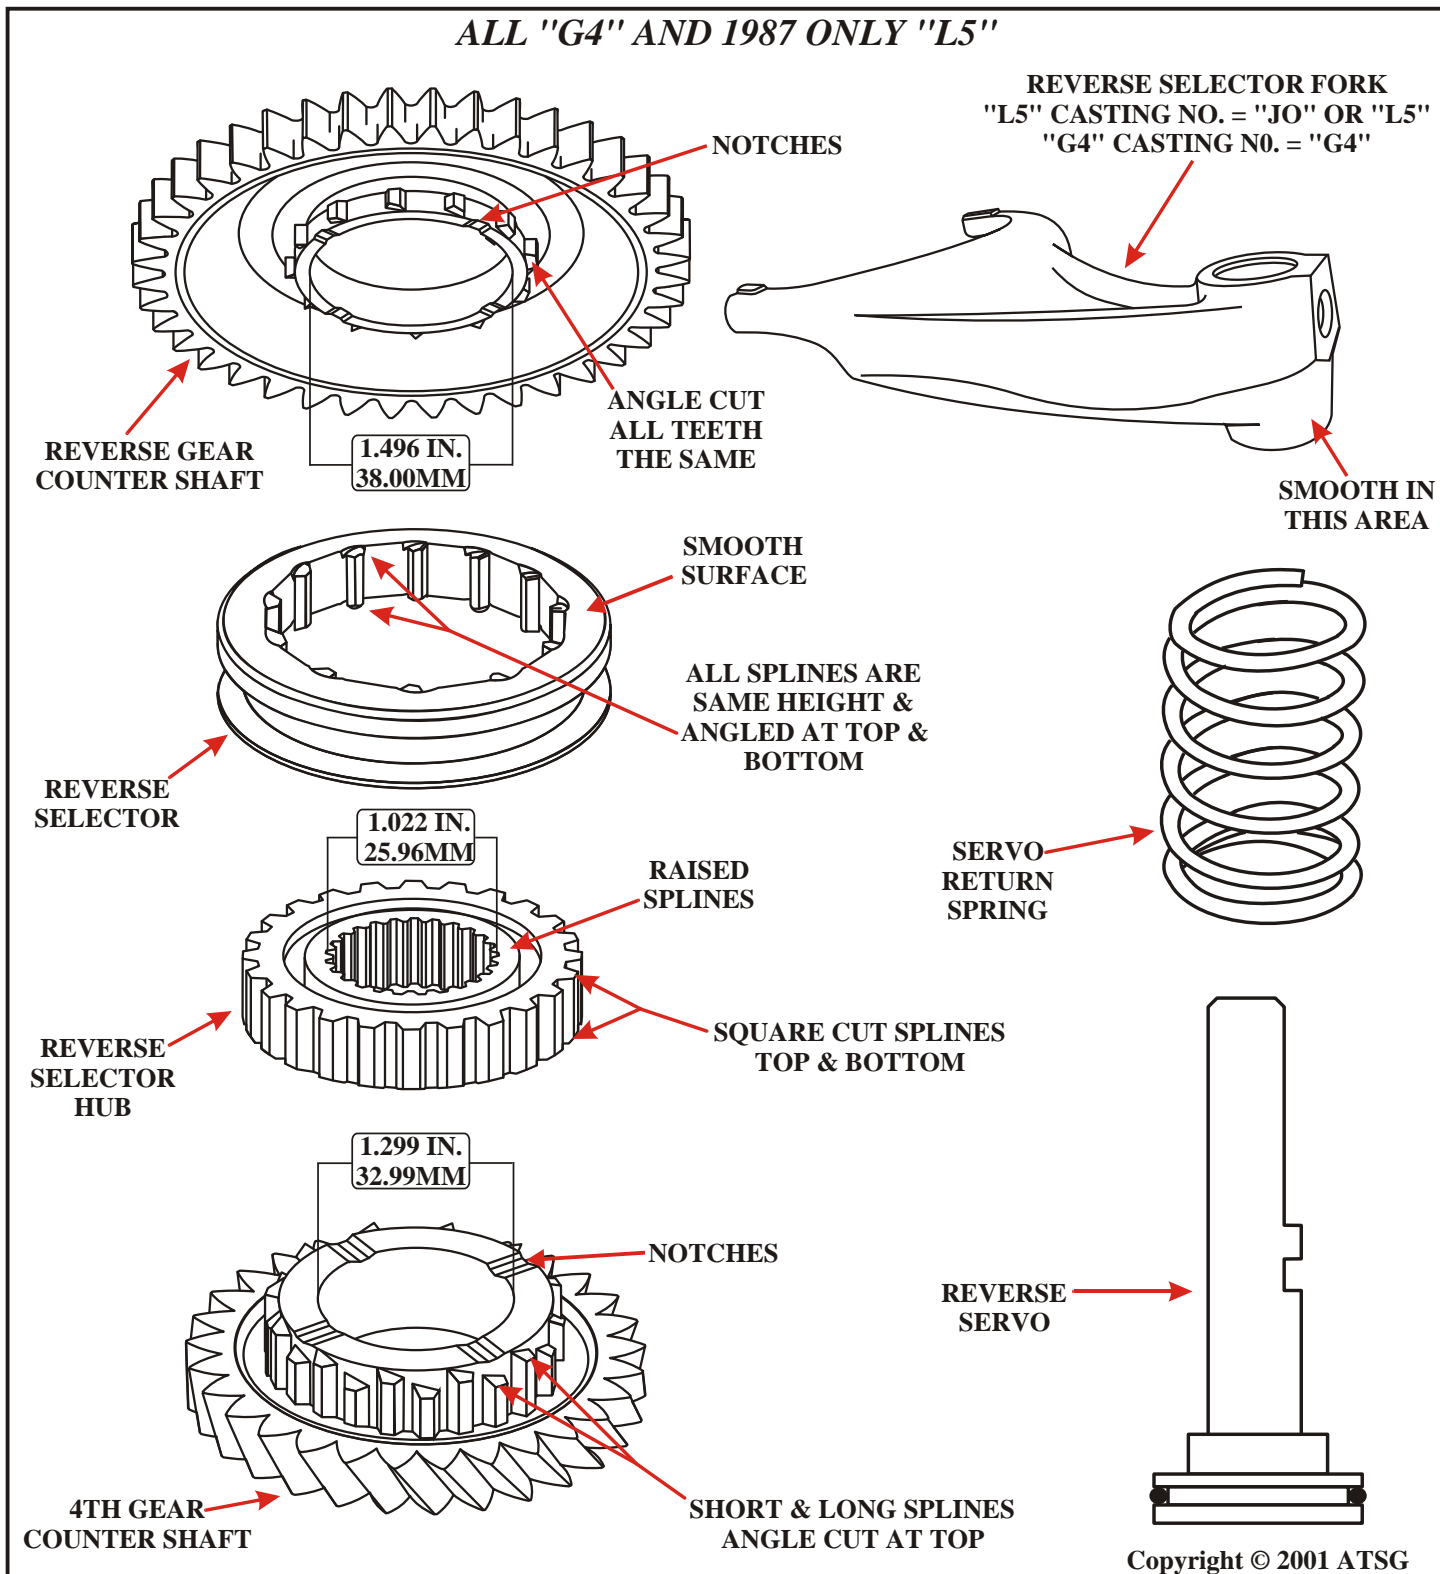
Figure 1

CORRECTION: *Figure 1* illustrates the differences in the "G4" and 1987 "L5" reverse counter shaft components. Take notice of the diameter of the components as well as tooth and spline configuration. The reverse servo uses a spring to return the piston to the 4th gear position.

Note: The original equipment G4 components were used in the 1987 Legend Coupe only, with the "L5" transaxle.

ALL "G4" AND 1987 ONLY "L5"

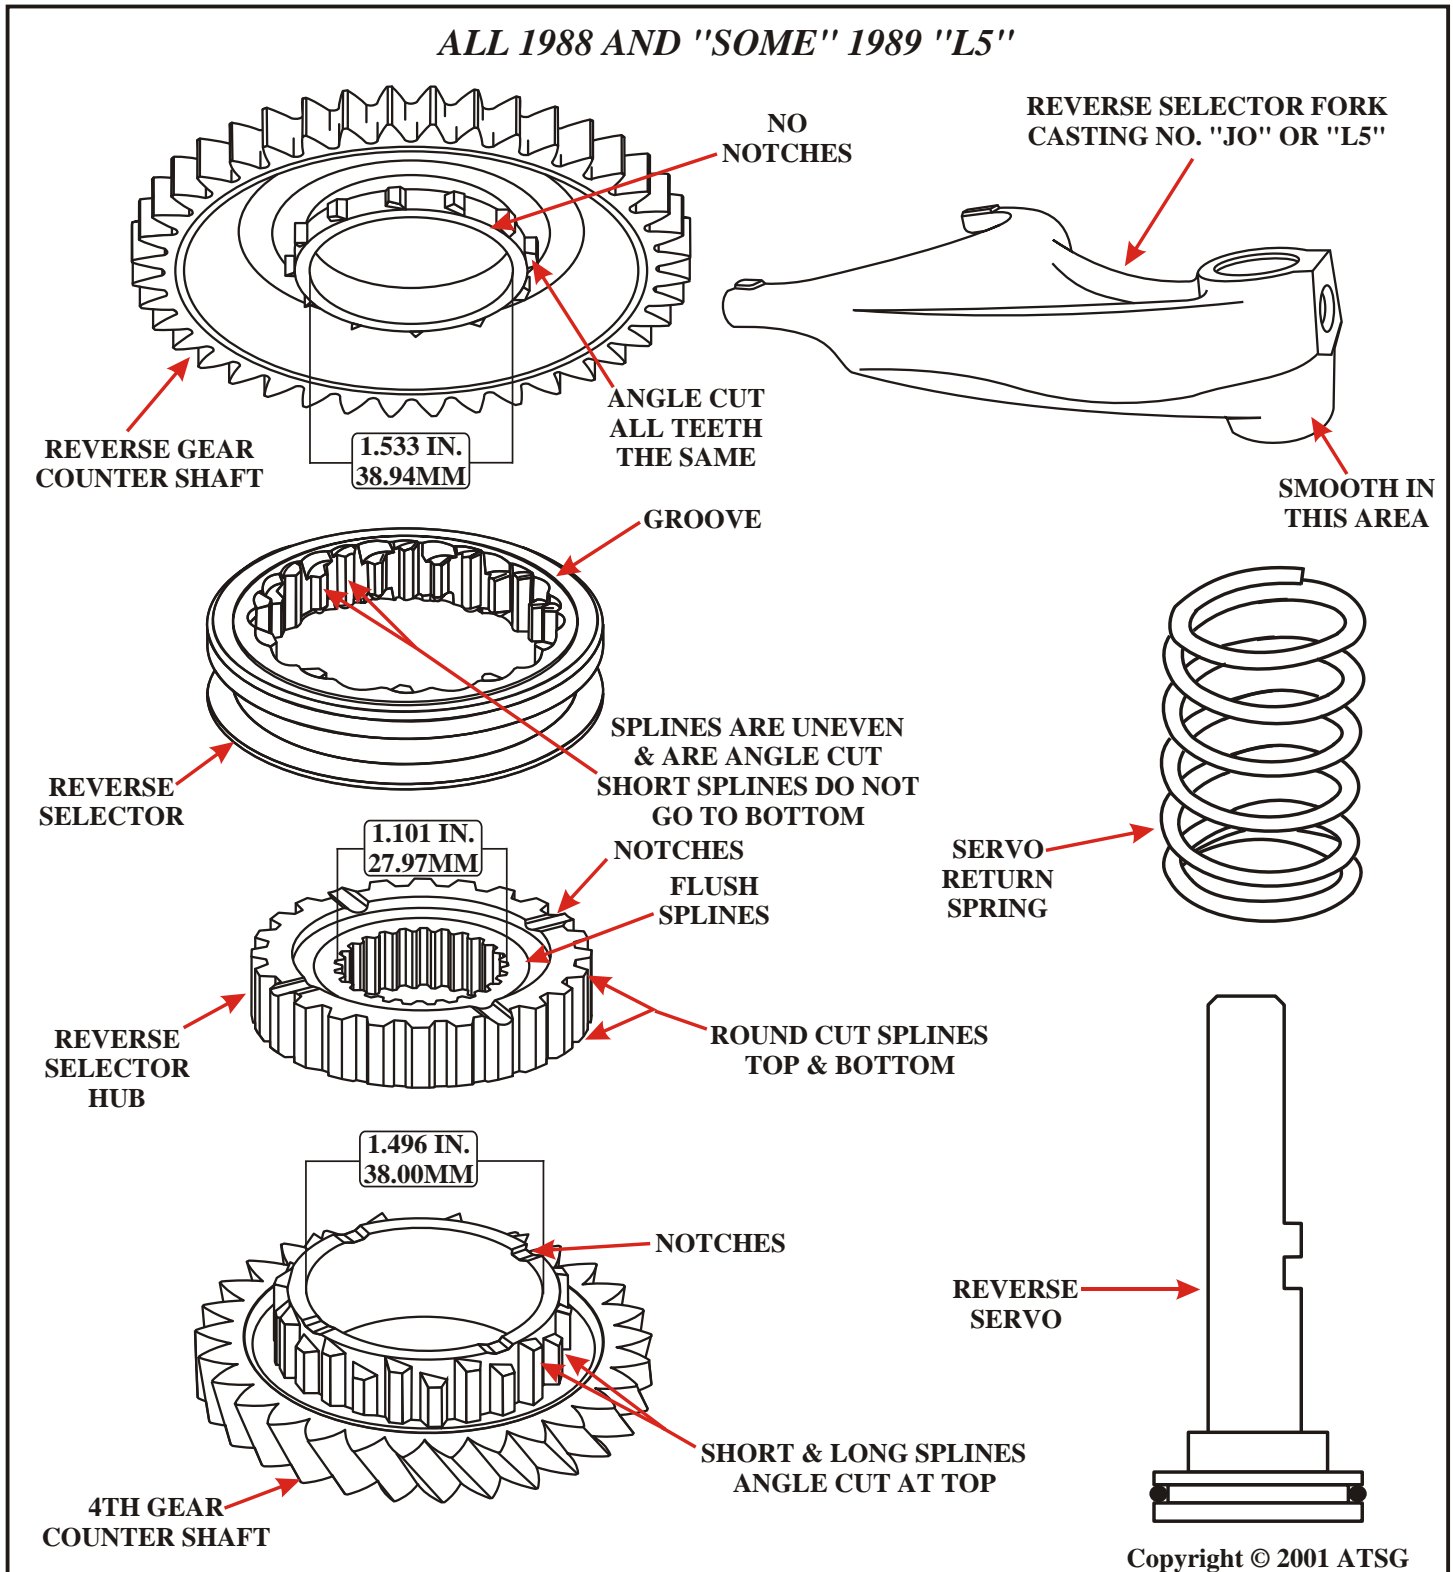
Figure 2 illustrates the differences in the 1988 "L5" and **Some** 1989 "L5" reverse counter shaft components. Take notice of the diameter of the components as well as tooth and spline configuration. This reverse servo also utilizes a spring to return the piston to the 4th gear position

ALL 1988 AND "SOME" 1989 "L5"

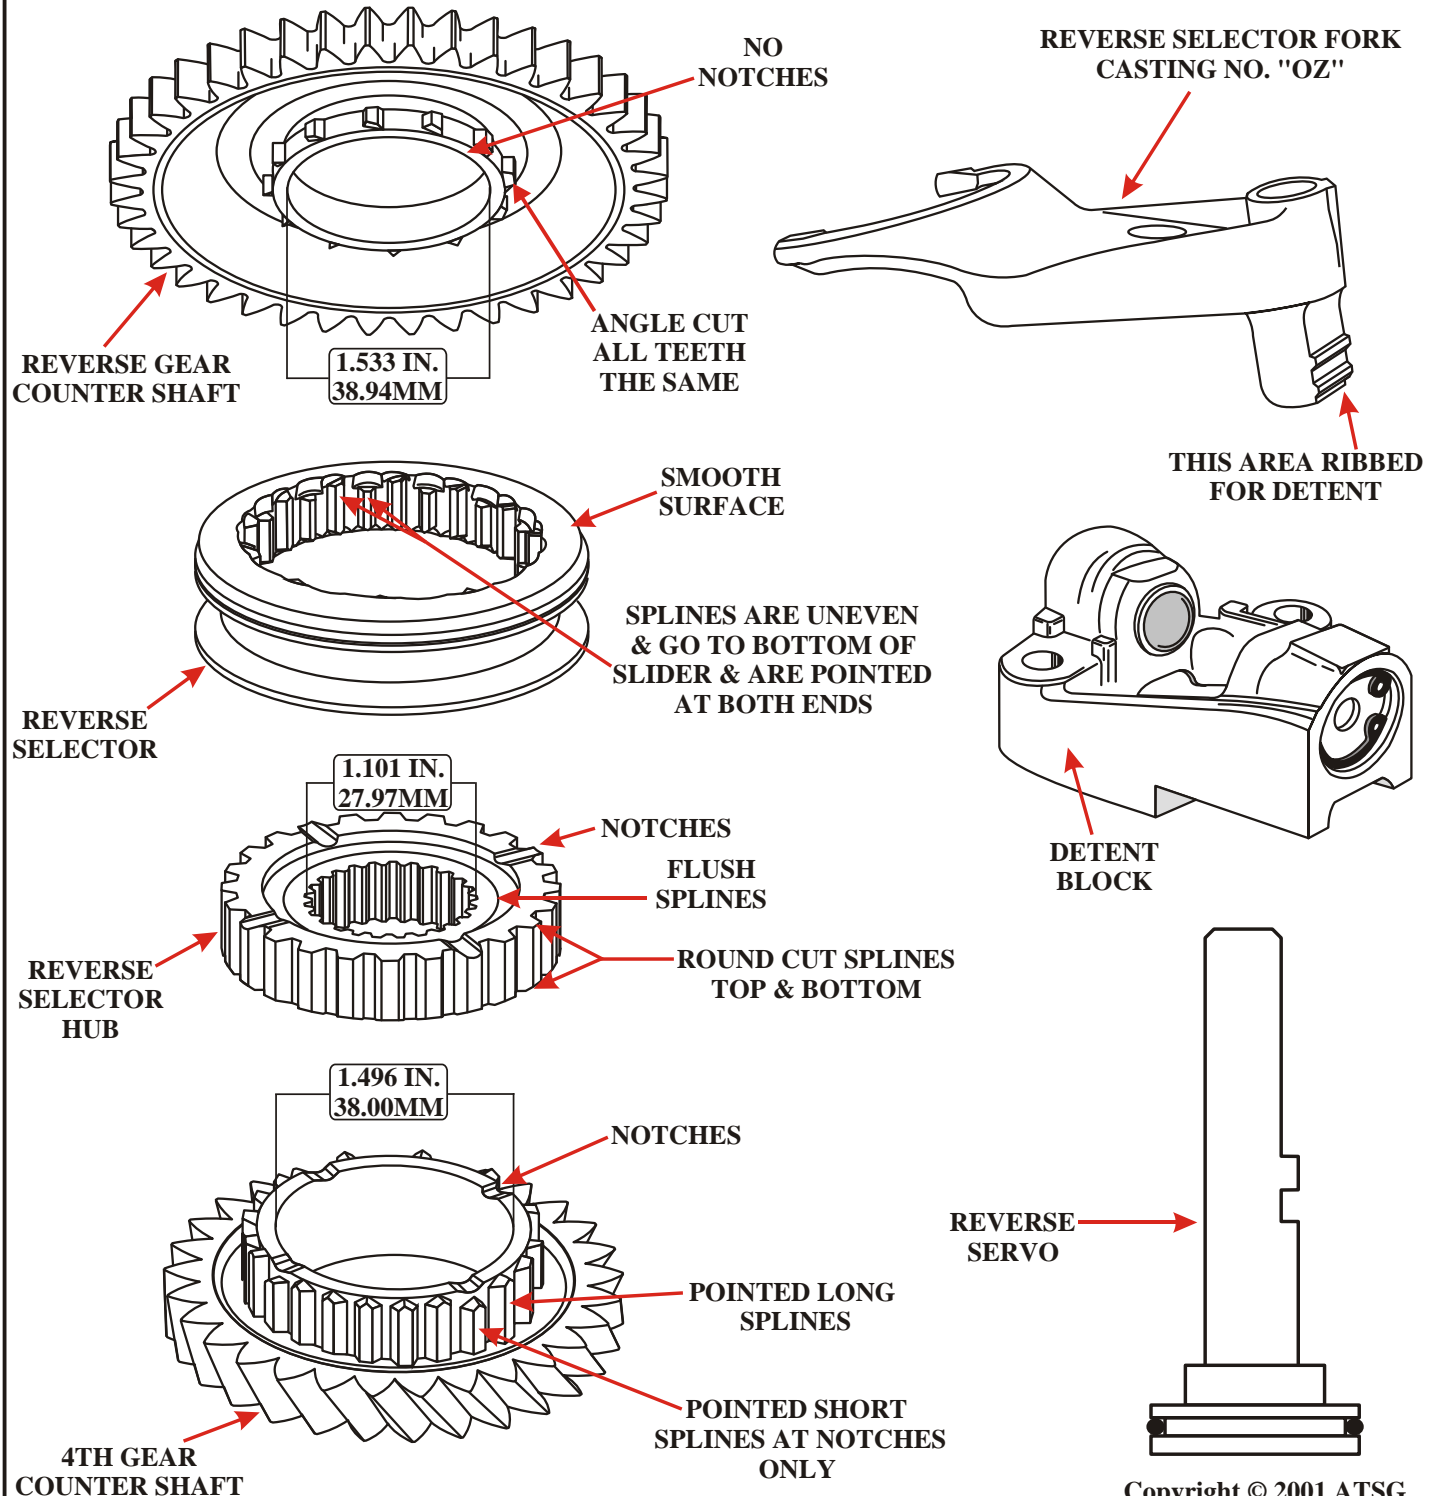
Figure 3 illustrates the differences in some 1989 "L5" and 1990 "PL5X" reverse counter shaft components. Take notice of the diameter of the components as well as tooth and spline configuration. The 1989 "L5" and 1990 "PL5X" **does not** use a servo return spring, as it has a detent mechanism to keep the reverse servo in the reverse or 4th gear position. The fork is also different than the previous design level in that it is ribbed to accommodate the detent mechanism.

"SOME" 1989 "L5" AND ALL 1990 "PL5X"
