Technical Service Information

CHRYSLER A604 UPDATED REPAIR PACKAGE

This bulletin applies to all Dynasty, New Yorker, Landau, Ram Van, Caravan, and Voyager vehicles.

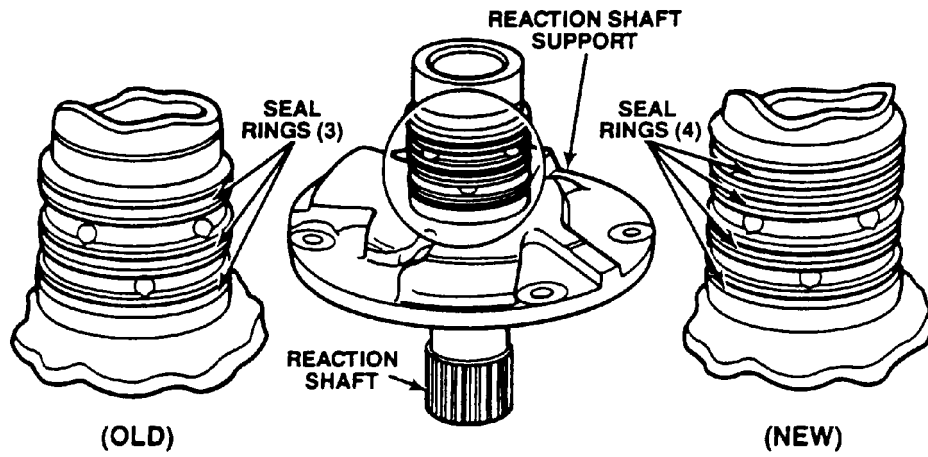
Figure 1

There is now available from OEM a new repair package, part number 4549248, that includes a new 4 ring front pump reaction shaft (See Figure 1), and a new input clutch hub with shallower "O" ring grooves to increase the compression of the "O" rings (See Figure 3). The new 4 ring front pump reaction shaft (Figure 1) provides better sealing for the overdrive clutch, and the new input clutch hub with shallower "O" ring grooves (Figure 3) provides better sealing for both the underdrive clutch and the reverse clutch. Both of these updated parts are highly recommended to provide better durability for the A604 transaxle.
