ZF4HP22 ERRATIC OR NO UPSHIFTS

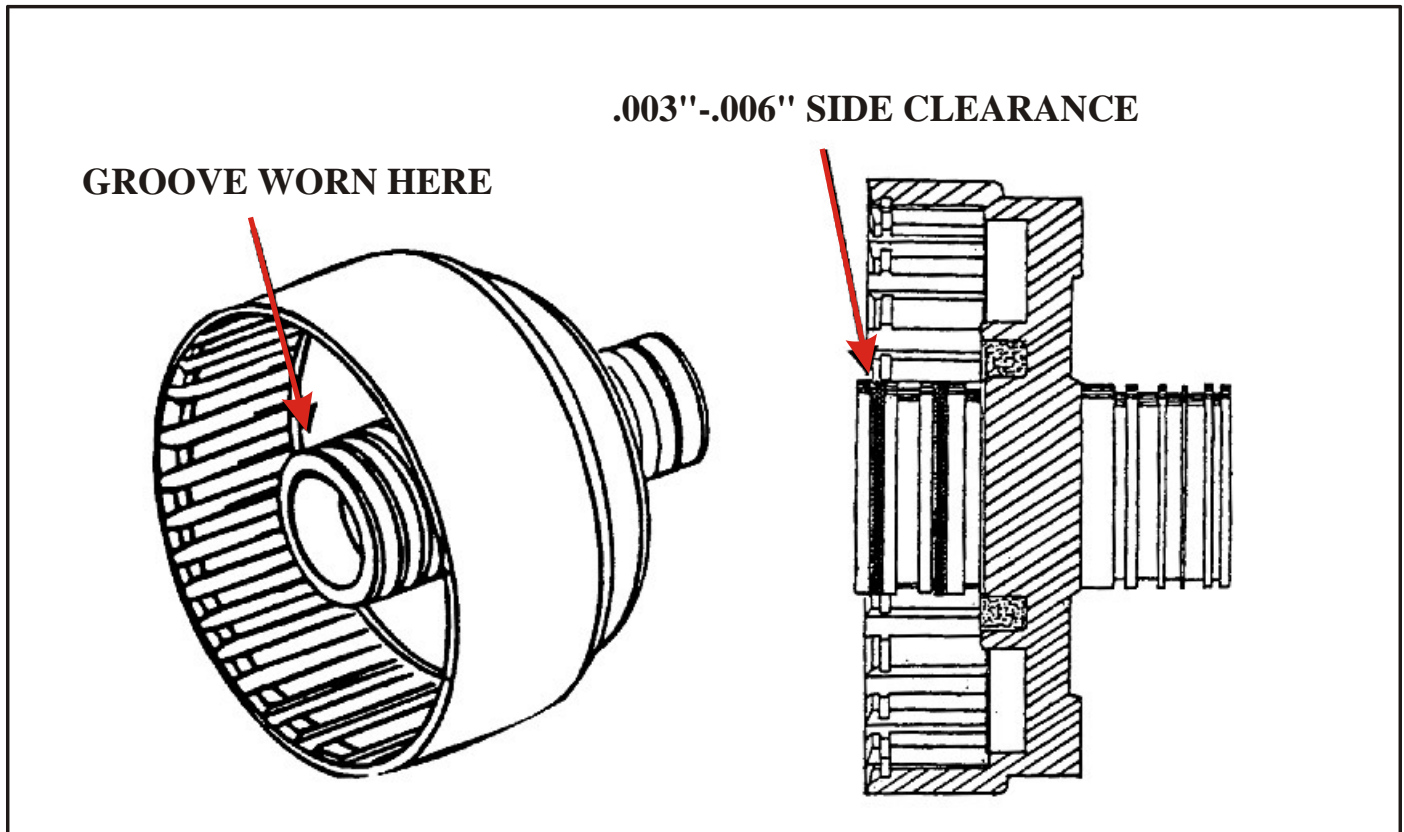
Figure 1

- COMPLAINT:** Vehicles equipped with the ZF4HP22 transmission may come to the shop with no upshift or complaints of erratic shifting.
- CAUSE:** During an internal inspection, close examination of the (F) clutch cylinder that bolts into the case will be necessary. Abnormal ring groove wear on the drum where the governor rides will cause the loss of governor pressure. With a new ring installed on the drum, side clearance should be .003"-.006" in. (SEE FIGURE 1).
- CORRECTION:** A new (F) clutch cylinder must be installed if any wear or damage is found. New sealing rings must also be installed. Rubber sealing rings will work, but steel rings are the preferred choice. The part number for the (F) clutch cylinder is 24-23-1217-088.
