1995 SEMINAR INFORMATION  
"HOW TO SURVIVE IN 95"

# "HOW TO SURVIVE IN '95"

## INTRODUCTION

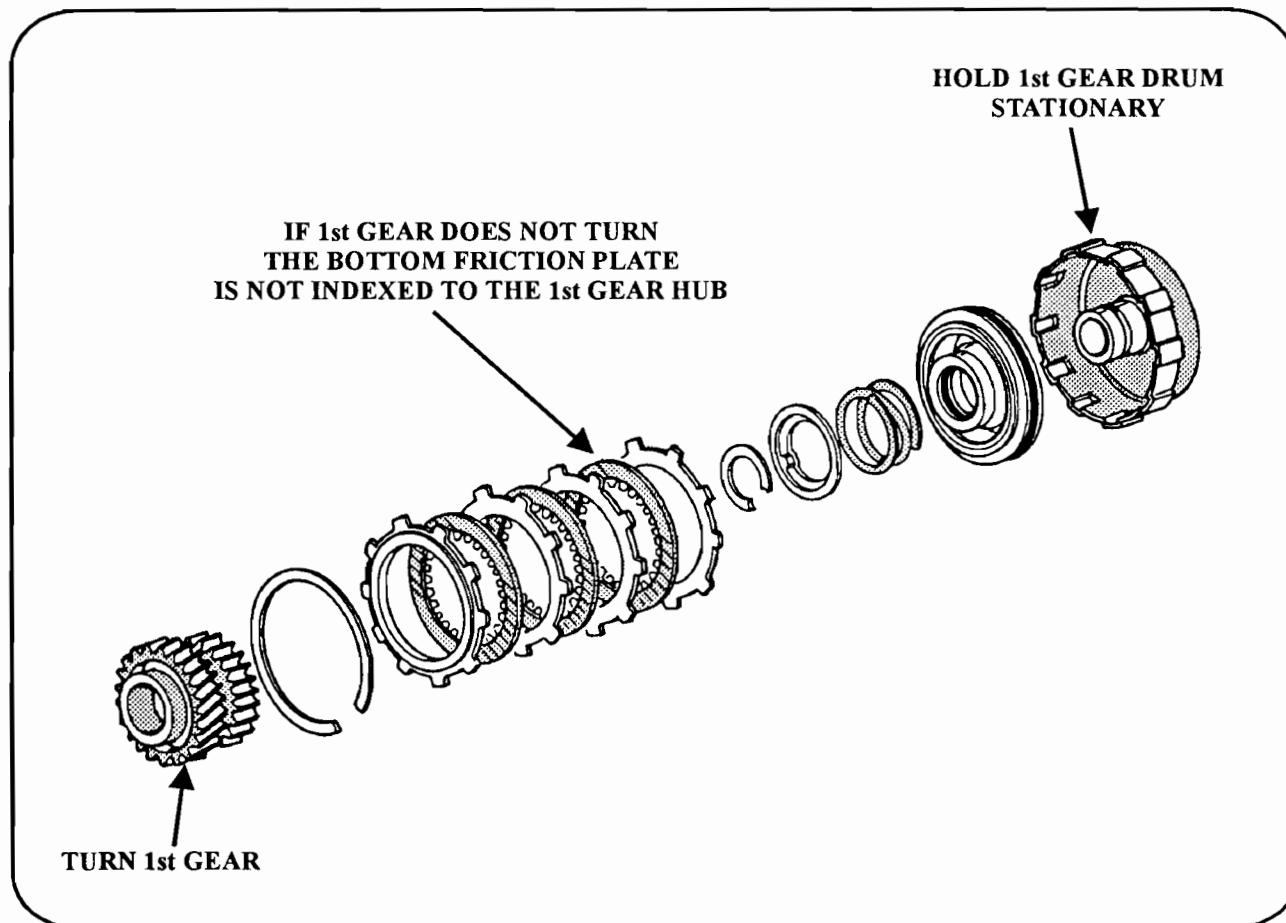
Figure 24

**CAUSE:** Improper indexing of the first gear hub to the low friction plates causing the last friction plate to be caught between the first gear hub and the piston.

**CORRECTION:** Make certain all three clutches have splined to the first gear hub. After tightening the mainshaft nut, make certain you can turn the clutch drum while holding the first gear hub. (Refer to Figure 24)

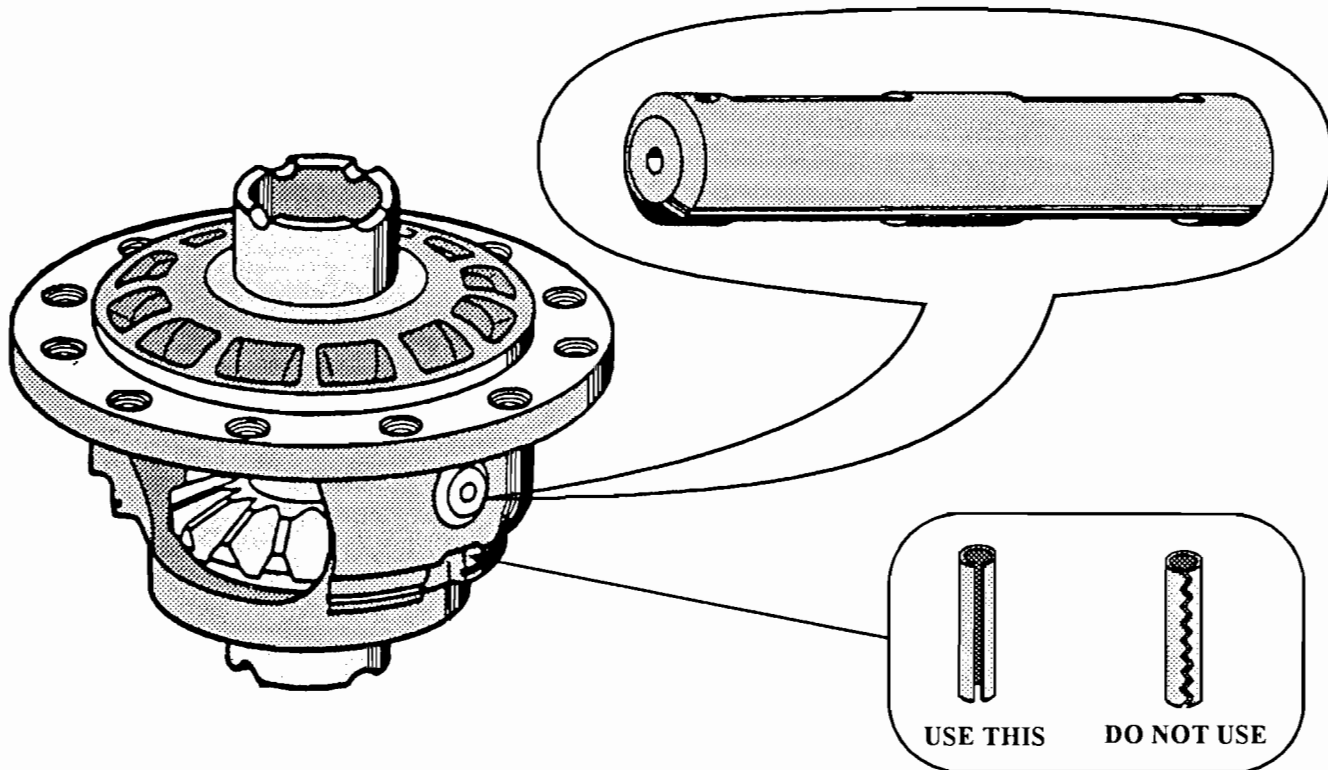
**COMPLAINT:** Failure of the differential cross shaft in the area of the cross shaft where the pinion gears rotate.

**CAUSE:** The cause may be the material from which the cross shaft was made.

The rolled pin that retains the cross shaft in the differential carrier should also be replaced with a different design. The original rolled pin, with the split that resembles a "ZIPPER" (See figure 23), should NEVER be used. ALWAYS replace it with a regular split type rolled pin of the proper dimension.

Refer to the chart in figure 23 for the dimensions and part numbers for the design differential cross shaft.

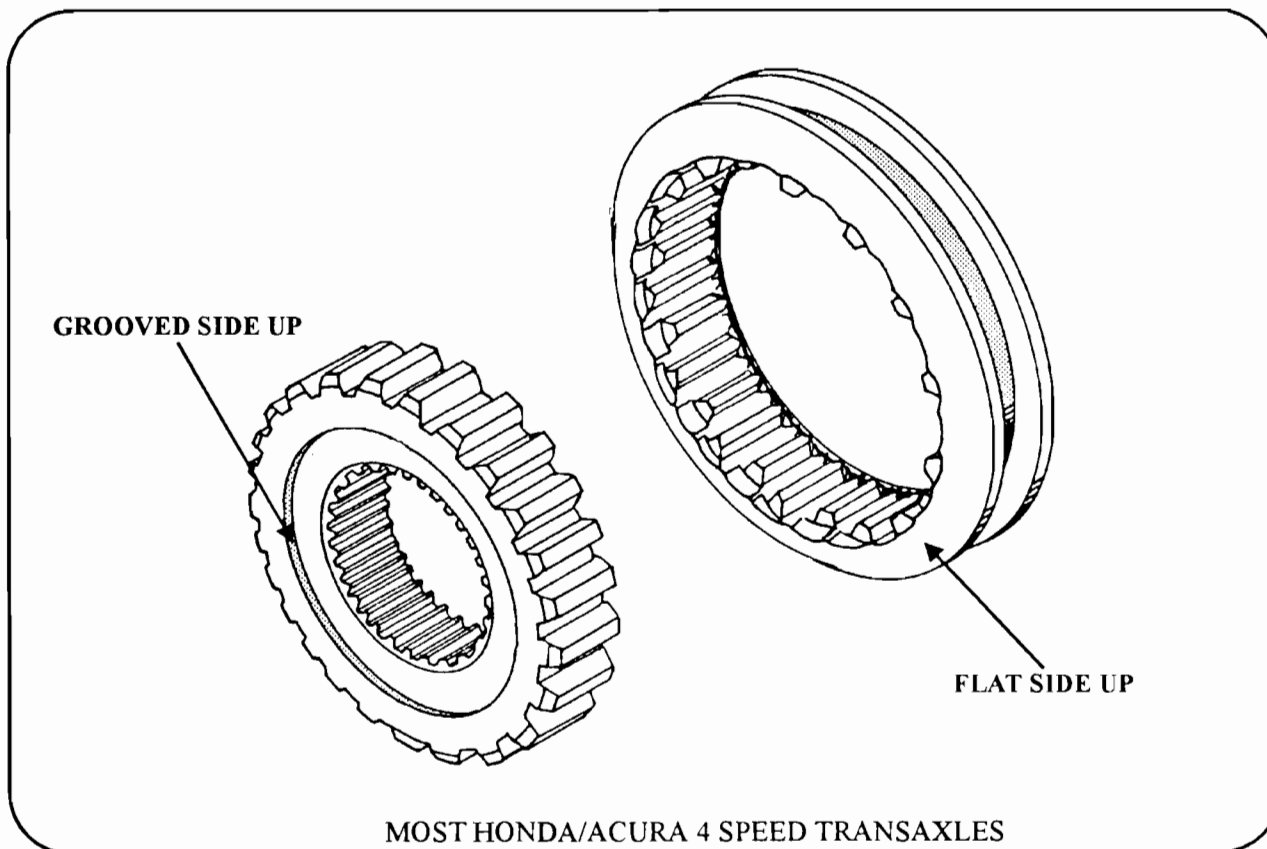
Figure 25

**Cause:** Misassembly of the reverse selector assembly

**Correction:** In most Honda 4 speed transaxles, the reverse selector is installed with the **FLAT SIDE UP**, and the selector hub is installed with the groove facing up. (See Figure 25)  
The PX4B found in 1990 Accords, is just the **OPPOSITE!**  
The reverse selector is installed with the **STEPPED SIDE UP**, and the selector hub is installed with the notches facing up. (See Figure 26 on the following page).

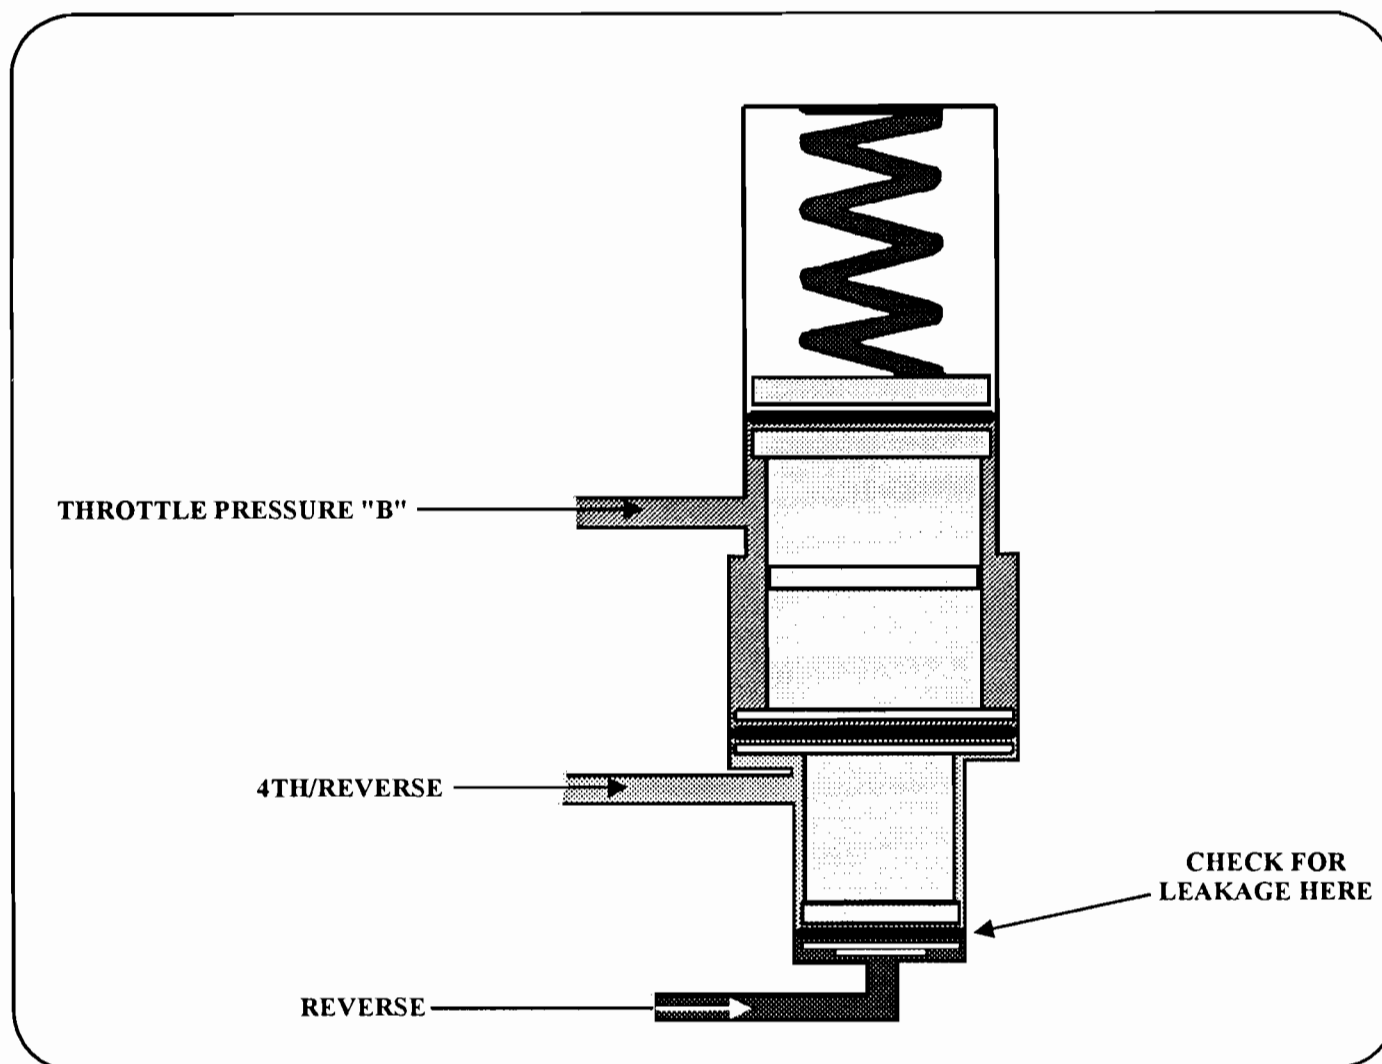
Figure 27

**CAUSE:** The PX4B uses a double action 4th/reverse accumulator. If the small accumulator "o" ring seal is leaking, (See figure 27) only the 3-4 shift will be affected as 4th gear oil leaks into the reverse circuit and could cause a soft or flared 3-4 shift. The 4th/reverse accumulator is the center accumulator piston located in the servo body section of the valve body assembly.

**CORRECTION:** Replace accumulator seals.

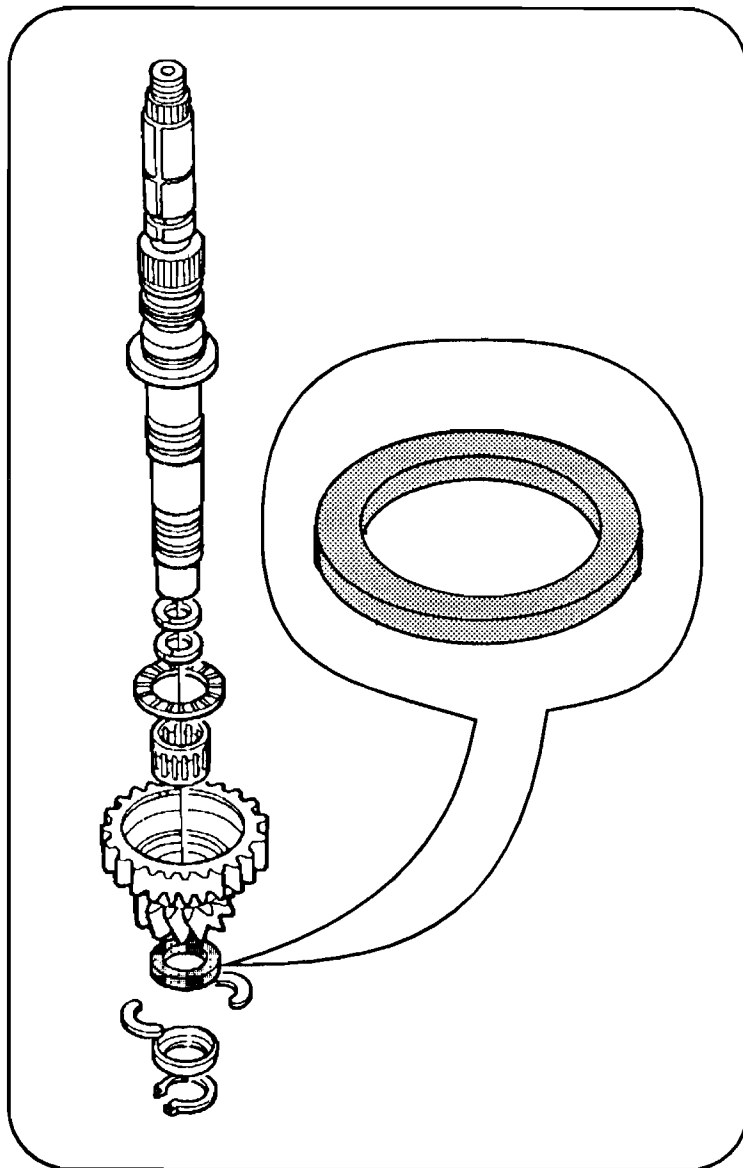
Figure 28

**Cause:** Other than the final drive, the PX4B uses NO SELECTIVES to adjust endplay

**Correction:** The countershaft distance collar must measure 46mm (1.811") in length. (See figure 28)  
The secondary shaft distance collar must measure 5mm (.1969") in thickness. (See figure 29)  
All clutch collars and hardparts should not be undercut.  
The counter shaft nut should be torqued to no more than 145 ft. lbs.  
The main shaft and secondary shaft nuts should be torqued to no more than 116 ft. lbs.

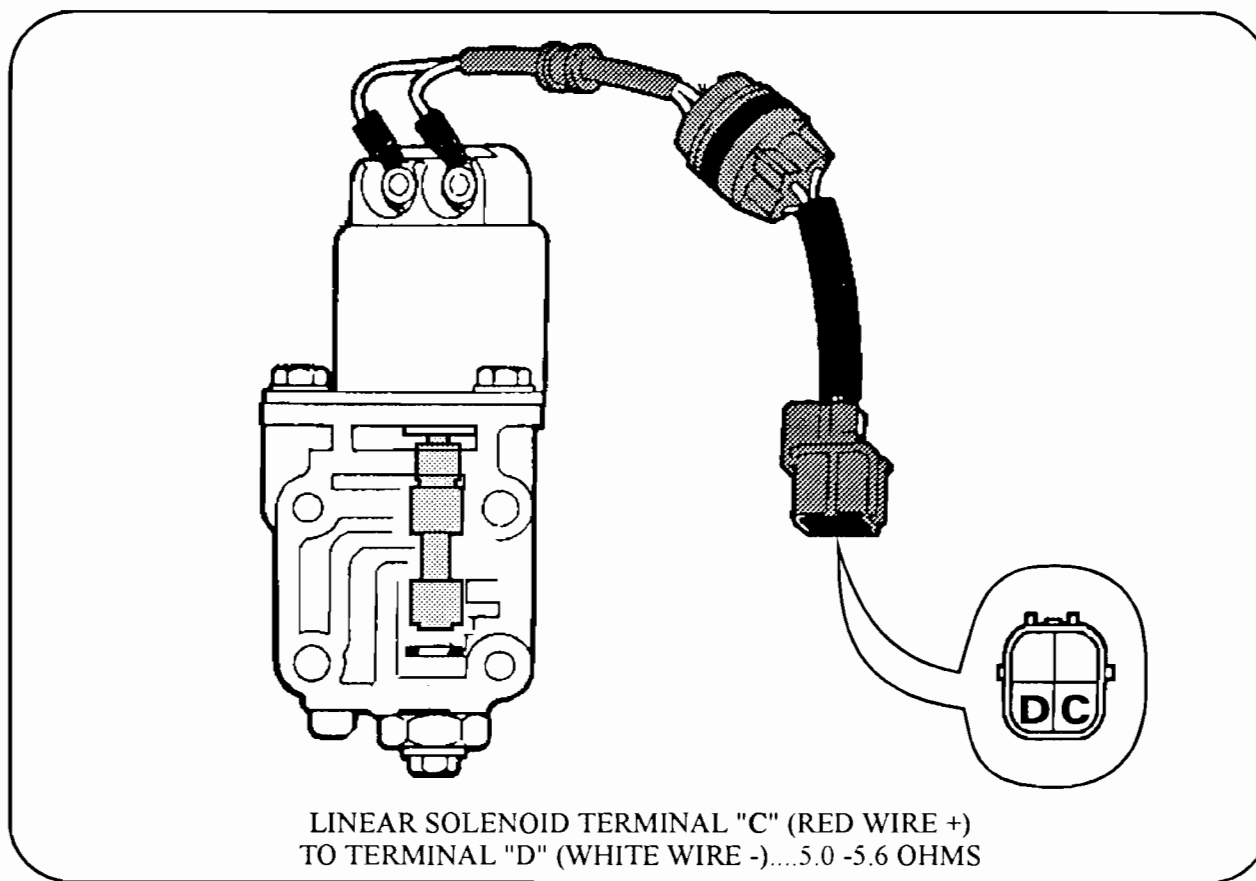
Figure 31

**Cause:** Failure of the Linear Solenoid

Therefore, failure of the Linear Solenoid or the signal to it or a sticking throttle valve could cause harsh upshifts, harsh coast downshifts or harsh kickdown.

The Linear Solenoid and the Shift Solenoids share a common connector, the Linear Solenoid specifications are listed below in figure 31.

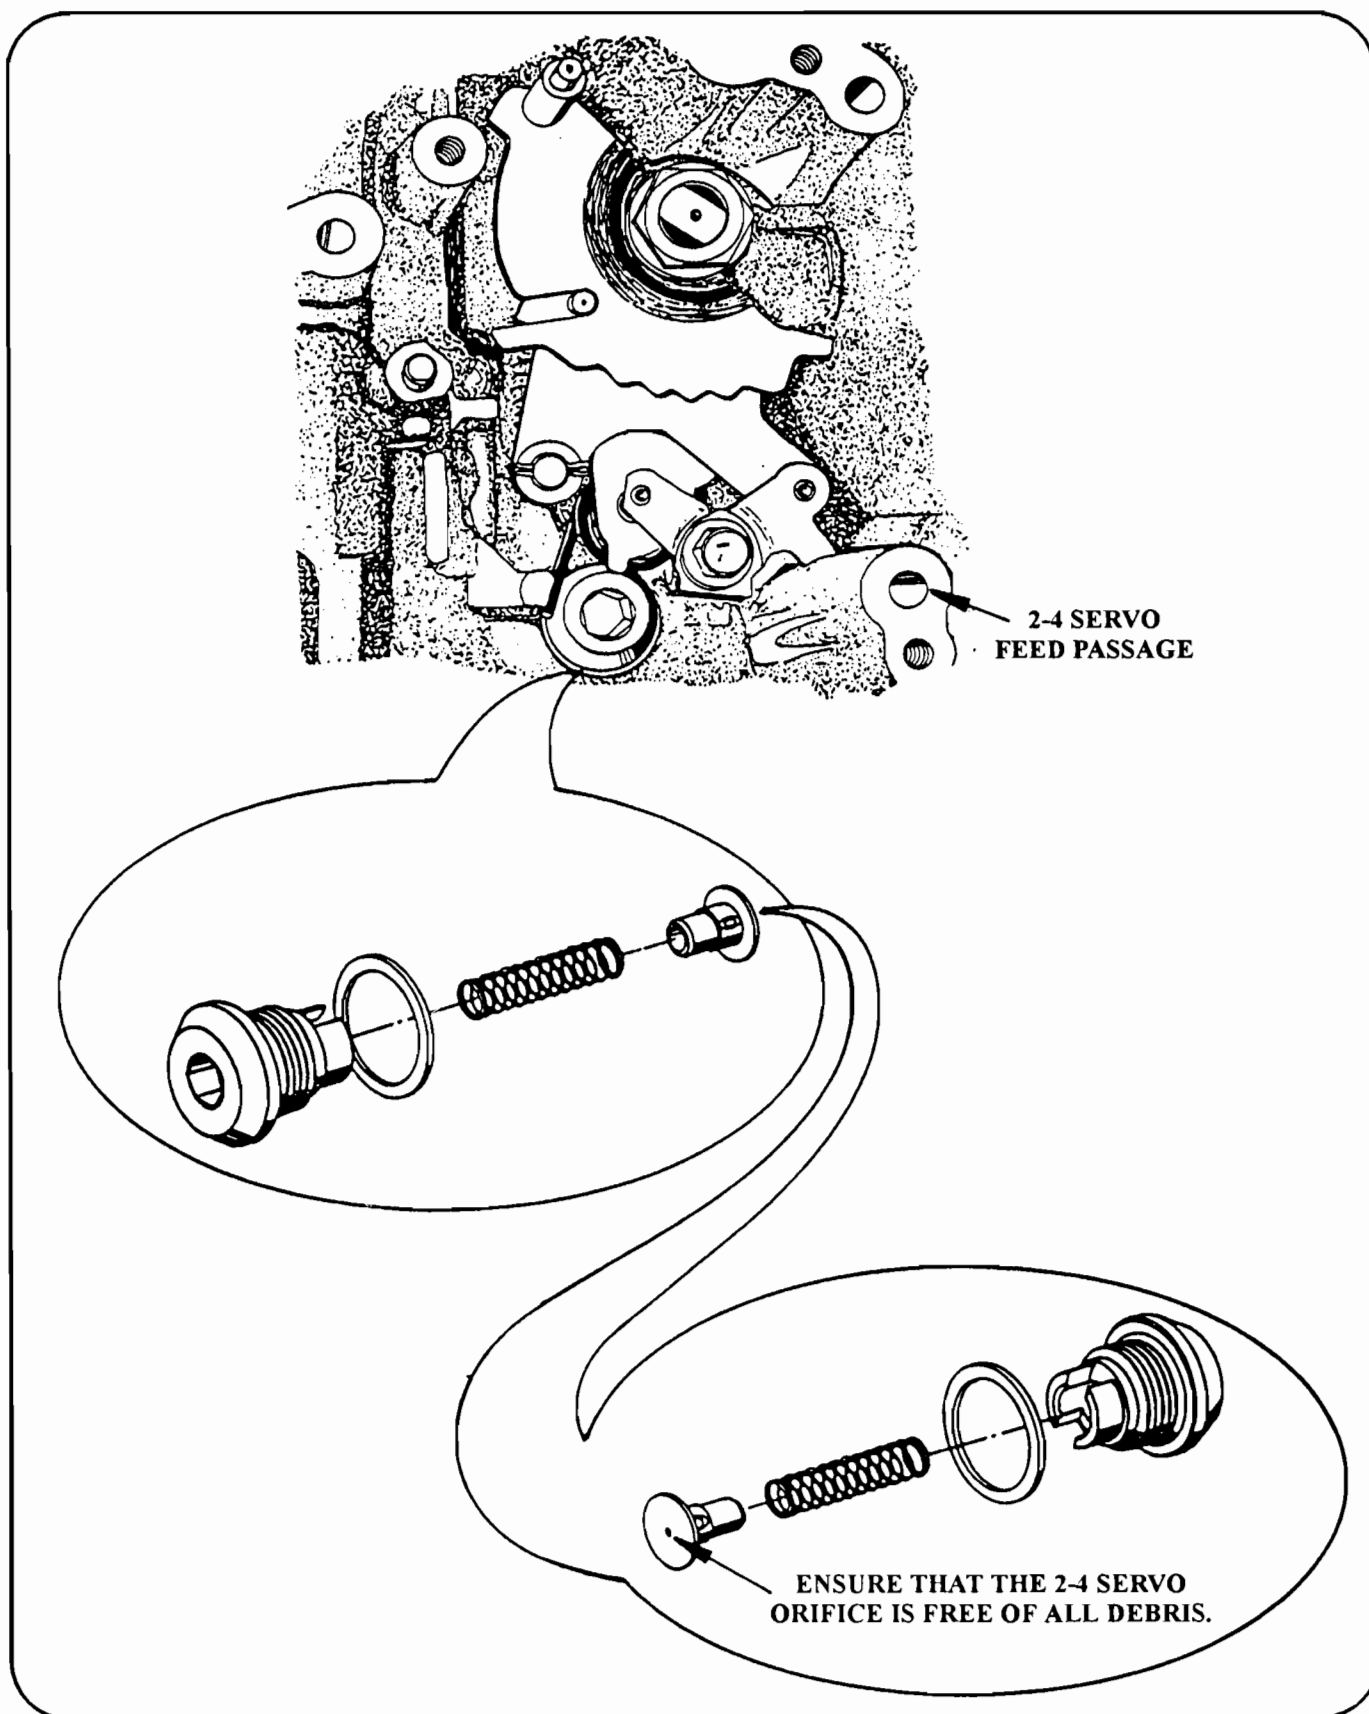
Figure 42  
*Automatic Transmission Service Group*

**COMPLAINT:** Vehicle exhibits a slipping condition going into 2nd gear, at times slipping through 2nd and on into 3rd gear, and a slipping condition going into 4th gear. Obviously this will also burn the 2-4 band. In severe conditions there will be NO 2nd gear, and NO 4th gear. The vehicle will shift 1-3 only.

**CAUSE:** The cause may be a clogged or partially clogged 2-4 servo feed orifice. The 2-4 servo feed orifice is only .038" in diameter, and will not tolerate much debris before the slipping condition will exist. If the 2-4 servo orifice becomes totally closed, there will be NO 2nd gear, and NO 4th gear. Another cause for NO 2nd and NO 4th gears could be a checkball that has been installed in the wrong location in the Premain valve body, as shown in Figure 43.

**CORRECTION:** Remove the 2-4 servo feed orifice assembly using a 10mm Hex socket. Refer to Figure 42 for the location in the case. Thoroughly clean the 2-4 servo orifice and all case passages with clean solvent. The spring in this assembly is larger on one end, and the larger end goes into the Hex bolt (See Figure 42). Also ensure that you have only TWO .243" diameter checkballs installed into the Premain valve body, in the locations shown in Figure 43.

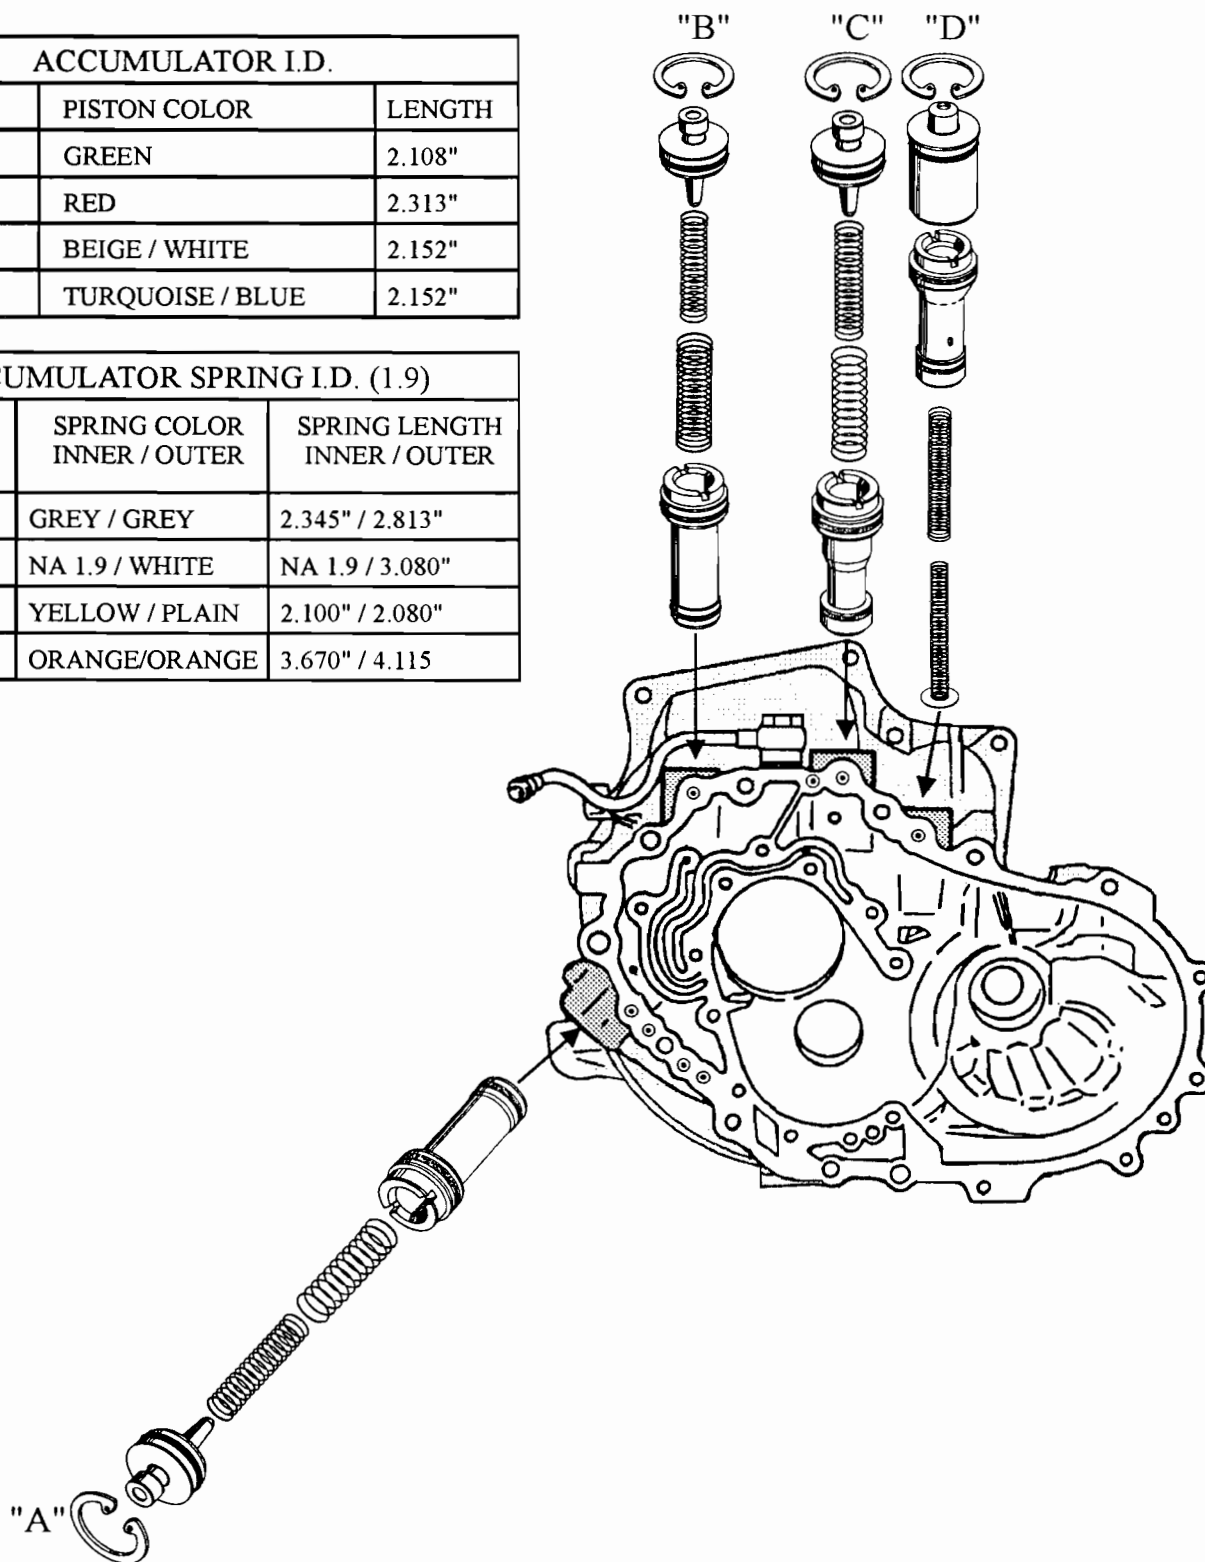
Figure 45

A: The cause may be, the 2-3 accumulator piston was installed into the 1-2 accumulator bore. Because of the difference in overall length, when the 2-3 accumulator piston is installed into the 1-2 accumulator bore, the sealing ring of the 2-3 accumulator piston provides an "Orifice" for 1-2 accumulator pressure (band apply) to enter the 3-4 clutch apply "circuit" on the 1-2 upshift.

B: The cause may be the 2-3, N-D or N-R accumulator was installed into the 1-2 accumulator bore, or the sealing ring at the small diameter of the 1-2 accumulator was damaged on installation into it's bore.

B: See figure 45 for the correct accumulator identification and assembly or replace the damaged sealing ring.

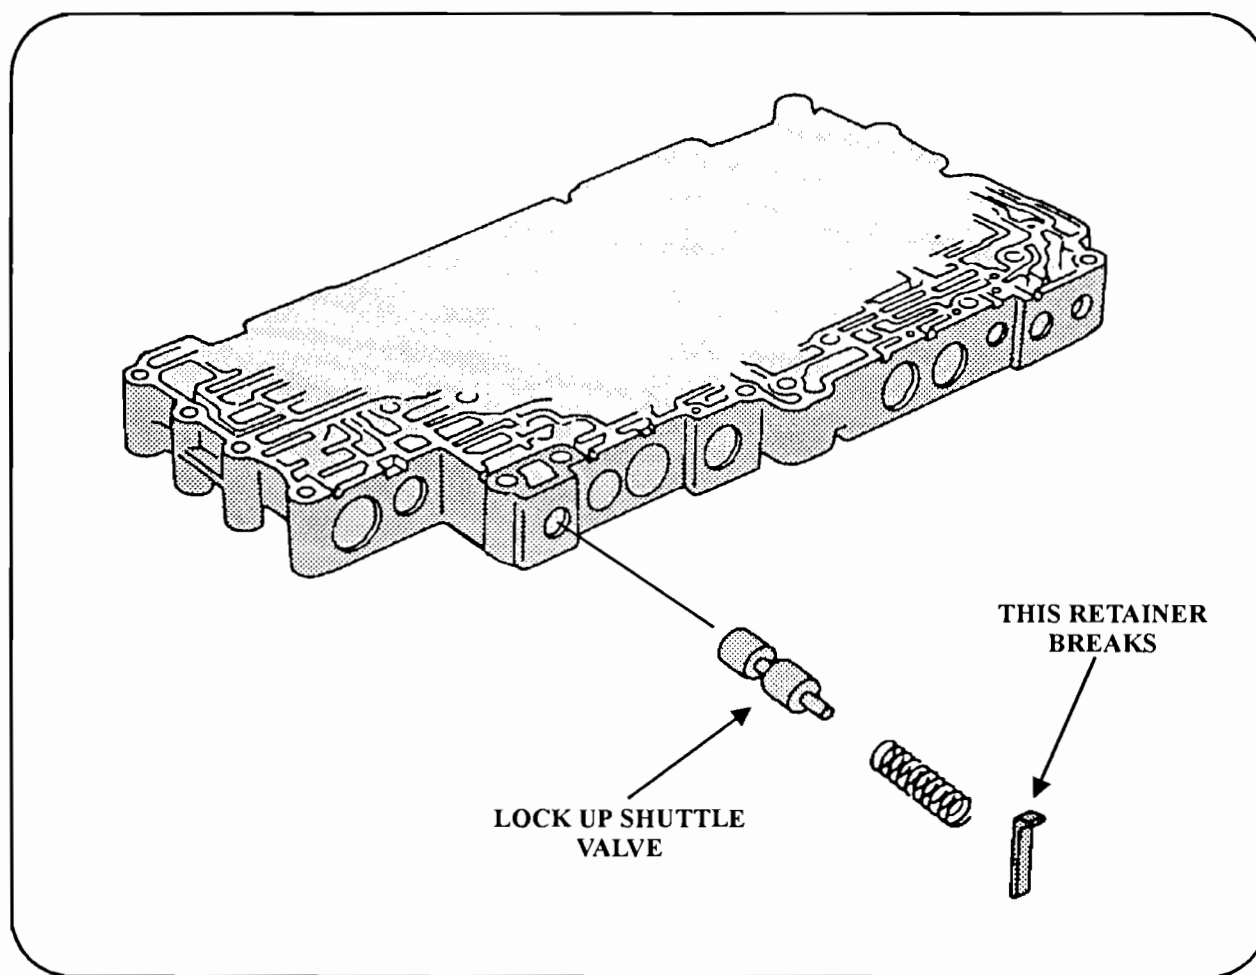
Figure 48

**CAUSE:** The torque converter clutch is immediately applied due to a broken lock up shuttle valve retainer (See figure 48), which has jammed the valve in the apply position.

**CORRECTION:** Free the lock up shuttle valve and replace the retainer

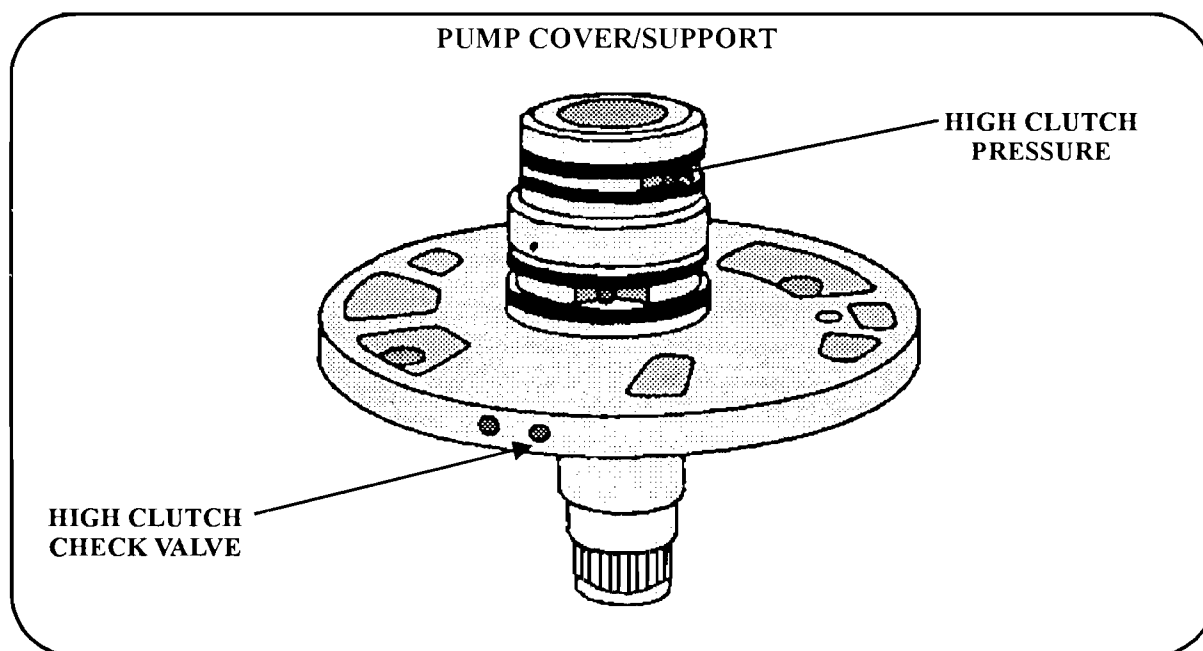
Figure 49

**COMPLAINT:** Premature failure of the high gear clutch.

**CAUSE:** Premature failure of the high gear clutch may be caused by a leaking high clutch check valve, which is located in the pump cover /support. (See figure 49)

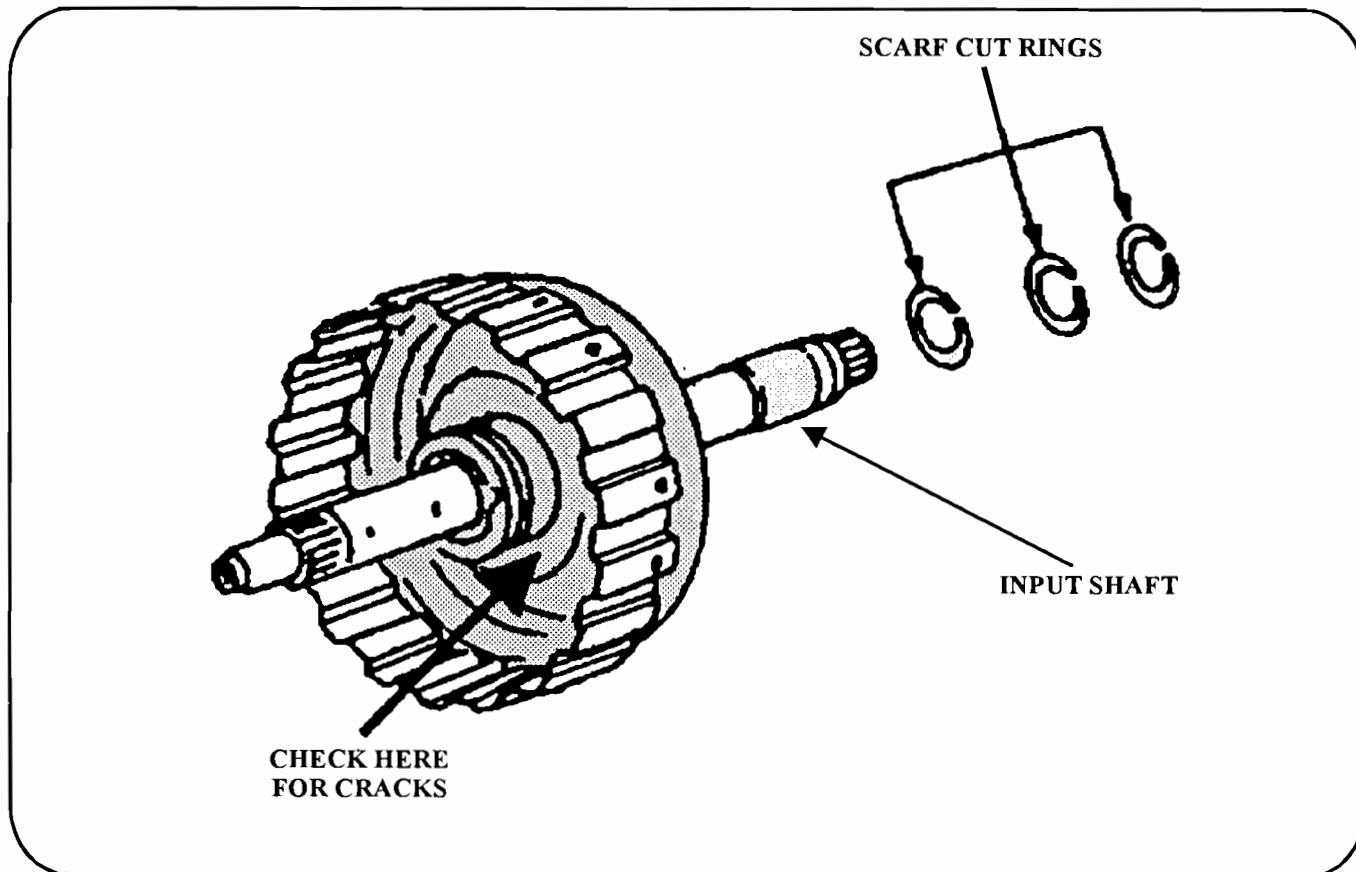
Figure 52

**COMPLAINT:** Some low mileage vehicles equipped with the RL4F03A/V Transaxle may exhibit a flared or slipping 2-3 upshift, or have no 2-3 upshift at all, after the transaxle is warm. UPON DISASSEMBLY AND INSPECTION THERE IS NO VISUAL ROOT CAUSE FOUND FOR THE CONDITION LISTED ABOVE.

**NOTE:** ATSG has found that the Chrysler 413/470 scarf-cut Teflon sealing rings provide much better sealing of direct clutch oil, when they are used on the input shaft in this unit. (See figure 52)

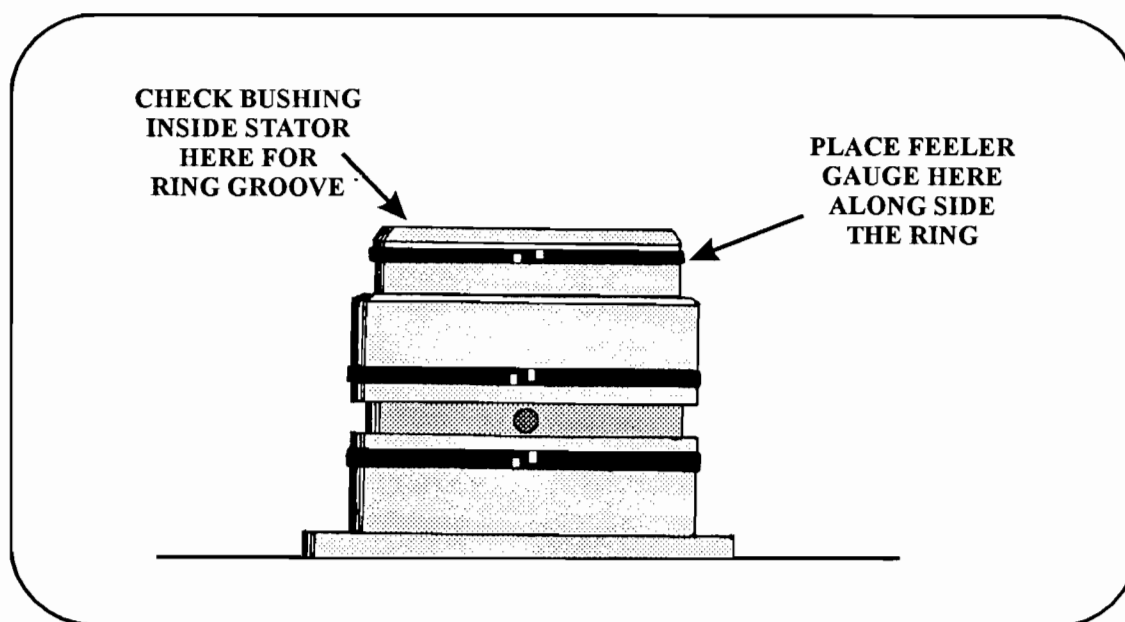
Figure 65

- COMPLAINT:** ZF-4HP-18 transmissions may exhibit a delayed forward engagement or premature forward clutch failure after overhaul.
- CAUSE:** One cause may be that the top sealing ring on the stator may have machined its groove wider causing a leak in the forward clutch circuit. The widening of the groove by the sealing ring is done so well that it may be overlooked during overhaul. Another cause may be the bushing in the stator having a ring groove cut into it by the turbine shaft sealing ring. This will also cause a forward clutch leak (See Figure 65).
- CORRECTION:** If a .040" or greater feeler gauge can fit into the groove along side the sealing ring, the stator will need to be replaced (See Figure 65). If the sealing ring groove is good and the bushing is bad, the bushing is serviced separately by aftermarket companies. Refer to your local supplier.

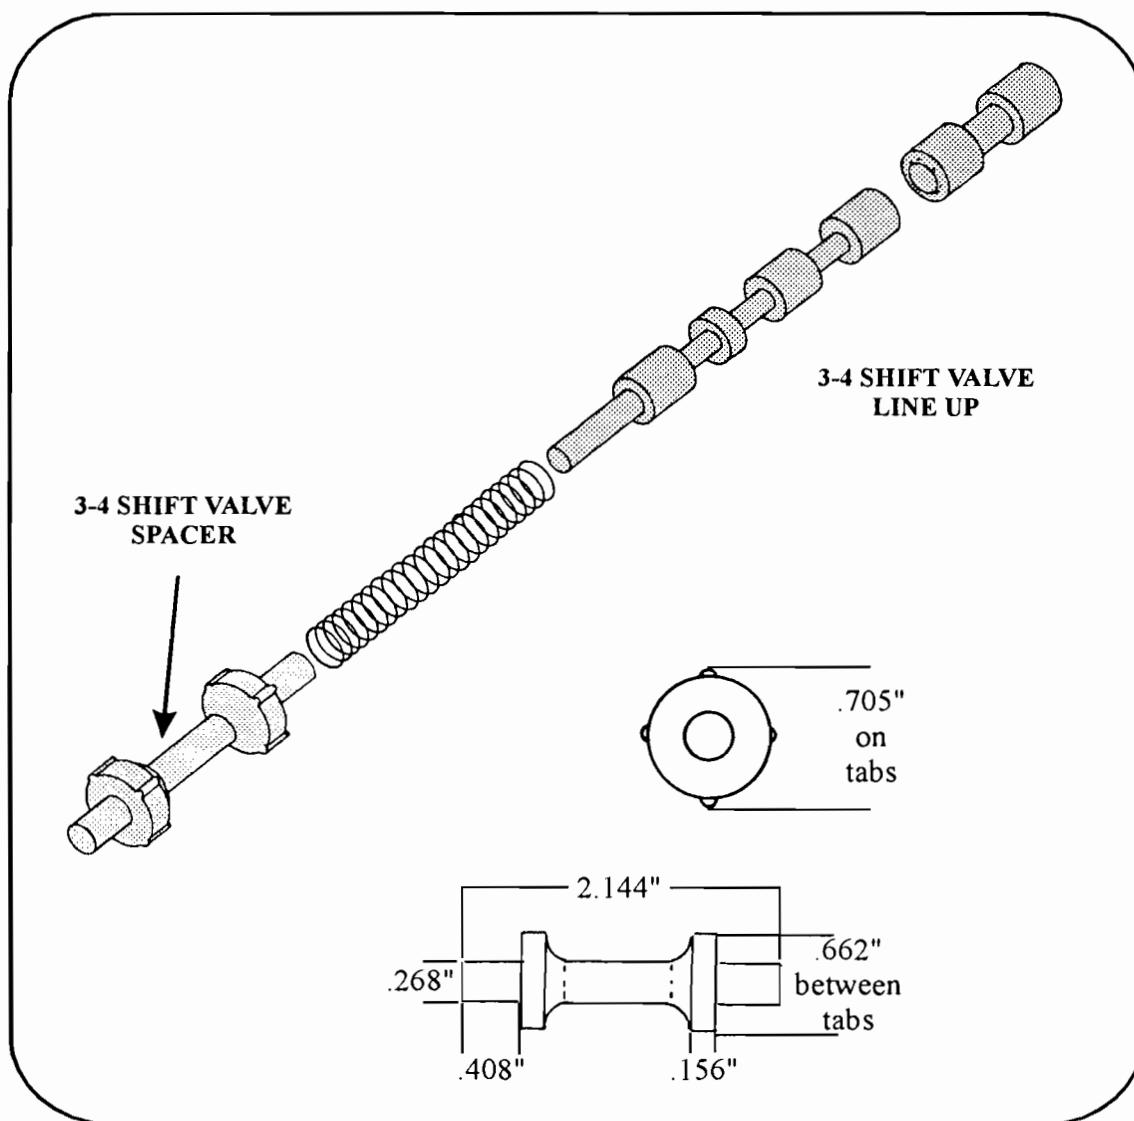
Figure 66

Both Saab and Eagle Premiers may exhibit a no 3-4 shift or a stacked 3-4 shift. One cause may be that the plastic spacer in the 3-4 shift valve line up had melted. The spacer could melt and block the 3-4 shift valve preventing the 3-4 shift, or it could melt and cause a loss of spring tension causing a stacked 3-4 shift. (see figure 66 below). This spacer can be purchased through a local authorized ZF distributor under the part # 1036 326 223. Dimensions of the spacer is provided below in figure 14 in the event one needs to be fabricated.

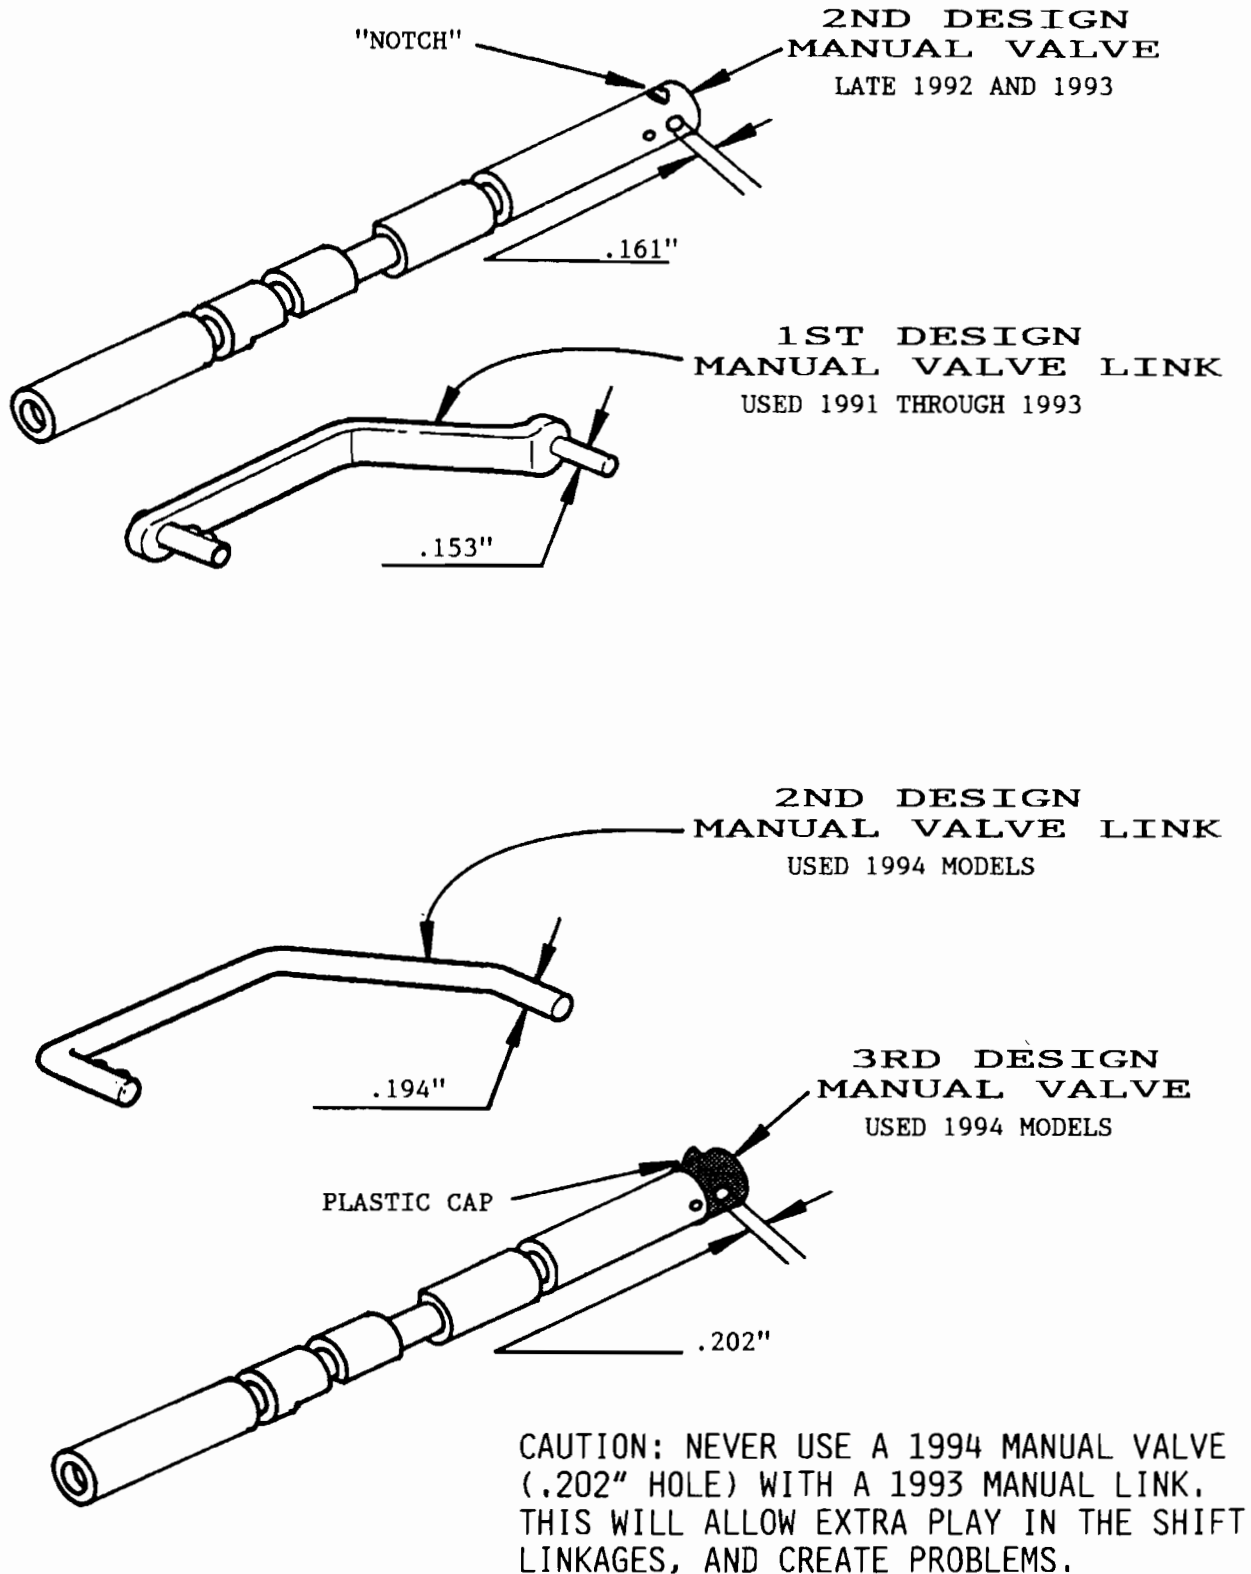
Figure 7

As a result of the change to the Manual Link, the hole in the Manual Valve also had to increase in diameter from .161" to .202", to accommodate the 2nd design manual link (See Figure 7). There was also a plastic cap added to the 1994 (3rd Design) Manual Valve as an assembly aid to prevent the manual valve from being installed to the manual link backwards (See Figure 7).
