AUTOMATIC TRANSMISSION SERVICE GROUP

REVISED EDITION

Since the introduction of the THM 440-T4 Transaxle in April, 1984, there have been many major engineering design changes. These changes have affected nearly every part used in the THM 440-T4. This Update Handbook will explain each change, the parts affected by the change, and any parts interchangeability problems created by the change.

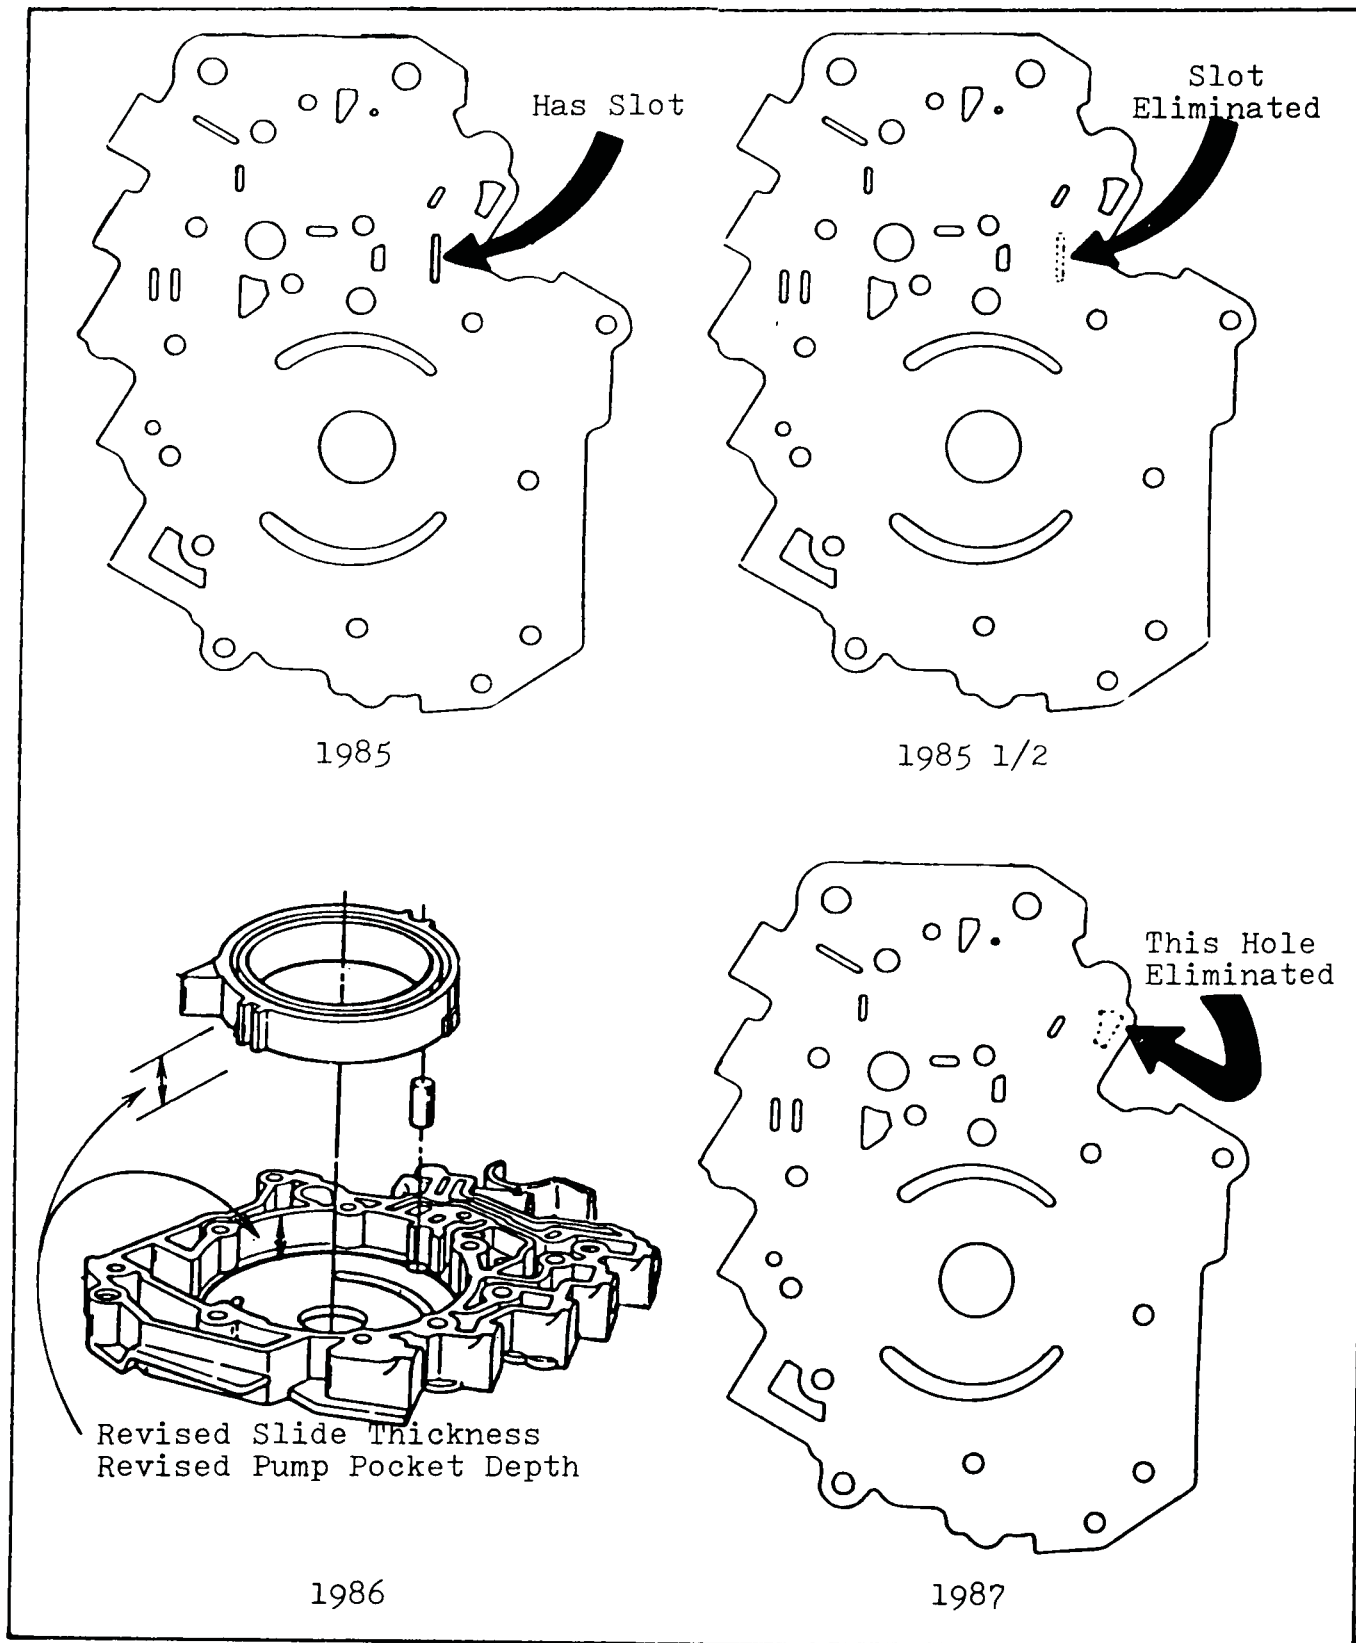
Figure 5

1985	Identification:	Has slot in pump body (See Figure 5).
	Interchangeability:	The 1985 pump body will not work on 1985 1/2 up valve body unless spacer plate is used to eliminate slot. If used without the spacer plate result will be tie-up when transaxle shifts to 4th gear.
1985 1/2	Identification:	Slot in pump body was eliminated (See Figure 5).
	Reason:	Addition of 3-2 TV bias valve in valve body and complete revision of hydraulic circuit for improved 3-2 downshift.
	Interchangeability:	Will interchange on 85 1/2 and 1986 models only.
1986	Identification:	No way to identify from 1985 1/2. Pump pocket depth was made shallower by .001" which created 5 new slide sizes unique to the 1986 pump. See chart on page 6.
	Reason:	Improved pump capacity.
	Interchangeability:	Will interchange with 85 1/2 only, as long as proper slide selection is made to correspond with depth of pump pocket.
1987	Identification:	Hole eliminated in pump body (See Fig. 5).

Reason:	Improved 3-2 downshift. Modulator oil was fed thru the hole in pump body to stroke the 3-2 coastdown valve. Improved 3-2 downshift could be obtained by using servo release oil to stroke the valve, so hole was eliminated and the 3-2 maneuver pipe was added to carry servo release oil to the 3-2 coastdown valve in pump body (See Figure 6). This also made a change in the pump cover necessary with an additional hole and seal to accept the 3-2 maneuver pipe.
	Interchangeability:	Will retro fit back to 85 1/2, and is recommended. The 3-2 maneuver pipe must be used with it. Not interchangeable unless 3-2 maneuver pipe is used.

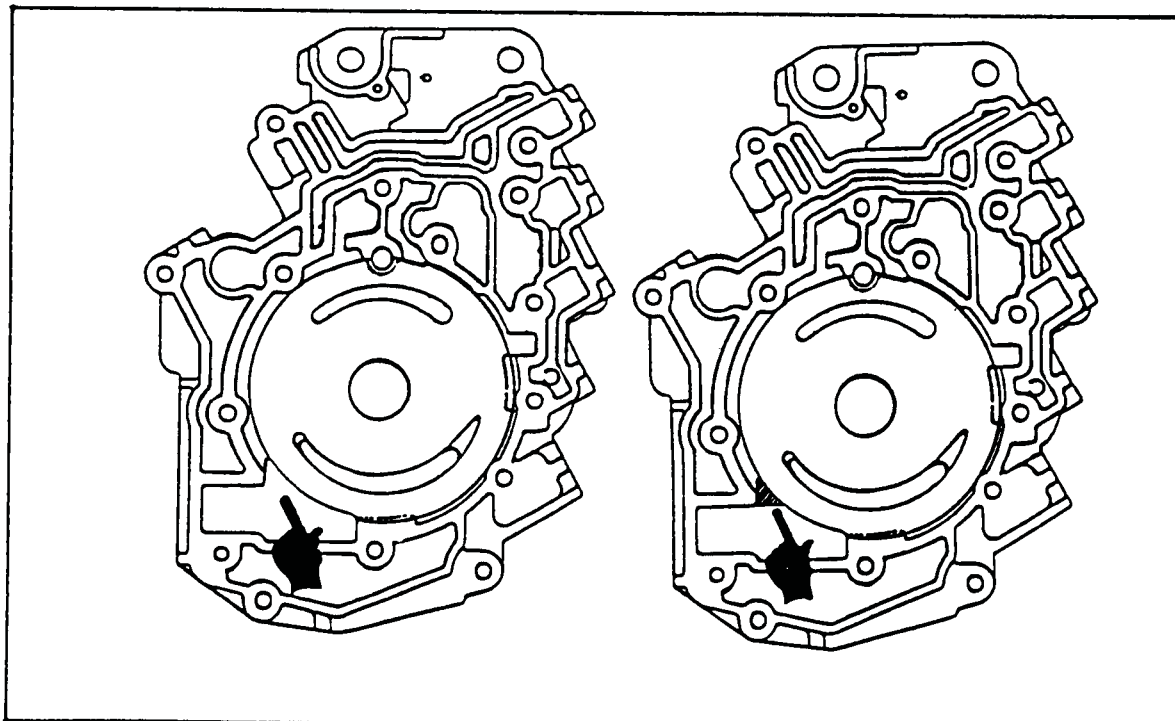
Figure 7

Some 1987 440-T4 transaxles built between November 26, 1986 (Julian Date 330) and January 12, 1987 (Julian Date 012), may exhibit a slip or no drive condition as a result of low line pressure.

This condition may be caused by the pump slide binding on excessive casting flash when the slide is in the low pressure position.

If pressures do not vary with vacuum signal changes, inspect for pump slide bind by removing the oil pump cover and slide springs. If present, excessive flash will cause the slide to bind when the cover is on and torqued.

If flash is present you will have to replace the oil pump assembly, or use a Dremel Tool with a carbide bit and remove flash from 87 model to match contour of 86 model (See Figure 7).

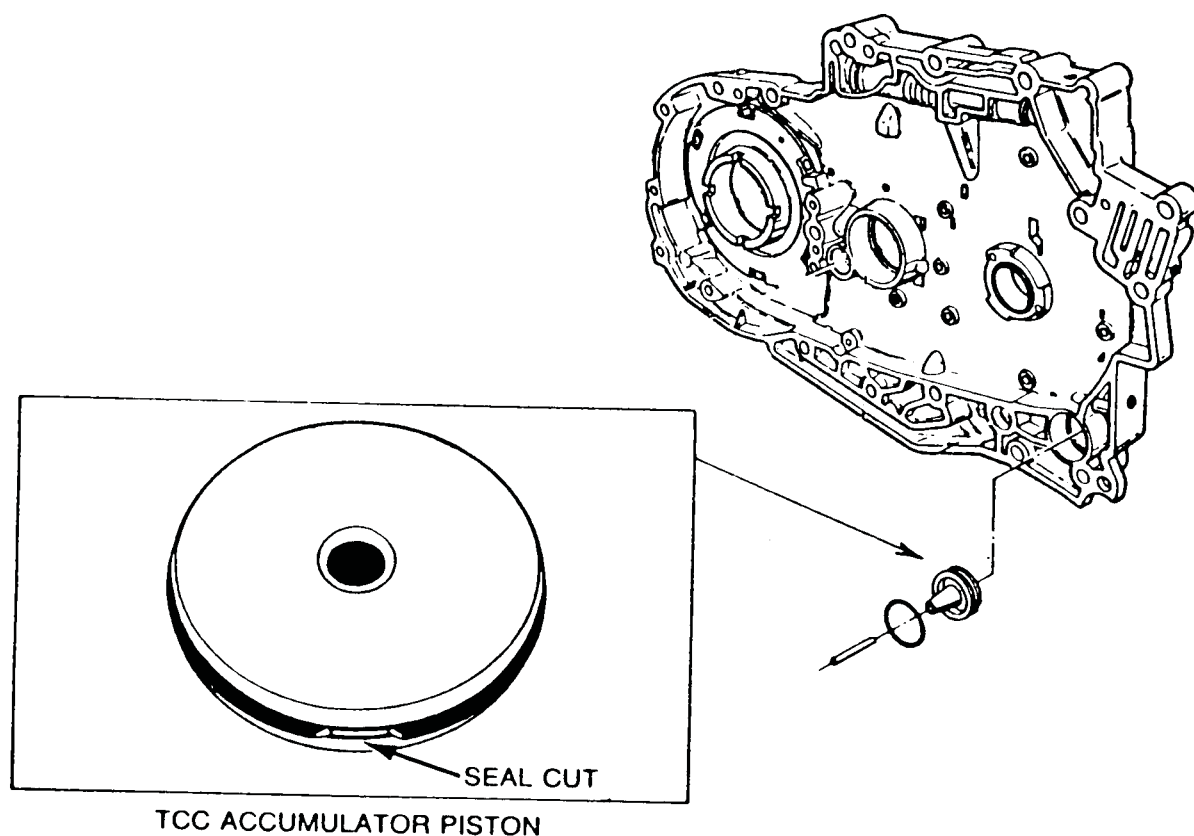
Figure 24

CAUSE: Some 1984 and some early 1985 THM 440-T4 transaxles may experience a no Torque Converter Clutch (TCC) apply or TCC shudder condition, which may be due to a cut or rolled TCC accumulator piston seal (See Figure 24).

CORRECTION: Install updated service package 8646926.
Updated service package 8646926 contains the following:

1. 1-TCC ACCUMULATOR PISTON
2. 1-TCC ACCUMULATOR PISTON PIN
3. 1-TCC ACCUMULATOR PISTON SEAL

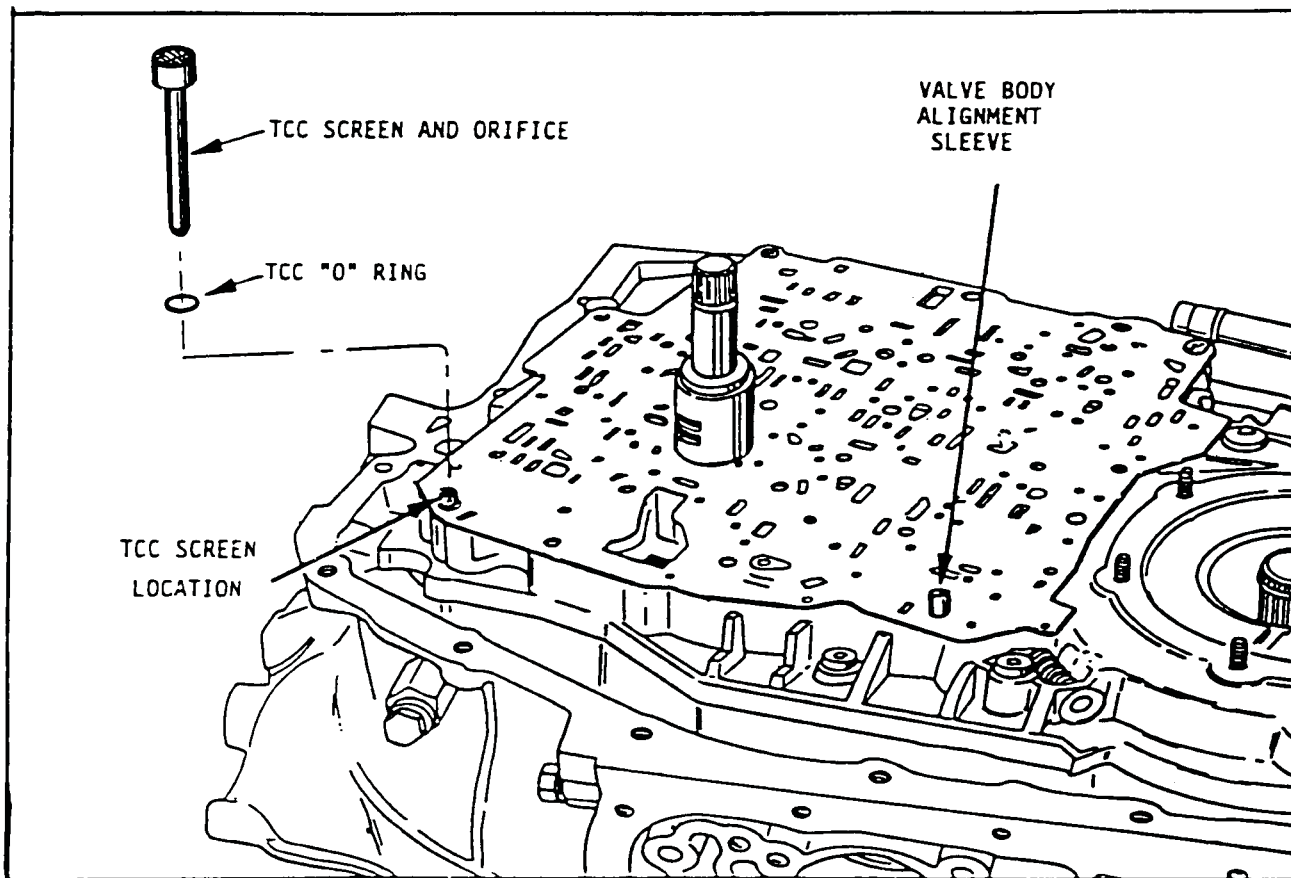
Figure 62

- COMPLAINT:** Premature lock-up - Sometimes described as no lock-up.
- CAUSE:** The cause may be a missing TCC screen and orifice (See Figure 62). If the TCC screen and orifice are left out of the 440-T4, the converter clutch will apply on the 1-2 shift because of the solenoids inability to exhaust TCC signal oil there by stroking the lock-up valve. The TCC screen and orifice must be in place, as well as the "O" ring (See Figure 62). The TCC screen "Snaps" into the spacer plate.
- CORRECTION:** Install the TCC screen and "O" ring into spacer plate in location shown in Figure 62. First install "O" ring on TCC screen and then "Snap" into place in the spacer plate. OEM part numbers as follows;
- TCC Screen and Orifice 8658060
"O" Ring, TCC Screen 8658109
