Technical Service Information

FORD VILLAGER/NISSAN QUEST 4F20E/RE4F04A SLIPS, DELAYS OR NO REVERSE

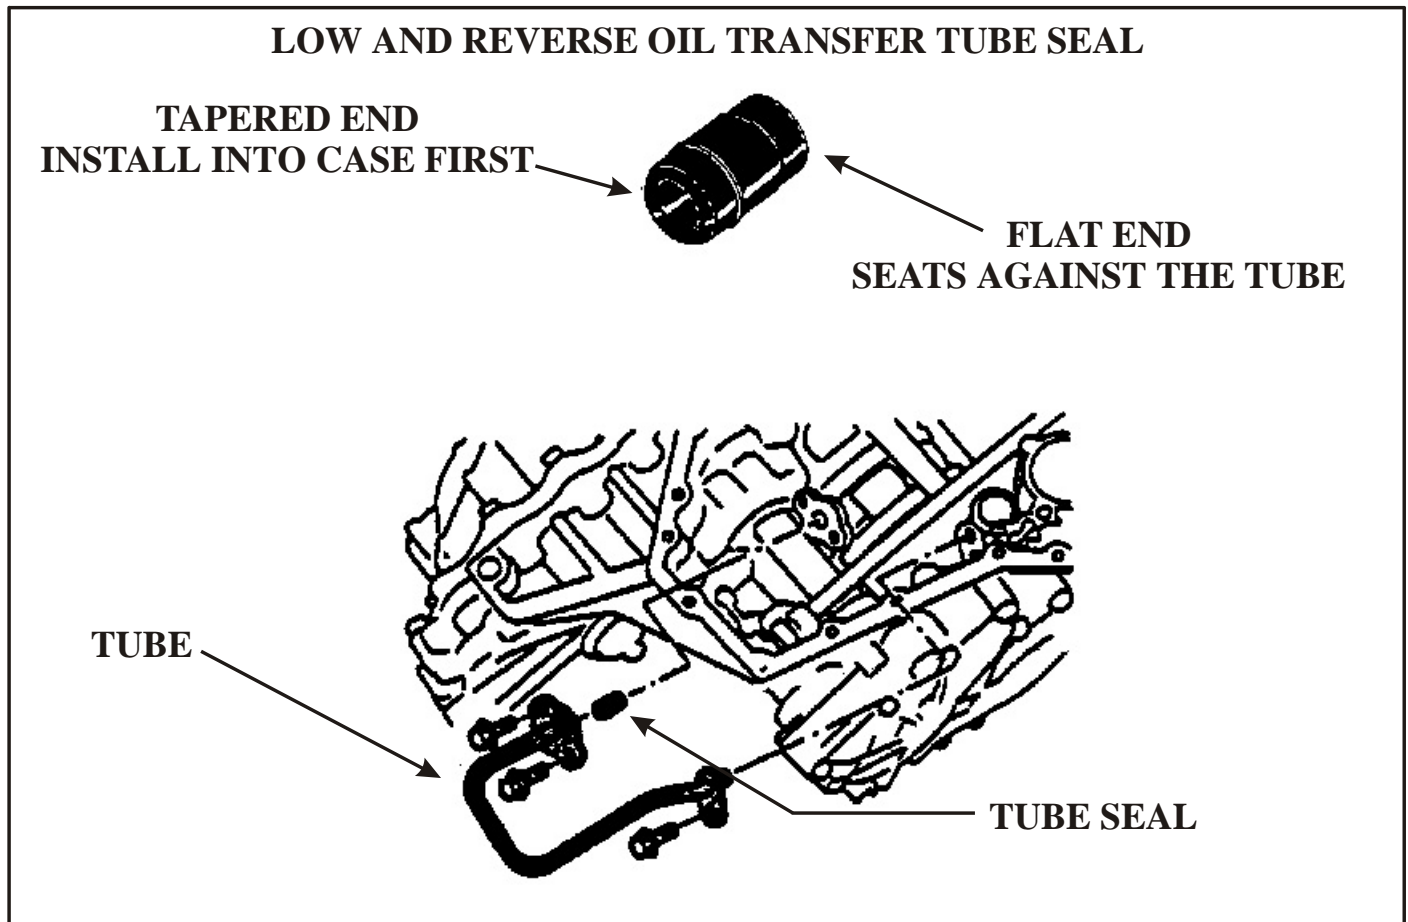
COMPLAINT: *After overhaul*, vehicle exhibits a slip, delay and or “NO Reverse.”

CAUSE: The cause may be, during overhaul the tube seal for the “Low and Reverse” oil transfer tube was damaged on disassembly and not replaced or the tube seal was installed backwards. The “Low and Reverse” oil transfer tube is located under the valve body and is attached to the case with three bolts. NOTE: The tube seal normally will not fall out of the case, when the tube is removed and is not always provided in overhaul kits.

CORRECTION: Refer to Figure 1 to identify the location of the “Low and Reverse” oil transfer tube and the identification and correct installation of the tube seal.

“LOW AND REVERSE OIL TRANSFER TUBE SEAL”(FORD#) . . . F3XY-7G085-A
