Technical Service Information

THM 4L80-E BUZZING NOISE IN PARK/NEUTRAL

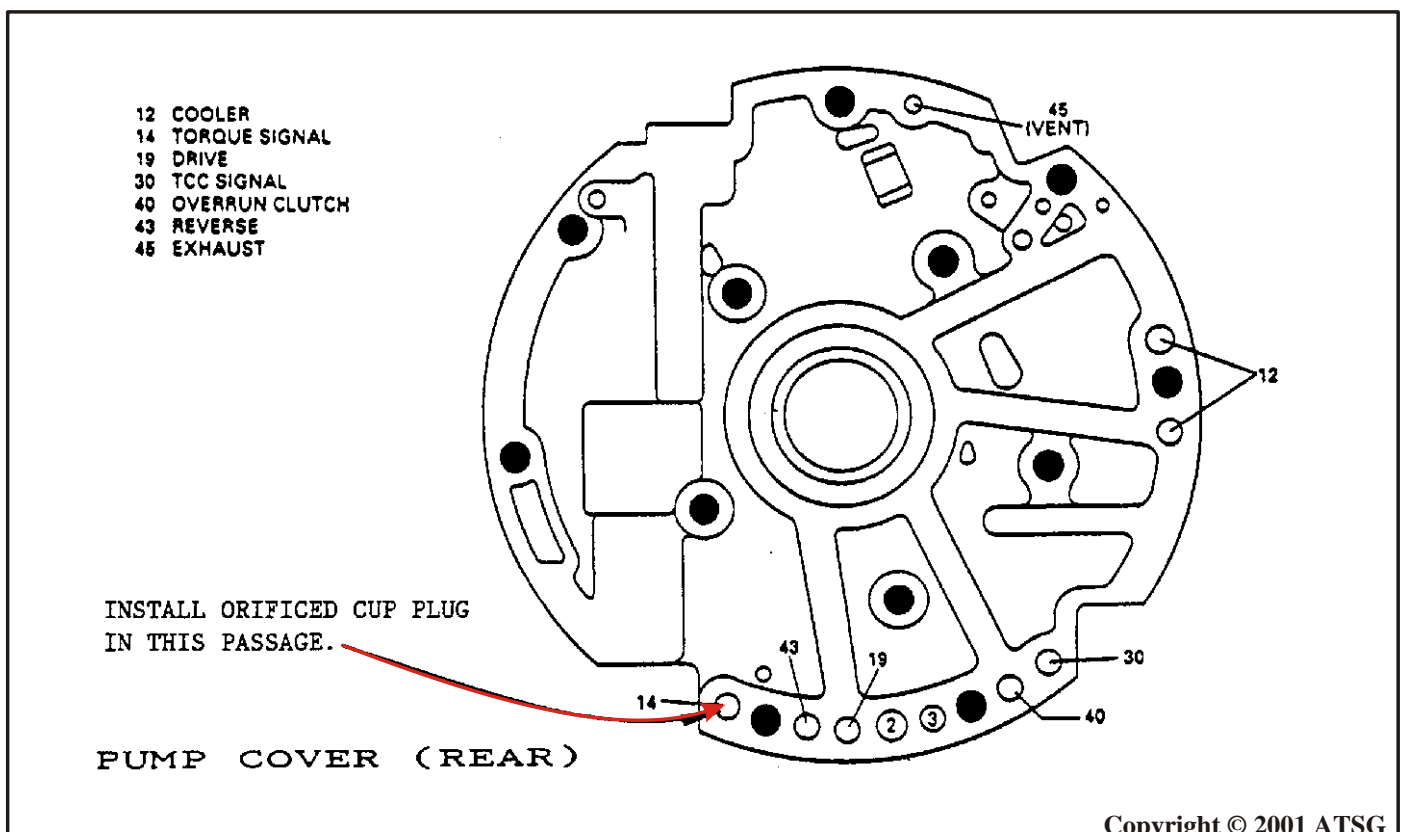
COMPLAINT: Some Hydra-matic 4L80-E/4L80-EHD transmissions may exhibit a buzzing or vibration noise while the selector lever is in the park or neutral position.

CAUSE: The cause may be, line pressure instability in the pressure regulator valve line-up located in the pump cover.

CORRECTION: The correction requires two steps:
STEP 1. There is now available from OEM, a new service package that includes an "Added" isolater spring, inside of the normal pressure regulator spring (See Figure 2).
The new service package is available under OEM part number 8682998. Refer to Figure 1 for proper assembly. NOTE: Ensure that the snap ring is installed with the flat side facing away from the boost sleeve.
STEP 2. Install a 9/32" diameter cup plug, with a .075" orifice hole drilled in the center of the cup plug, into the torque signal oil passage of the pump cover (See Figure 1).
