Technical Service Information

NISSAN RE5R05A TCM FUSE BLOWS

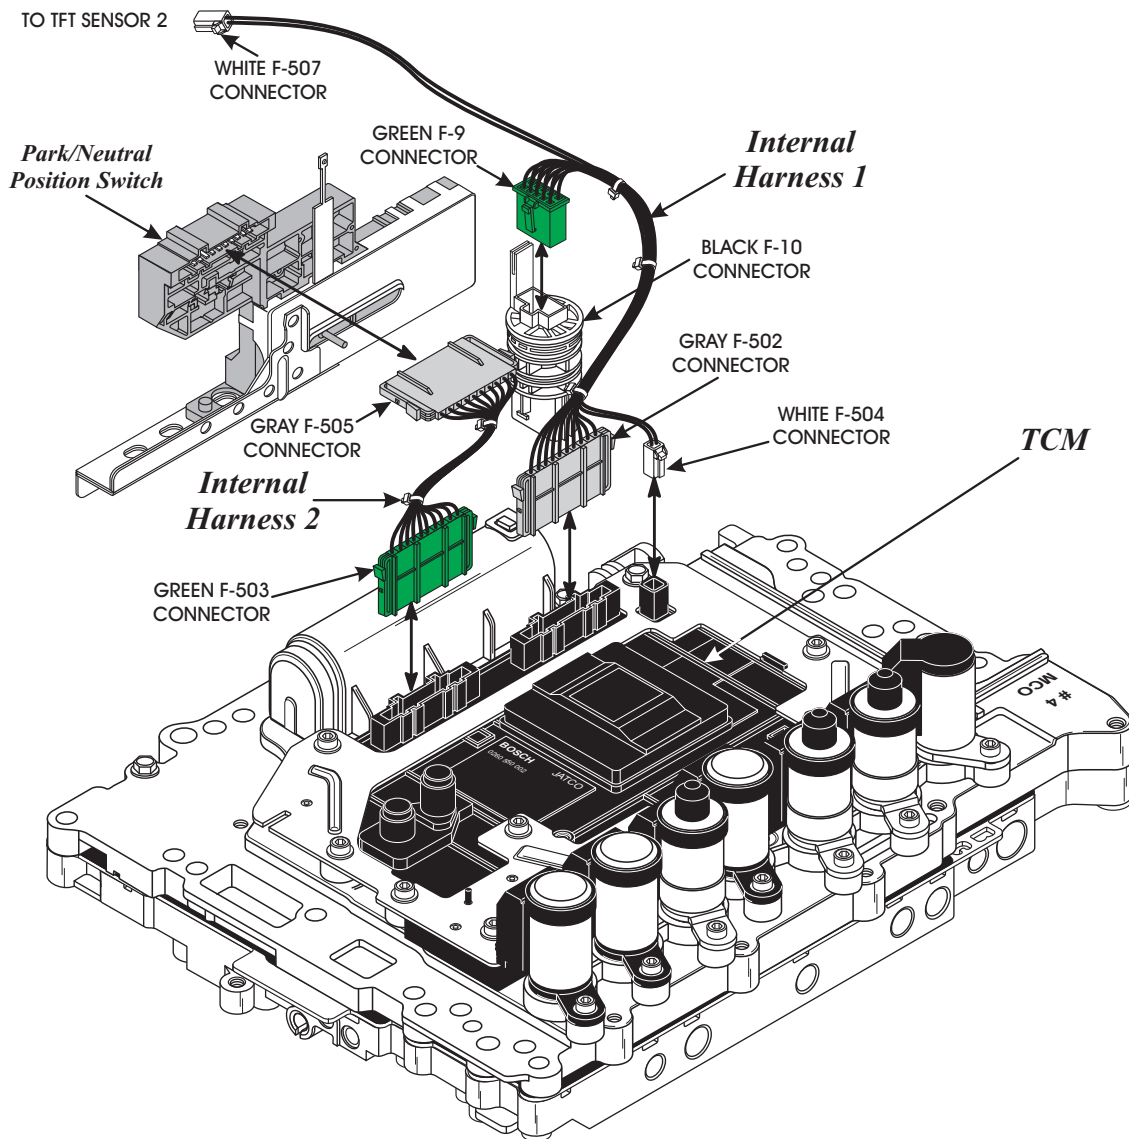
Figure 2

NISSAN RE5R05A WITH INTERNAL TCM

- Internal Harness 1**
- 10 pin "Gray" connector to TCM.
 - 2 pin "White" connector to TCM.
 - 10 pin "Green" connector to pass-thru case connector.
 - 2 pin "White" connector to TFT Sensor 2 connector.
- Internal Harness 2**
- 10 pin "Gray" connector to Park/Neutral Position Switch.
 - 10 pin "Green" connector to TCM.

CORRECTION: To correct this condition, refer to figure 2 to locate the F-502 connector, which is connected to internal harness 1 that leads to the green F-9 connector, which is connected the Transmission Control Module. Connector F-505 connects to internal harness 2, which connects to the Park/Neutral position switch. **Note:** both of these connectors are gray and have the exact same configuration so cross-connecting them is very easy. Refer to figure 3 for connector I.D. and configuration. Refer to Figure 4 for a wire schematic of the TCM, internal harness 1 and 2 and the case connector.

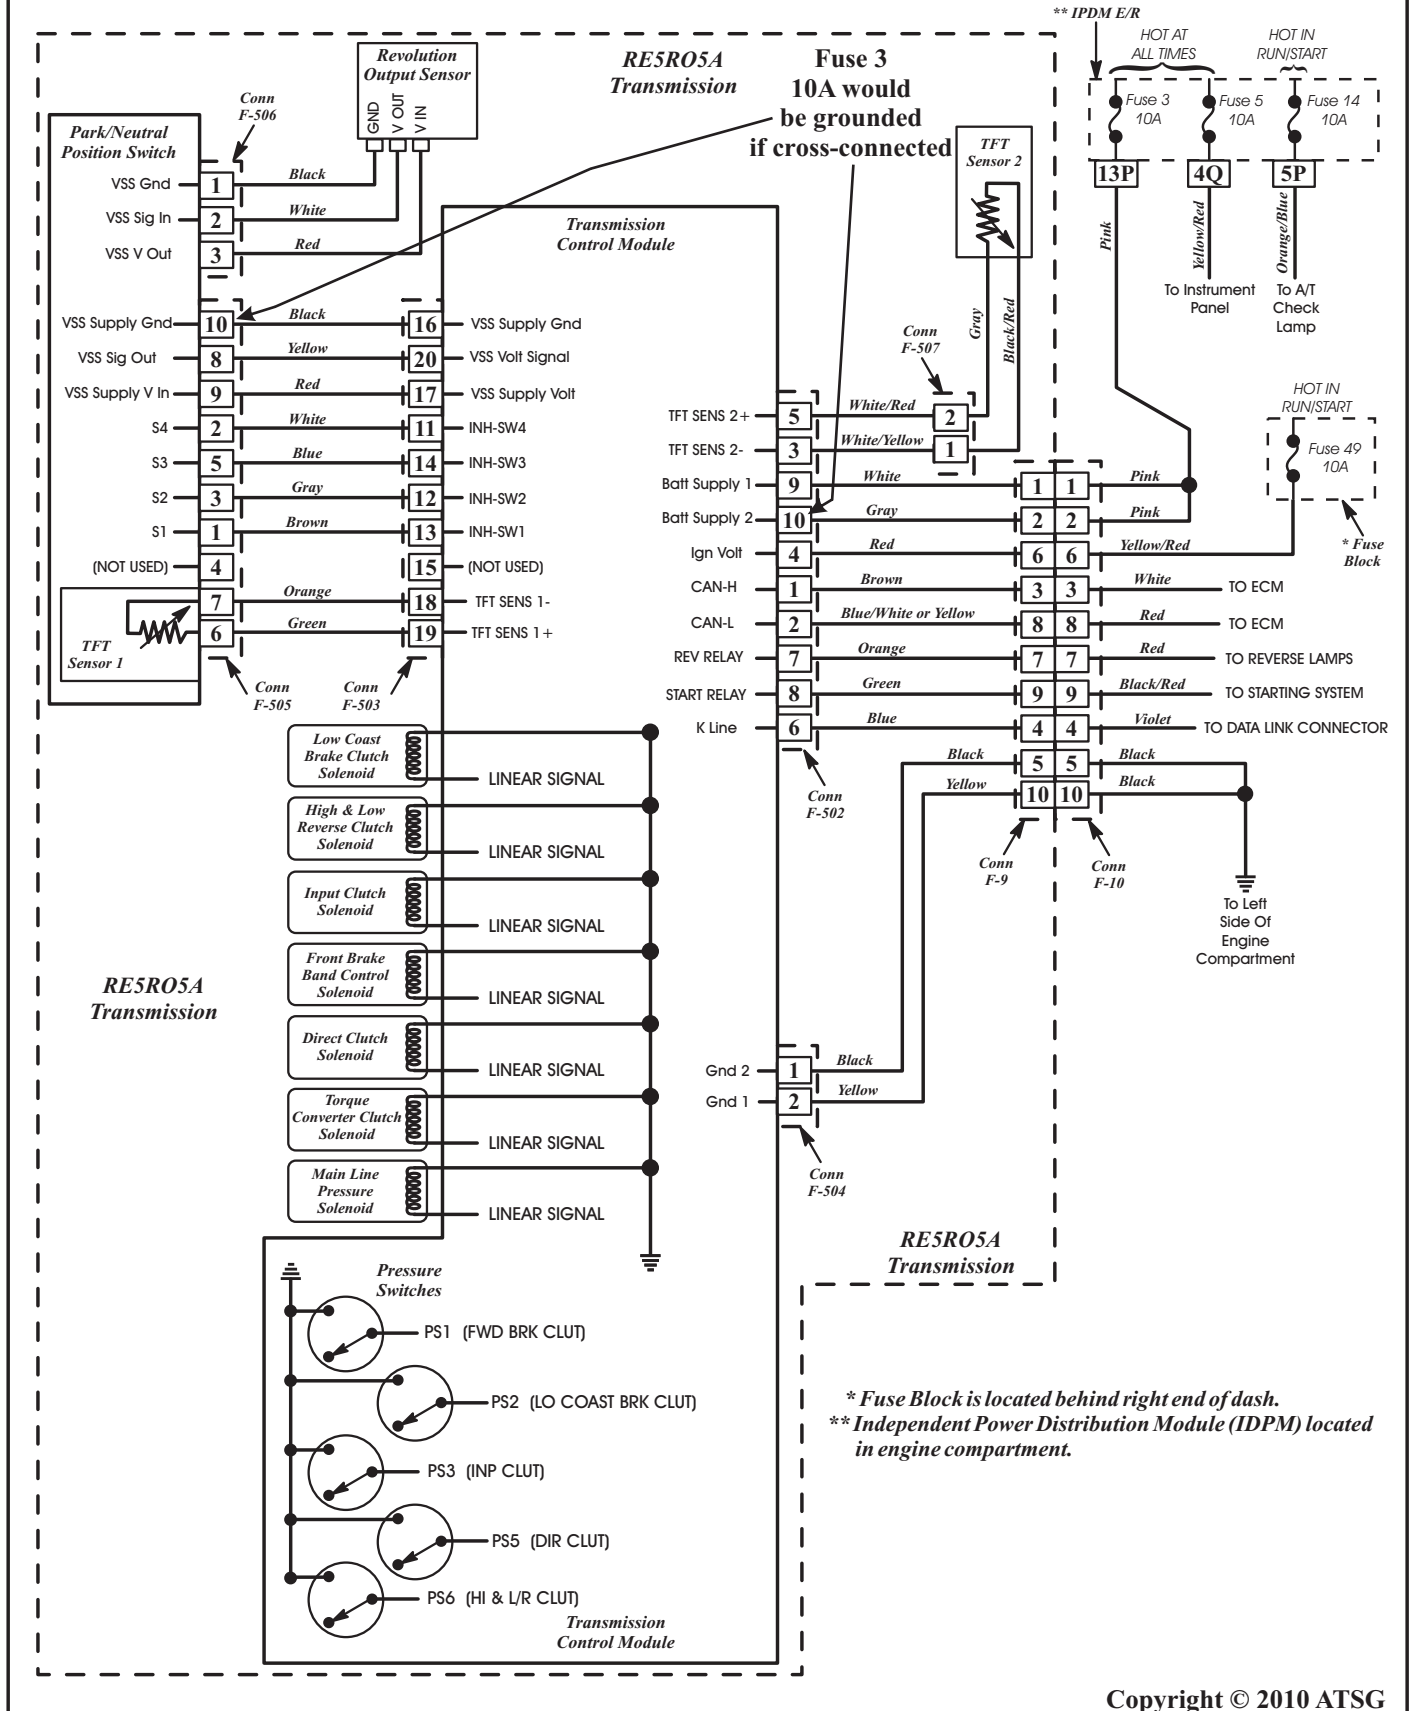
Figure 4

RE5R05A PARTIAL WIRE SCHEMATIC

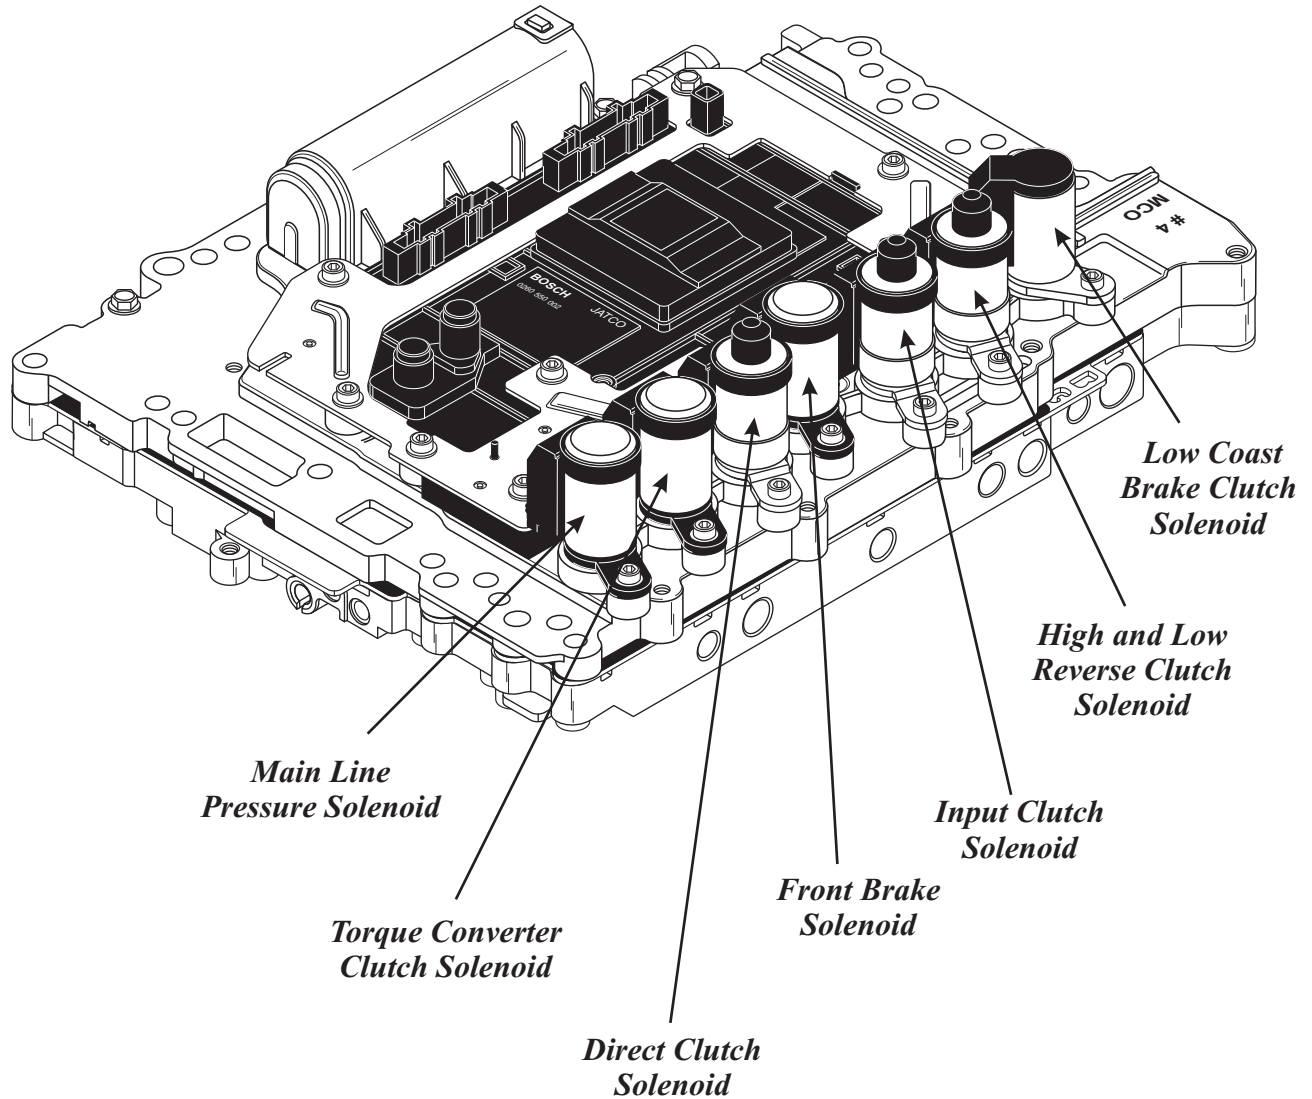
Figure 5

Special Note: In the 2008 Seminar we provided information on Solenoid Identification that was unfortunately incorrect, please refer to figure 5 for the correct solenoid locations for the RE5R05A.

NISSAN RE5R05A SOLENOID LOCATIONS
