Technical Service Information

THM 200-4R SECOND GEAR STARTS

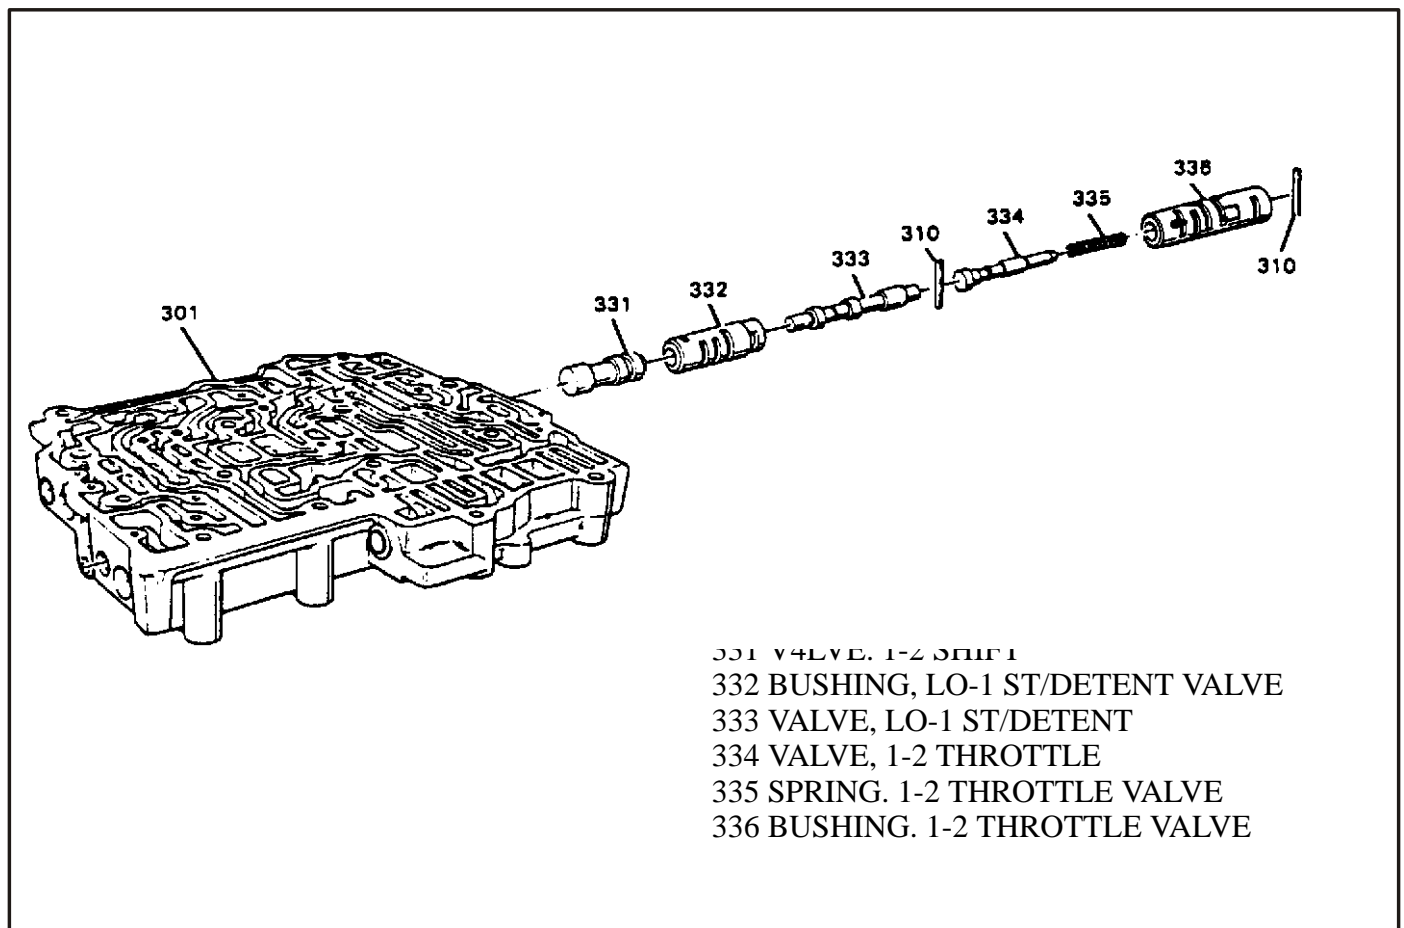
COMPLAINT: No 2-1 coastdown shift in cold weather conditions, and then may exhibit normal operating conditions after warm.

CAUSE: The cause may be an incorrect 1-2 throttle valve spring (See Figure 1). This affects ONLY 1987-1988 models CCF, CHF, CRF, CTF, CYF, and CZF.

CORRECTION: Replace the 1-2 throttle valve spring, available under OEM part number 8643619. Refer to Figure 1 for proper assembly of valves and sleeves.
