4L60/65/70E

PUMP & INPUT SHAFT USAGE

Technical Service Information

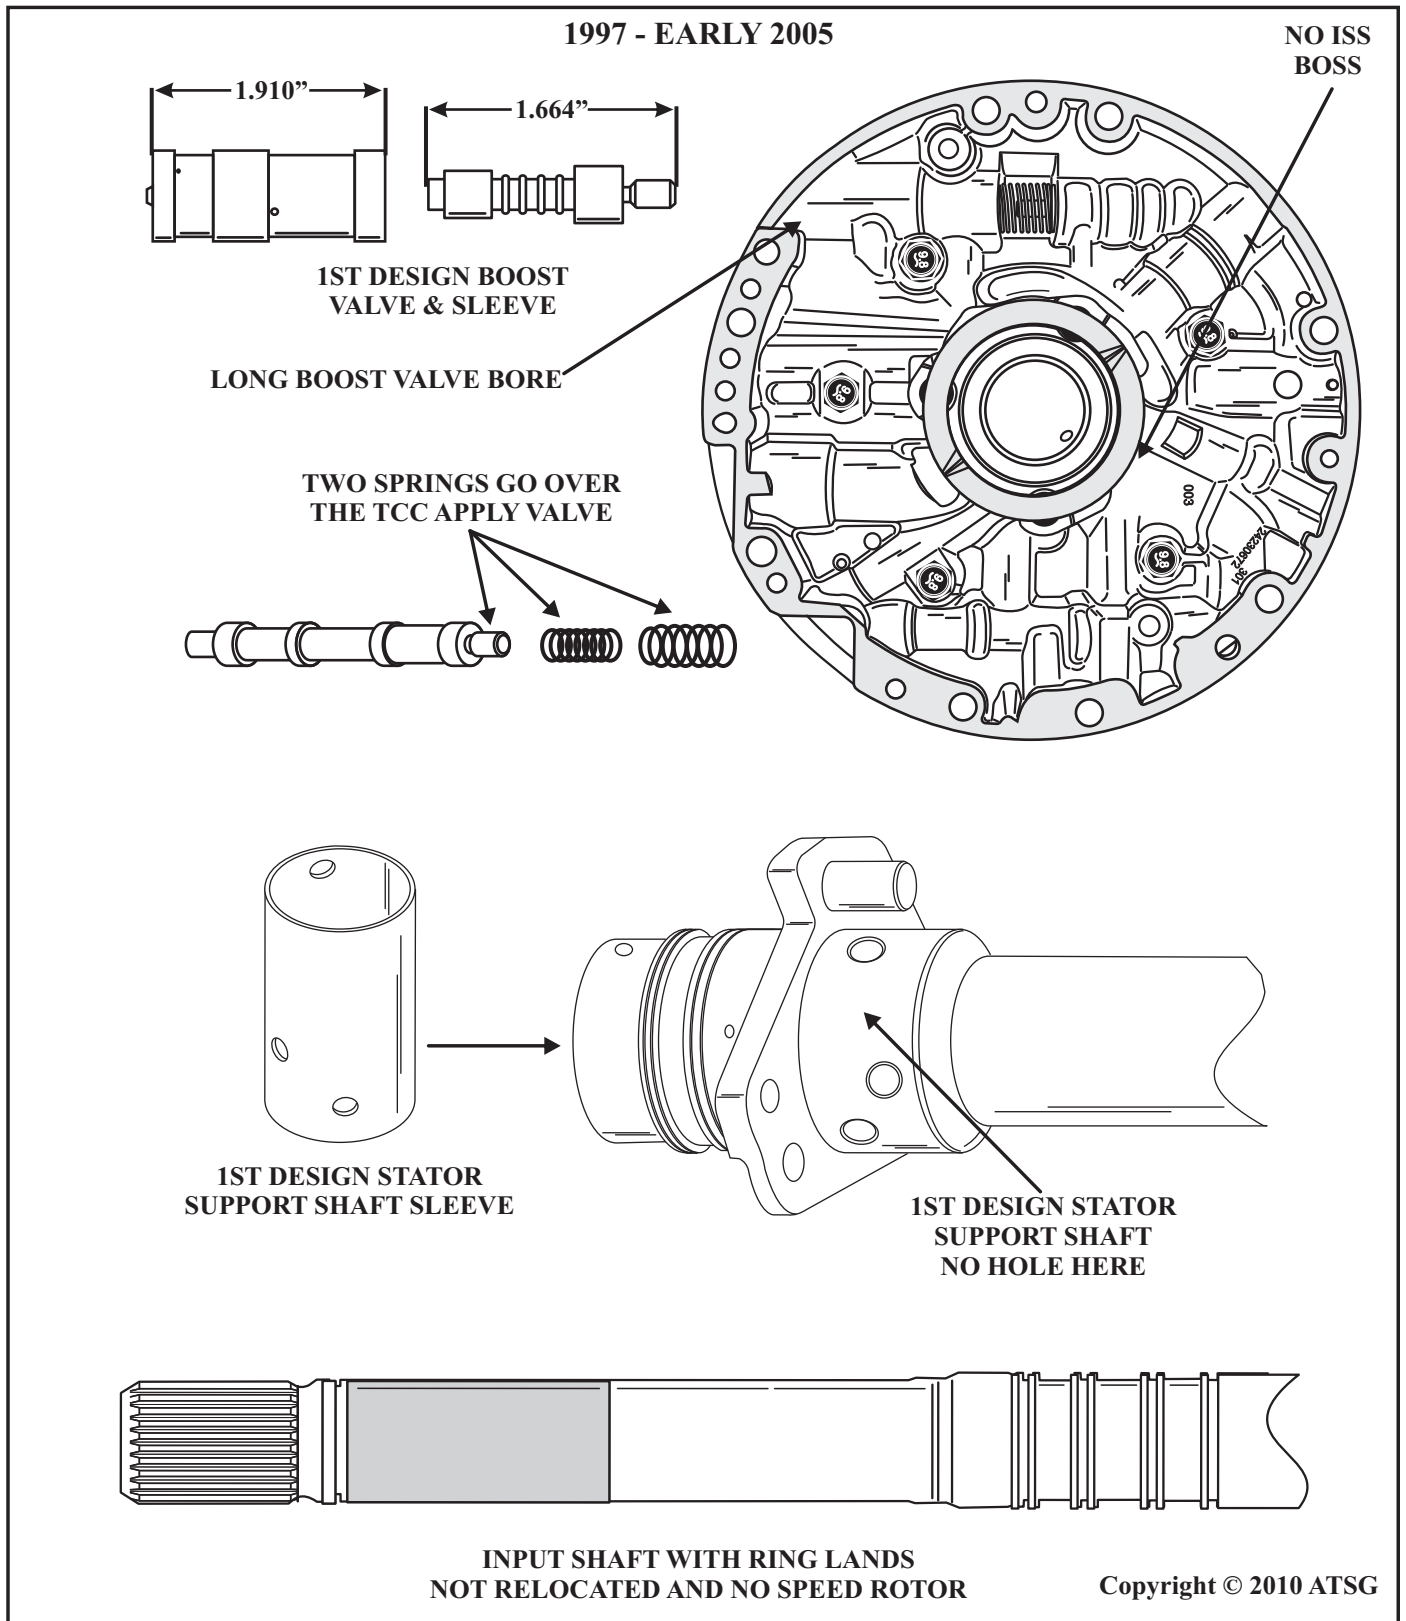
Figure 1

(1) In model years 1997 to early 2005, the 4L60E series transmissions utilized a pump cover with no provisions for an ISS, the input shaft sealing ring grooves had not changed and there was no speed sensor rotor. The pump cover used the 1st design internal stator shaft sleeve and the 1st design boost valve which is 1.664" with a boost valve sleeve of 1.910" in length as well as two springs that went on the TCC apply valve, (Refer to Figure 1).

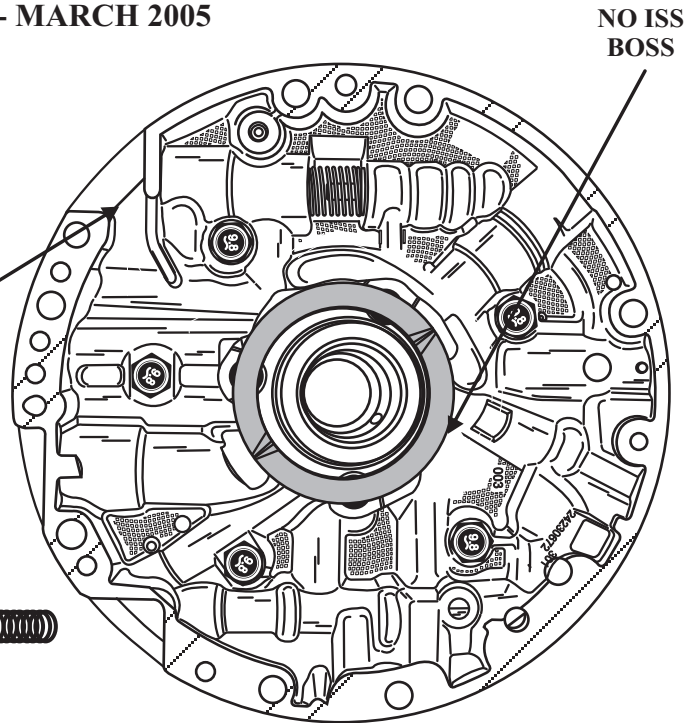
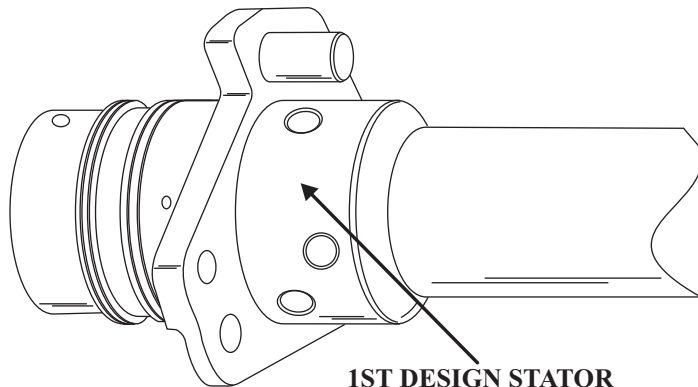
Figure 2

(2) Effective February 1st, 2005, the oil pump cover now uses a new design TCC valve with a single spring, (Refer to Figure 2).

(3) Effective March 7th, 2005, the oil pump cover now uses a more compact boost valve and sleeve. The snap ring groove location for the boost sleeve is now situated 2.57" from the bottom of the bore compared to 2.68" for the previous design. The bore length for the boost sleeve and snap ring has been reduced by approximately 0.110", also seen in Figure 2.

2ND DESIGN BOOST
VALVE & SLEEVE

THE BOOST VALVE BORE
HAS BEEN SHORTENED .106"

ONE SPRING GOES INTO
THE TCC APPLY VALVE

1ST DESIGN STATOR
SUPPORT SHAFT SLEEVE

1ST DESIGN STATOR
SUPPORT SHAFT
NO HOLE HERE

INPUT SHAFT WITH RING LANDS
NOT RELOCATED AND NO SPEED ROTOR

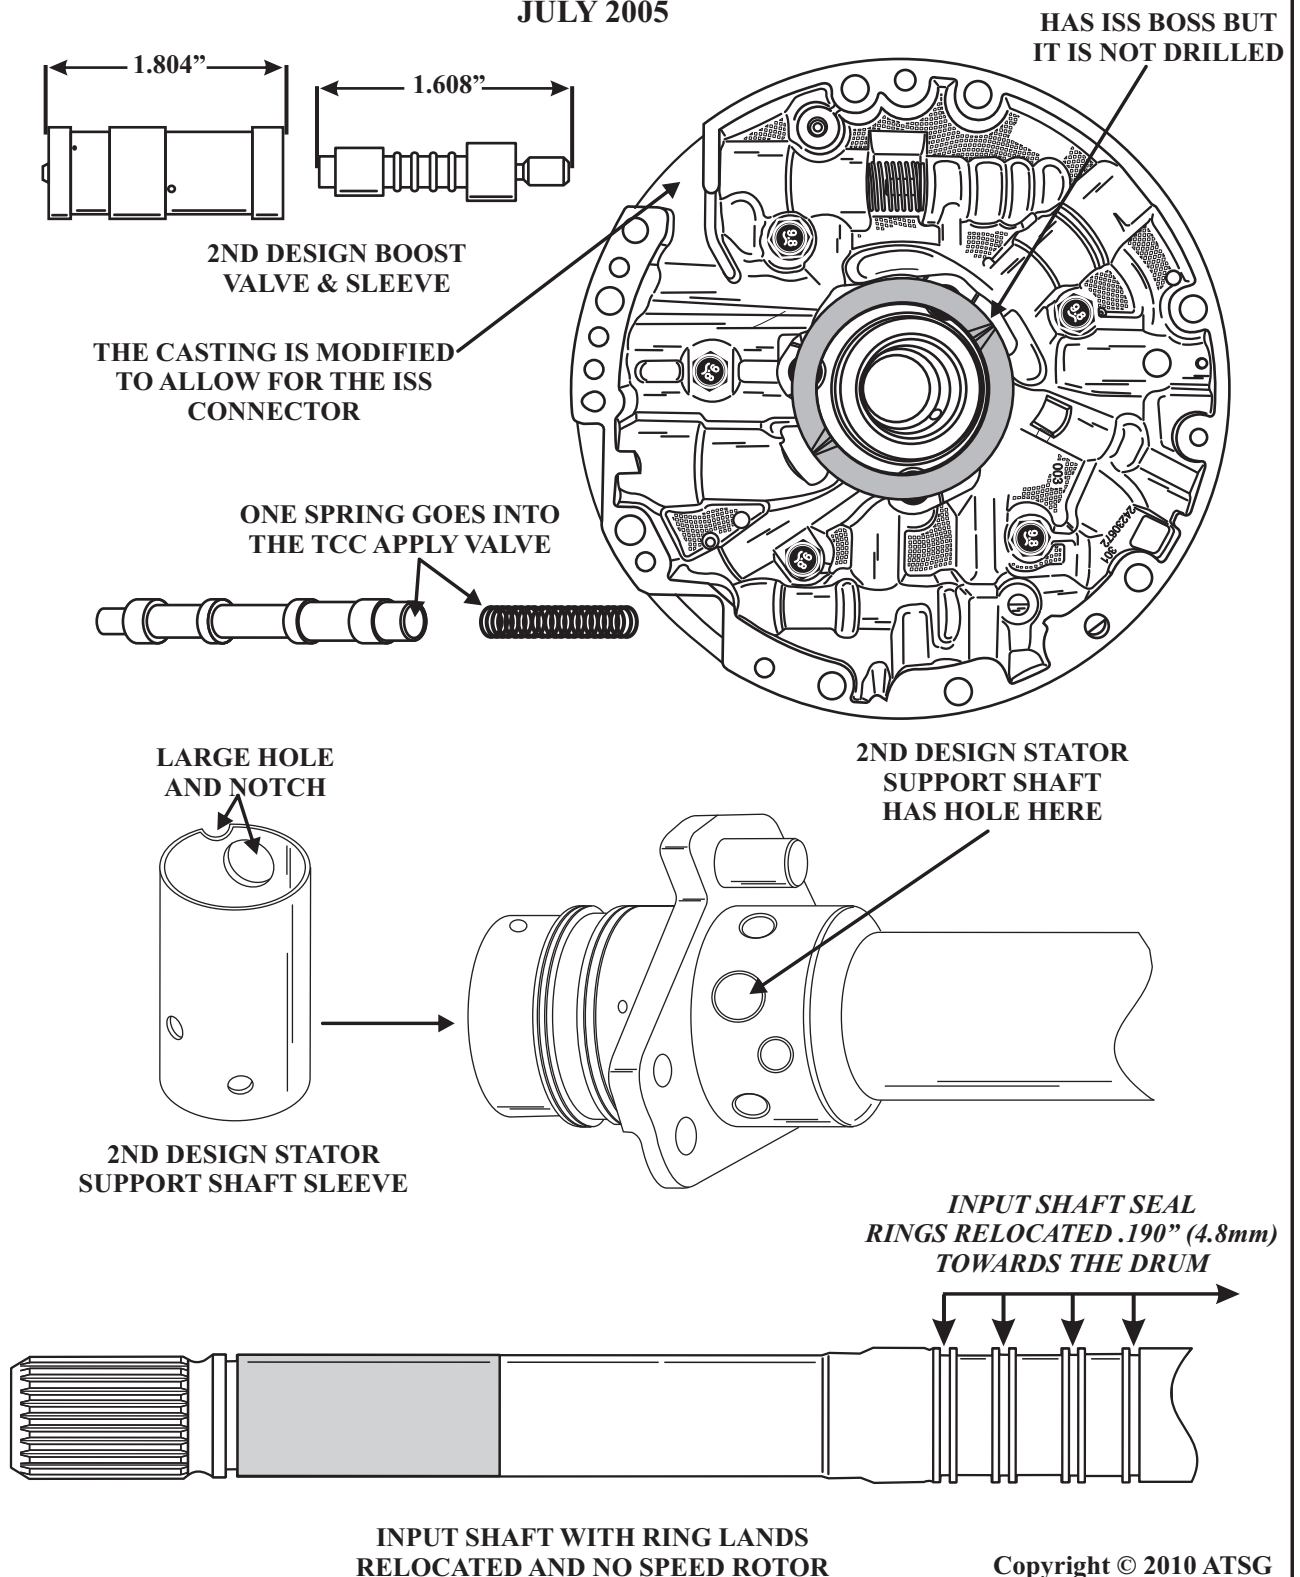
Figure 3

(4) After July 16th, 2005, the pump cover casting was modified in order to situate the ISS connector. This modification removed metal directly below the PR valve and boost sleeve bore and extended a cast wall inward. The internal TCC release passage was also modified at this time. The ISS mounting holes are not yet machined into the oil pump cover, (Refer to Figure 3).

At the same time, the turbine shaft oil seal ring grooves were moved inboard towards the rear of the unit approximately 0.190"(in.) to produce an area with which to manufacture 15 rotor teeth, this can also be seen in Figure 3.

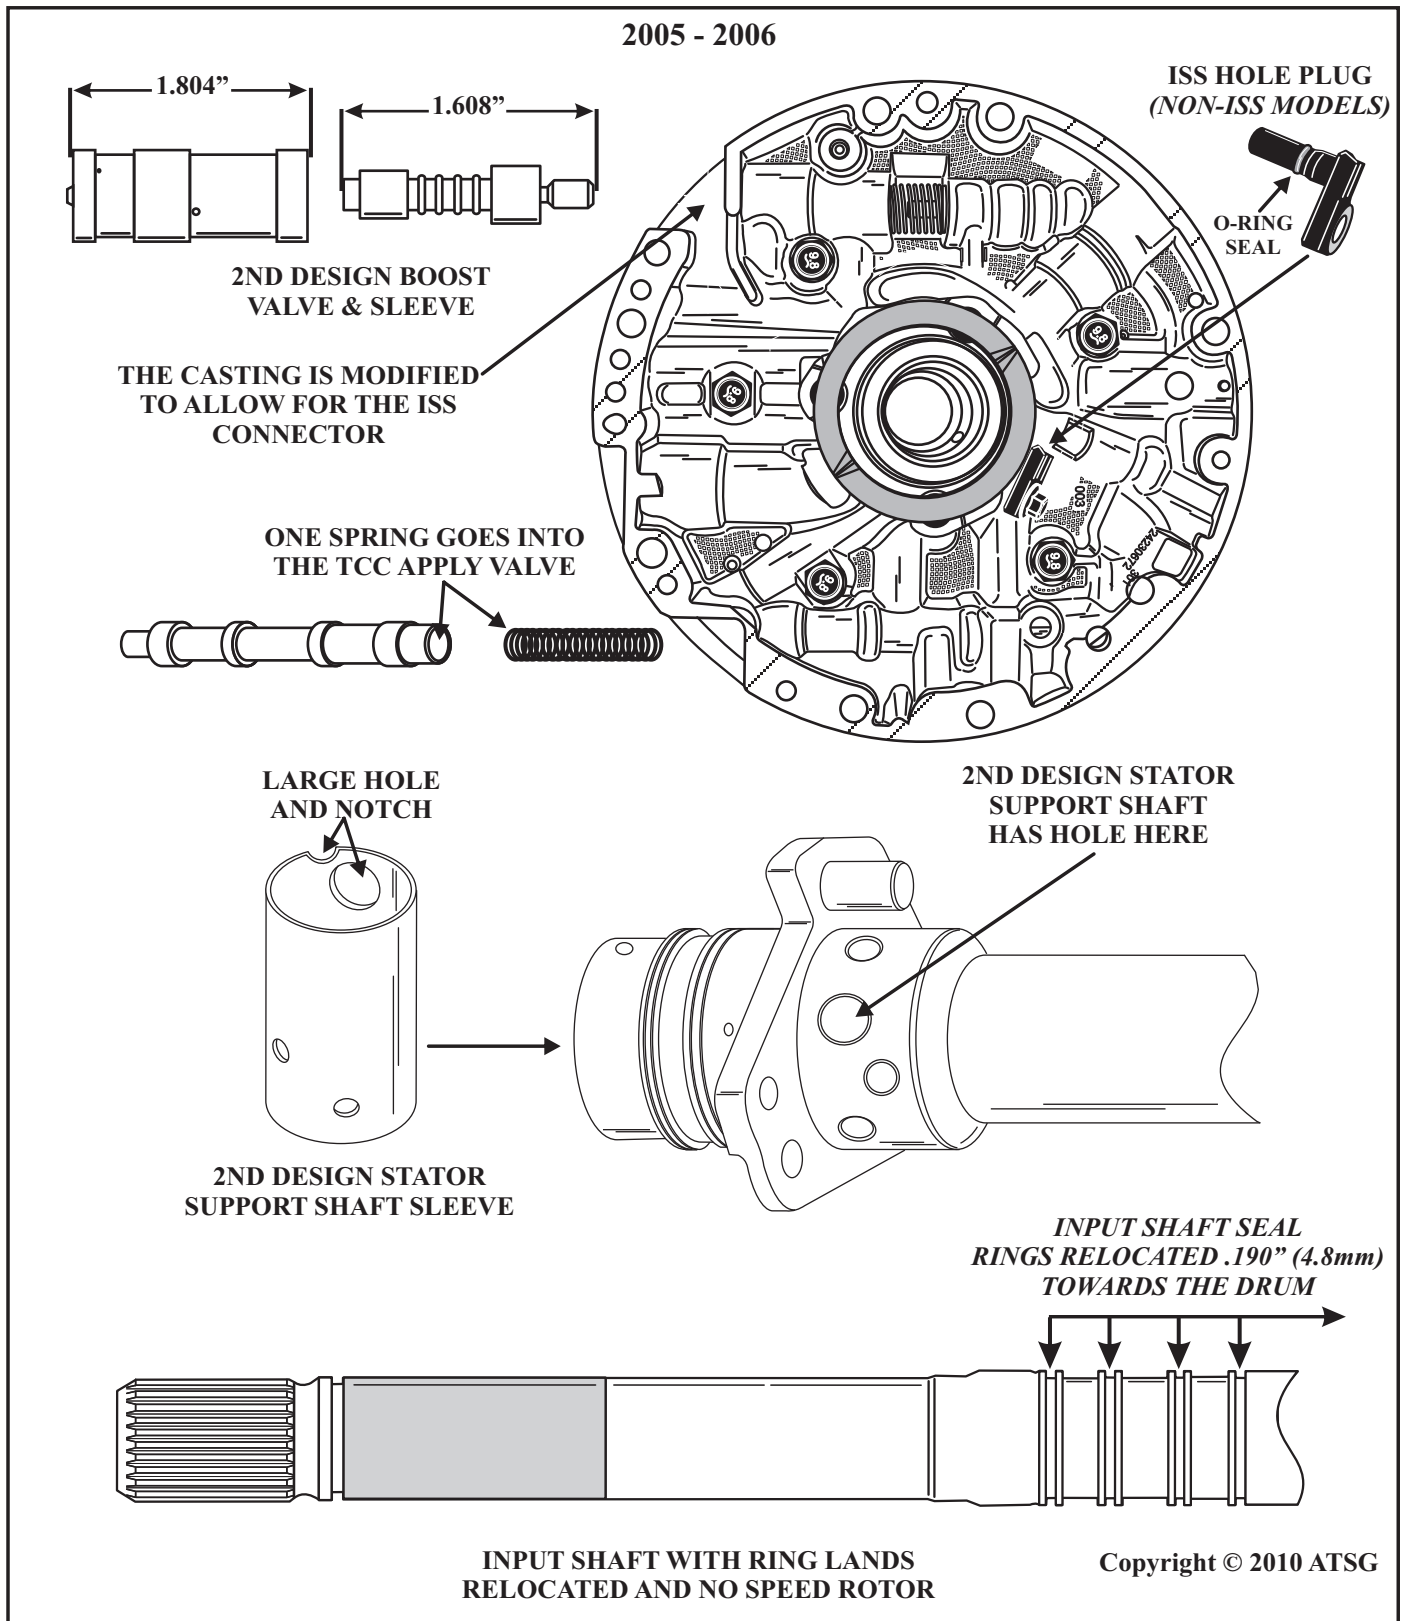
Figure 4

continued: (4) Late in 2005 and early in the 2006 model year, some pre ISS models may still not have the ISS mounting holes machined into the cover. This will be evident as a smooth un-machined surface without the ISS mounting holes. For non ISS models, an ISS hole plug will be used in place of the ISS assembly, (Refer to Figure 4).

On Non-ISS models that have a functional ISS hole in the pump cover, the rubber plug with an o-ring seal must be installed. Failure to do so will result in no converter charge and the vehicle will not move.

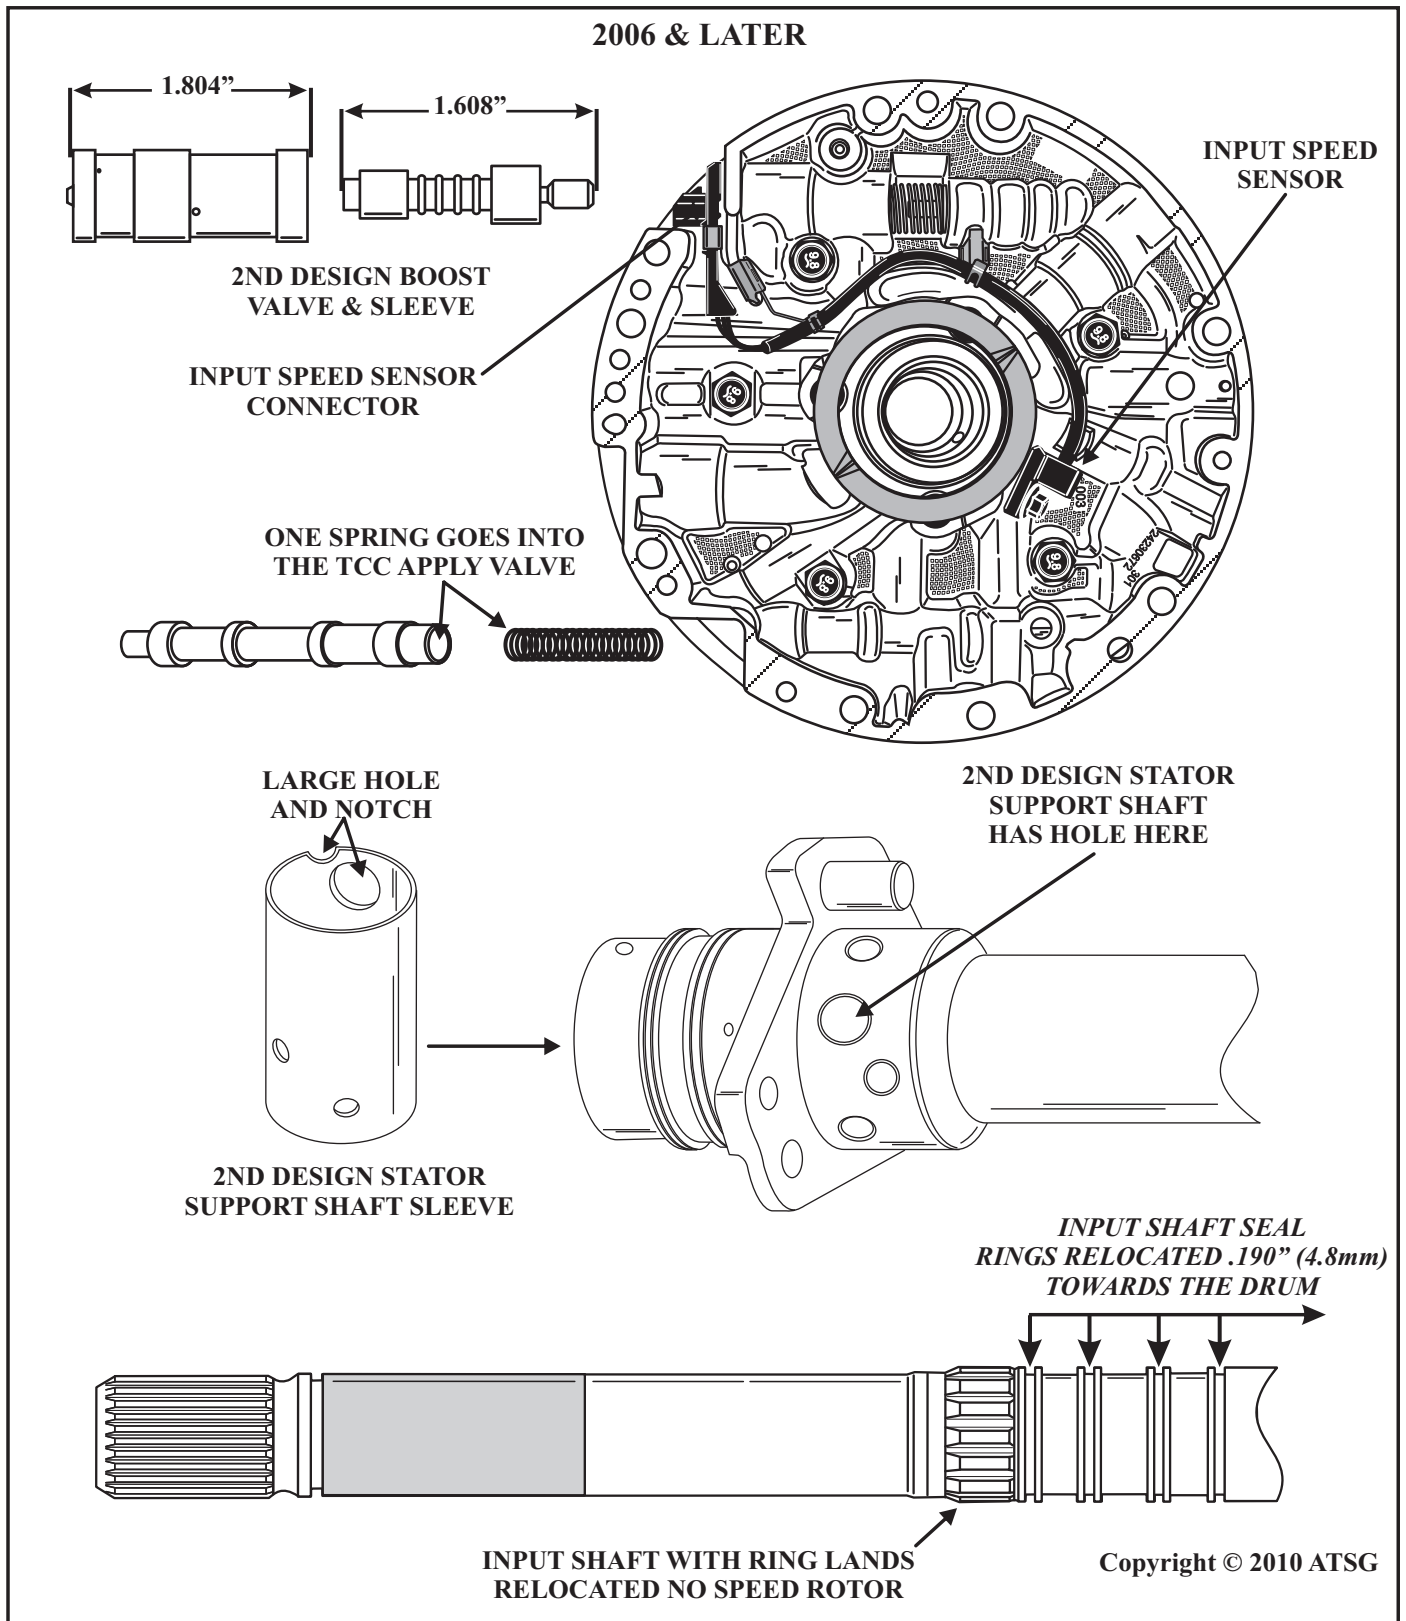
Figure 5

As ISS models were introduced, later in the 2006 model year, the machining took place and the input speed sensor (ISS) was added, (Refer to Figure 5), the presence of the ISS also necessitated a new internal wire harness to accommodate the ISS and software changes to the PCM provided code capability for ISS malfunctions.

If an input shaft is used without the speed rotor, and the pump cover has an ISS, codes P0716 or P0717 will be stored which could cause TCC slip and gear ratio calculation errors.

If the pump cover and input shaft are mismatched, severe friction and geartrain damage will occur in a short period of time.
