Technical Service Information

THM 4T60-E HARSH OR FIRM 3-4

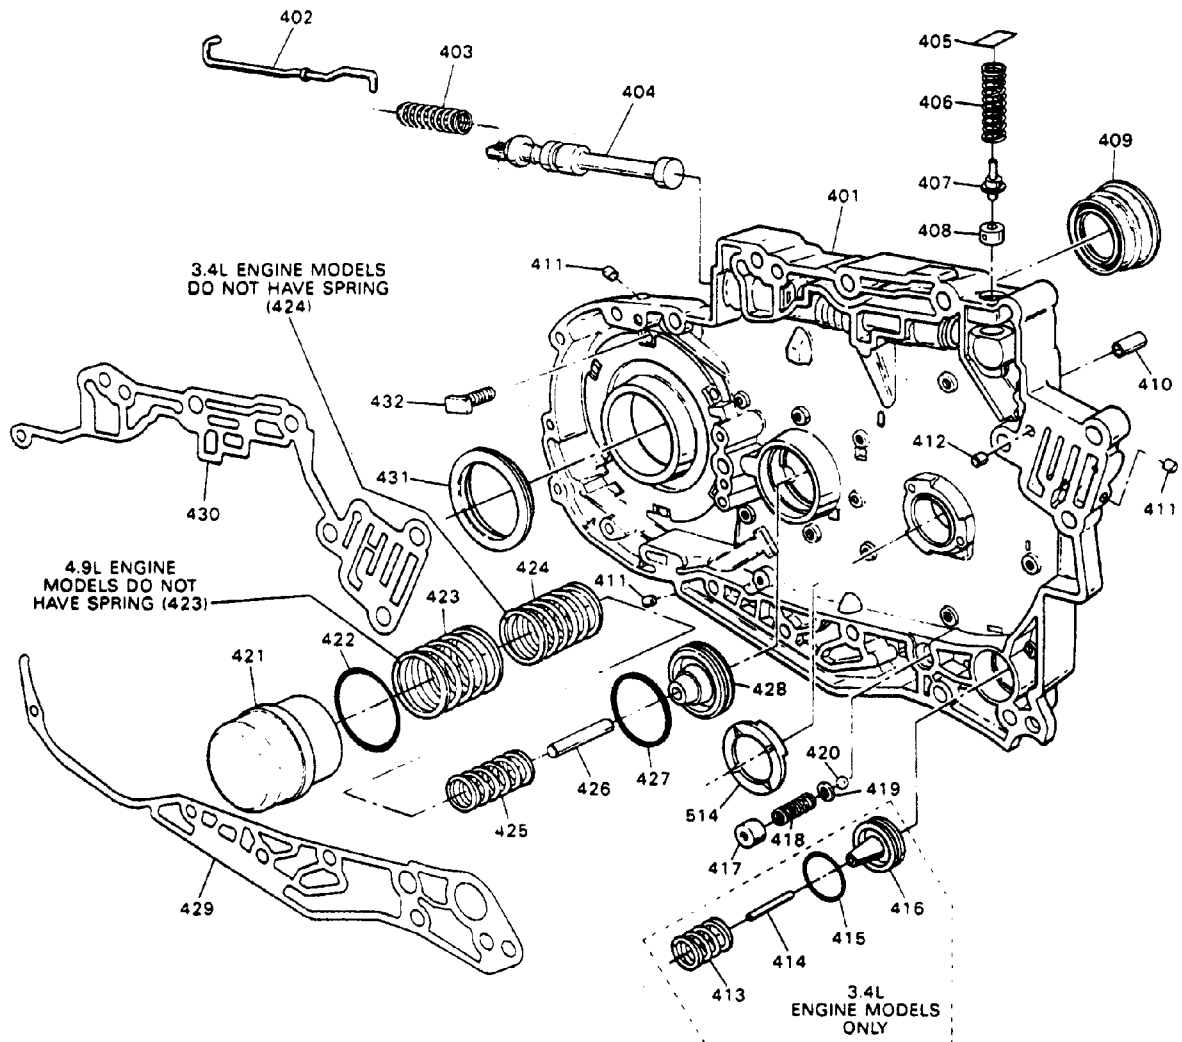
Figure 3

COMPLAINT: Some early model 1992 THM 4T60-E transaxles in the "C" body cars may exhibit a harsh or firm 3-4 upshift. This condition may become more noticeable at high altitudes.

CAUSE: It has been determined that the third spring in the 3-4 accumulator canister may contribute to a harsh or firm 3-4 upshift (See Figure 3).

CORRECTION: Remove the channel plate and disassemble the 3-4 accumulator canister. If the 3-4 accumulator contains 3 springs, remove and discard the outer most (Largest Diameter) 3-4 accumulator spring (423) and re-assemble as shown in Figure 3.
