# Technical Service Information

## **MERCEDES 722.3 /.4 ERRATIC DOWNSHIFTS**

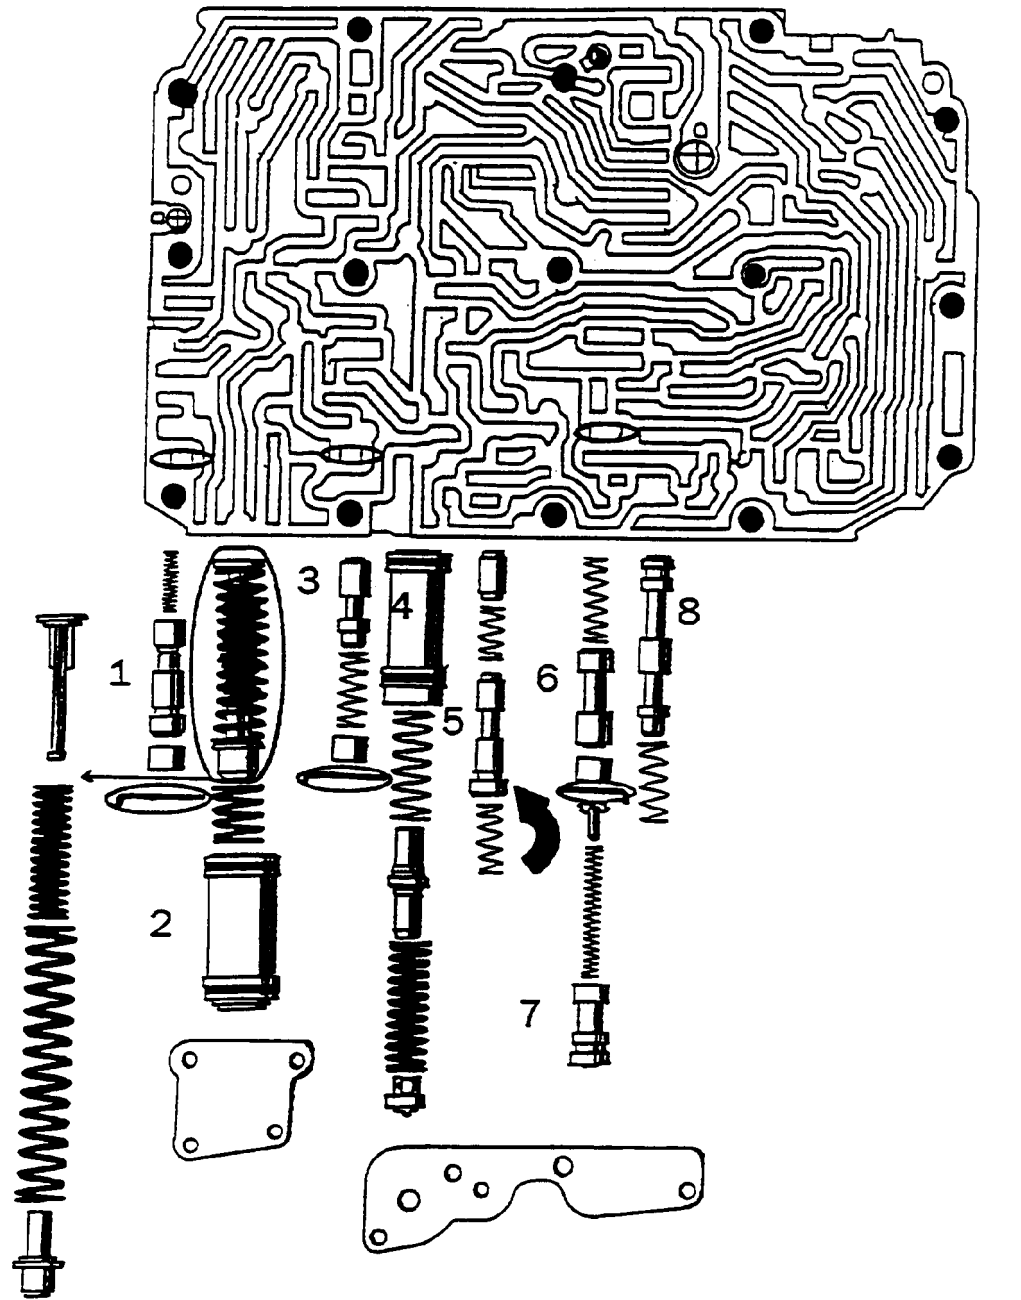
**CAUSE:** Throttle linkage and/or control pressure detent/Bowden cable is not adjusted properly, or the reaction valve in the valve body is binding. Or the shut off valve is binding. Figure 1 and Figure 2 show the location of these valves.

**CORRECTION:** Drive the vehicle with the detent cable disconnected (control pressure Bowden cable). If manual downshift will take place then the problem is not the transmission nor the valve body, but that the detent/Bowden cable is out of adjustment. Make necessary adjustment to the cable. If the downshift still will not occur, then the problem is either the RV5 shut off valve shown in Figure 1 is binding or the brake shut off valve in Figure 2 is binding.
