Technical Service Information

THM 440-T4 NO TCC APPLY OR TCC SHUDDER

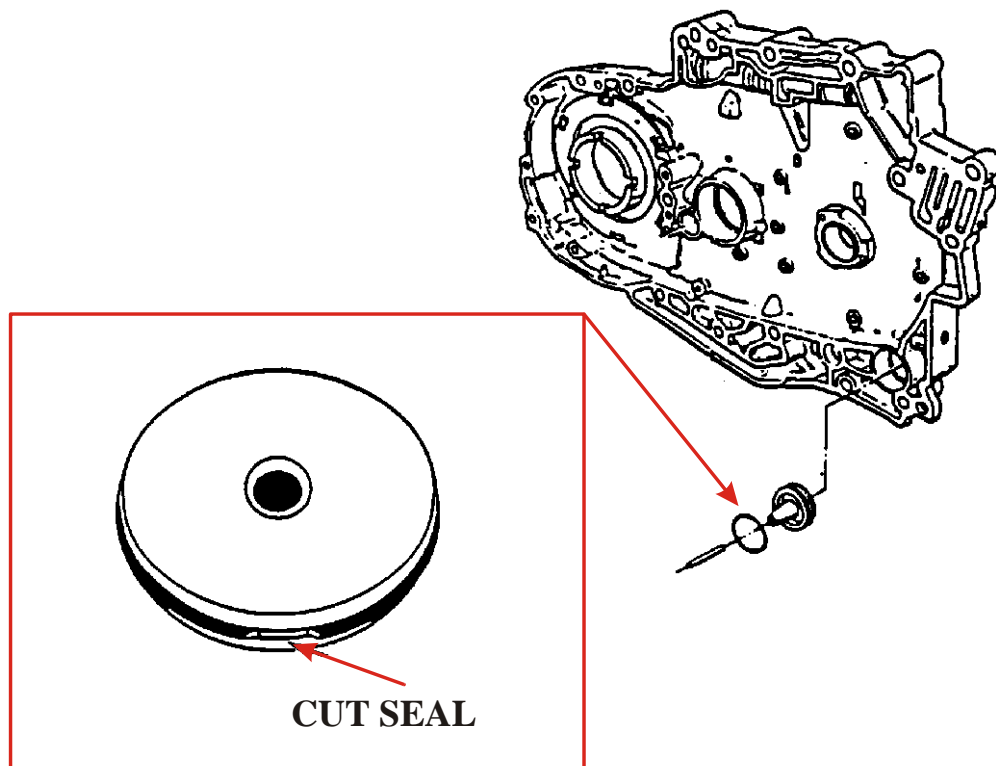
Figure 1

COMPLAINT: No TCC apply or TCC shudder

CAUSE: Some 1984 and some early 1985 THM 440-T4 transaxles may experience a no Torque Converter Clutch (TCC) apply or TCC shudder condition, which may be due to a cut or rolled TCC accumulator piston seal (See Figure 1).

CORRECTION: Install updated service package 8646926. Updated service package 8646926 contains the followings

- 1.1-TCC ACCUMULATOR PISTON
- 2.1-TCC ACCUMULATOR PISTON PIN
- 3.1-TCC ACCUMULATOR PISTON SEAL
