"2004" SEMINAR INFORMATION

AUTOMATIC TRANSMISSION SERVICE GROUP

"What's in Store for 2004" Seminar Information

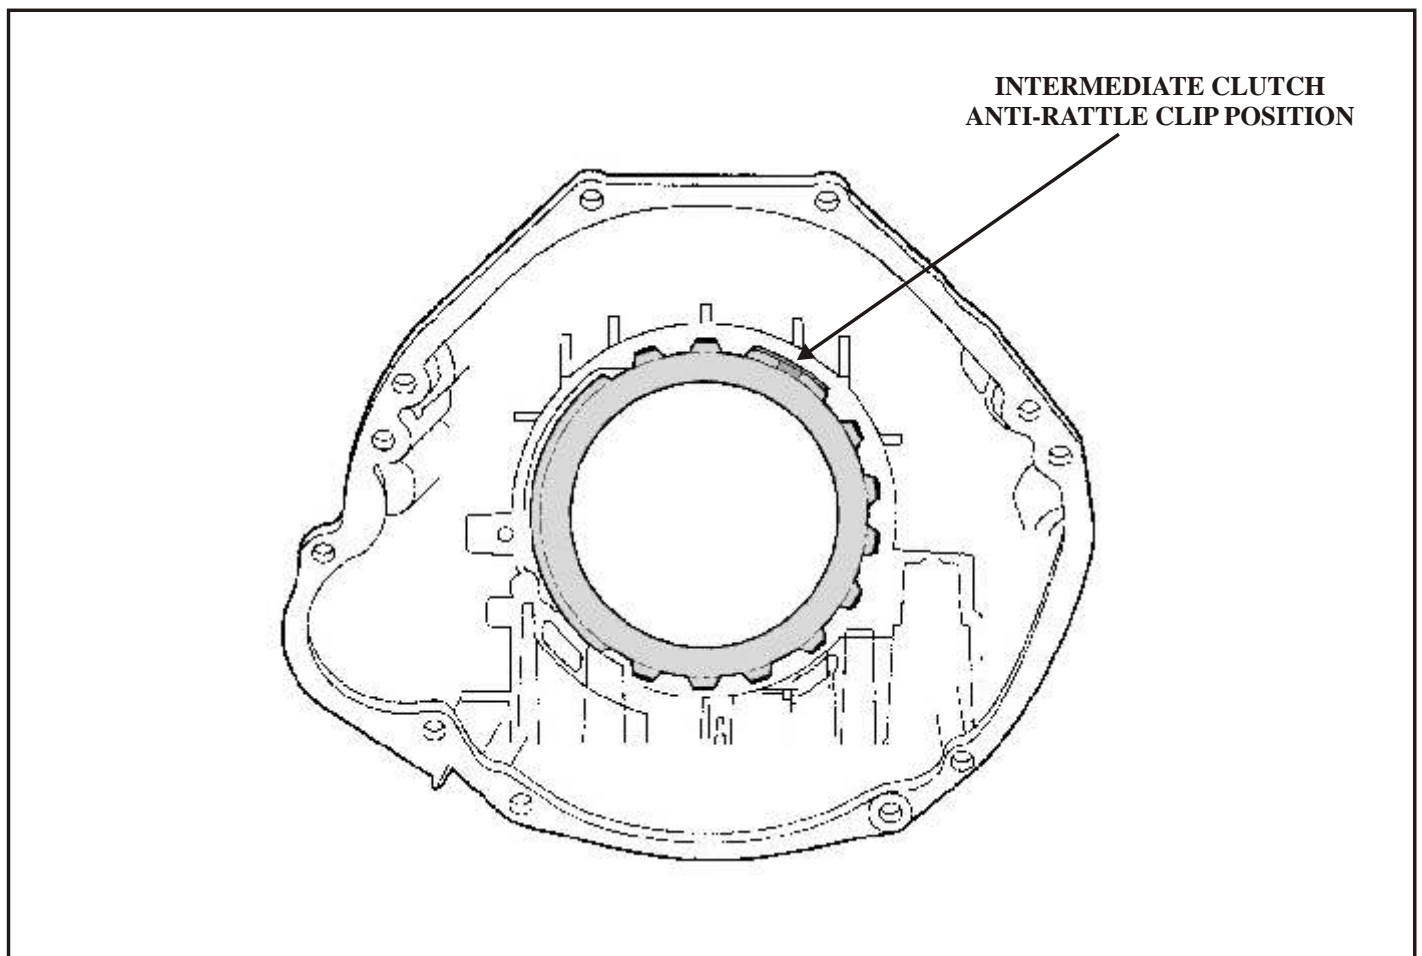
Figure 1

COMPLAINT: A rattle or clicking sound is coming from the transmission until the 1-2 shift is completed. An odd looking clip may be found on the builder's bench after overhaul.

CAUSE: This may be caused by the intermediate clutch pack rattling in the case when the clutch is released in first gear.

Intermediate Clutch Anti-Rattle Clip.....YL3Z-7A609-AA

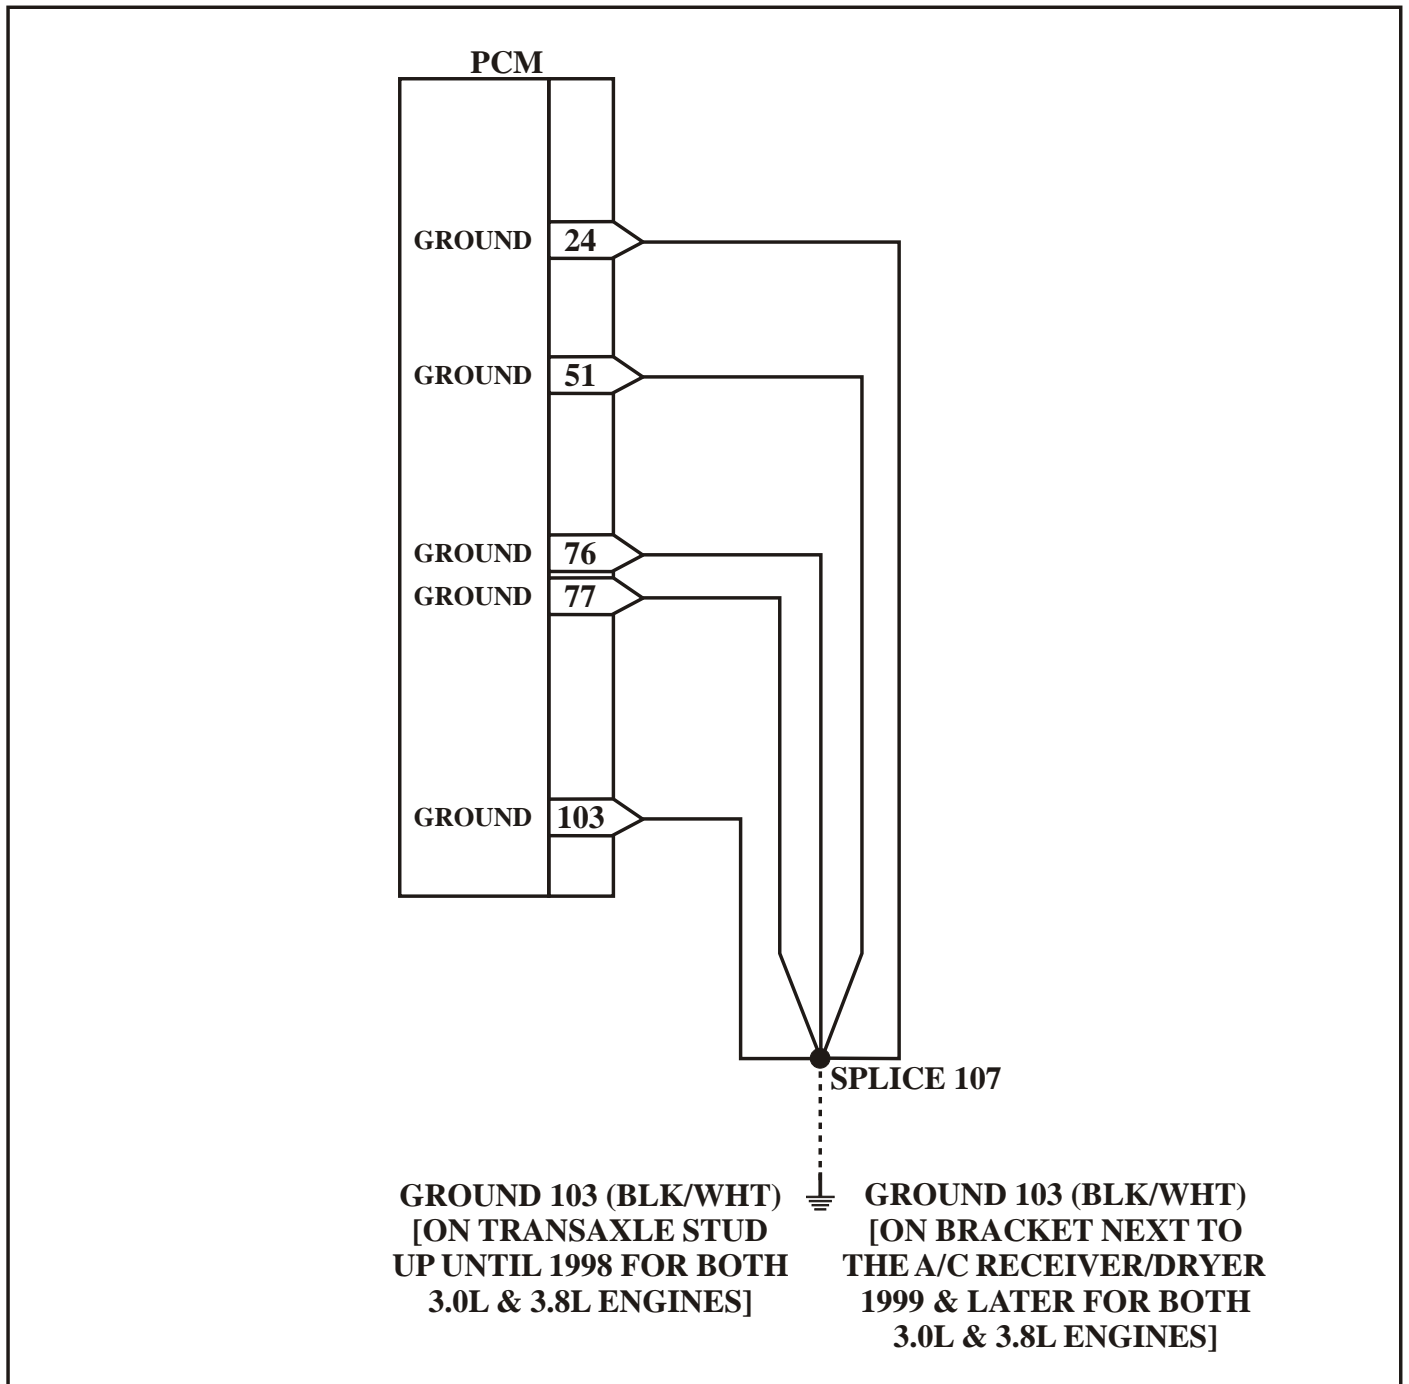
Figure 1

CAUSE: The **G103** ground is bad and is responsible for the above complaints. *When* this ground is located on the unpainted bracket next to the A/C Receiver/Dryer at the passenger side strut tower, condensation from the Receiver/Driver collects on this ground and causes rust and corrosion to form, resulting in a poor ground at this location. The G103 ground serves as ground for the PCM as seen in Figure 1.

This is the source of the confusion. When the technician looks for the **G103** ground at the transmission bell housing stud on a 1999 and later Windstar, none is found.

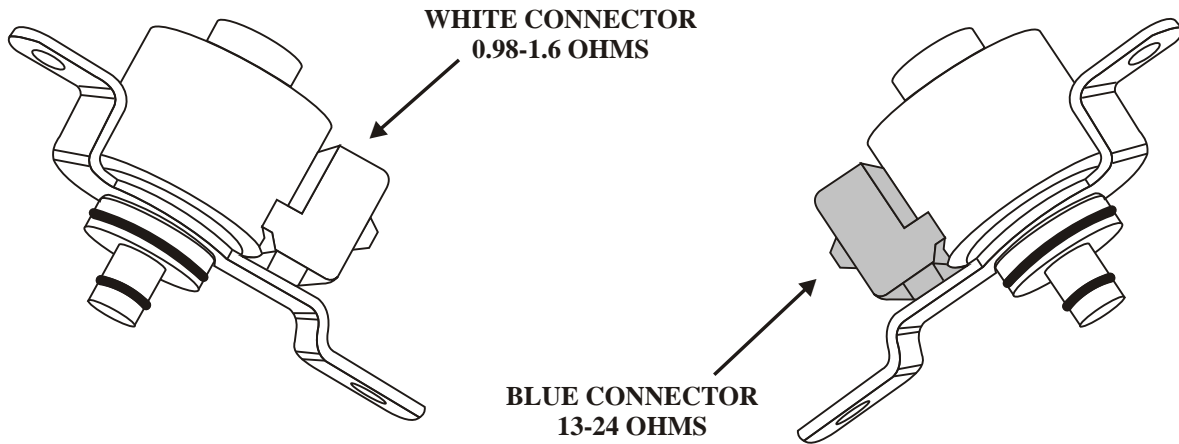
Figure 1

- CAUSE:**
- #1. The incorrect lockup solenoid was installed in the transmission. The lockup solenoid with the **WHITE** connector, which has a resistance value of 0.98 to 1.6 ohms, is NOT interchangeable in all applications with the lockup solenoid with the **BLUE** connector which has a resistance value of 13 to 24 ohms as shown in Figure 1.
Installing the lockup solenoid with the **BLUE** connector on vehicle/transmission combinations that were originally equipped with the lockup solenoid with the **WHITE** connector could be responsible for the above complaints with the exception of the P0743 code.
Installing the lockup solenoid with the **WHITE** connector on vehicle/ transmission combinations that were originally equipped with the lockup solenoid with the **BLUE** connector could be responsible for the P0743 code due to the additional amperage that’s allowed to flow through the circuit.

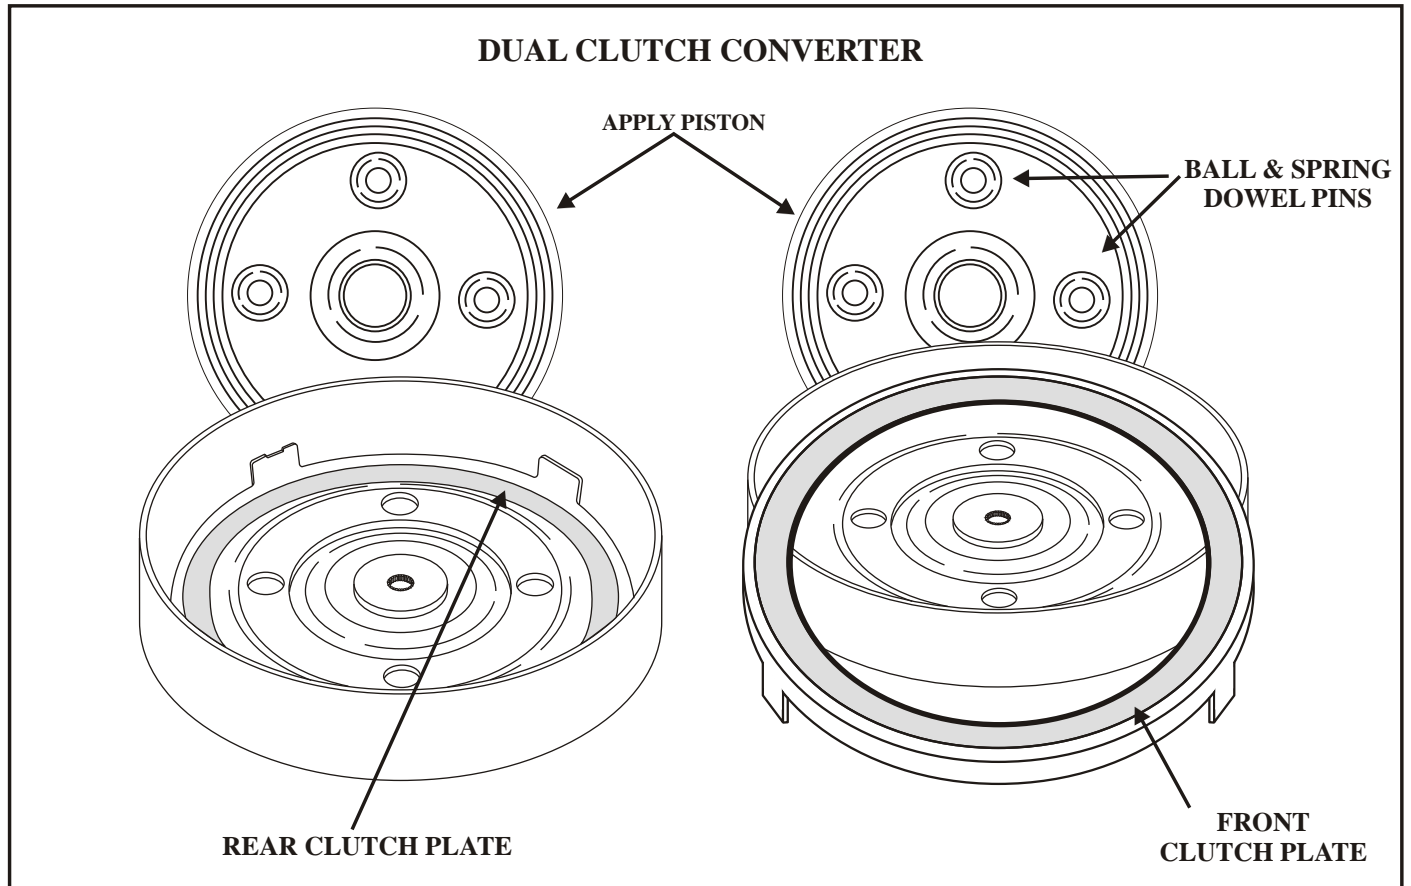
Figure 5

#2. The incorrect converter was installed in the vehicle. There are two types of converter used for these vehicle/transmission combinations. The differences in these converters involve the type of converter clutch used inside them. The use of a single sided clutch type converter in a vehicle that requires a dual clutch converter can cause the above complaint. The converter clutch can be a single sided clutch, with the clutch bonded to the front cover, and the damper/apply piston shown above it in Figure 4. Or it can be a Dual Modulated, two sided converter clutch with a friction surface bonded to the front and rear sides of a disc suspended between the cover and the apply piston. The apply piston has four ball and spring dowel pins which align and snap into the cover in order to keep the suspended friction disc centered between the disc and the cover (Refer to Figure 5), and connect to the damper assembly as shown in Figure 6.

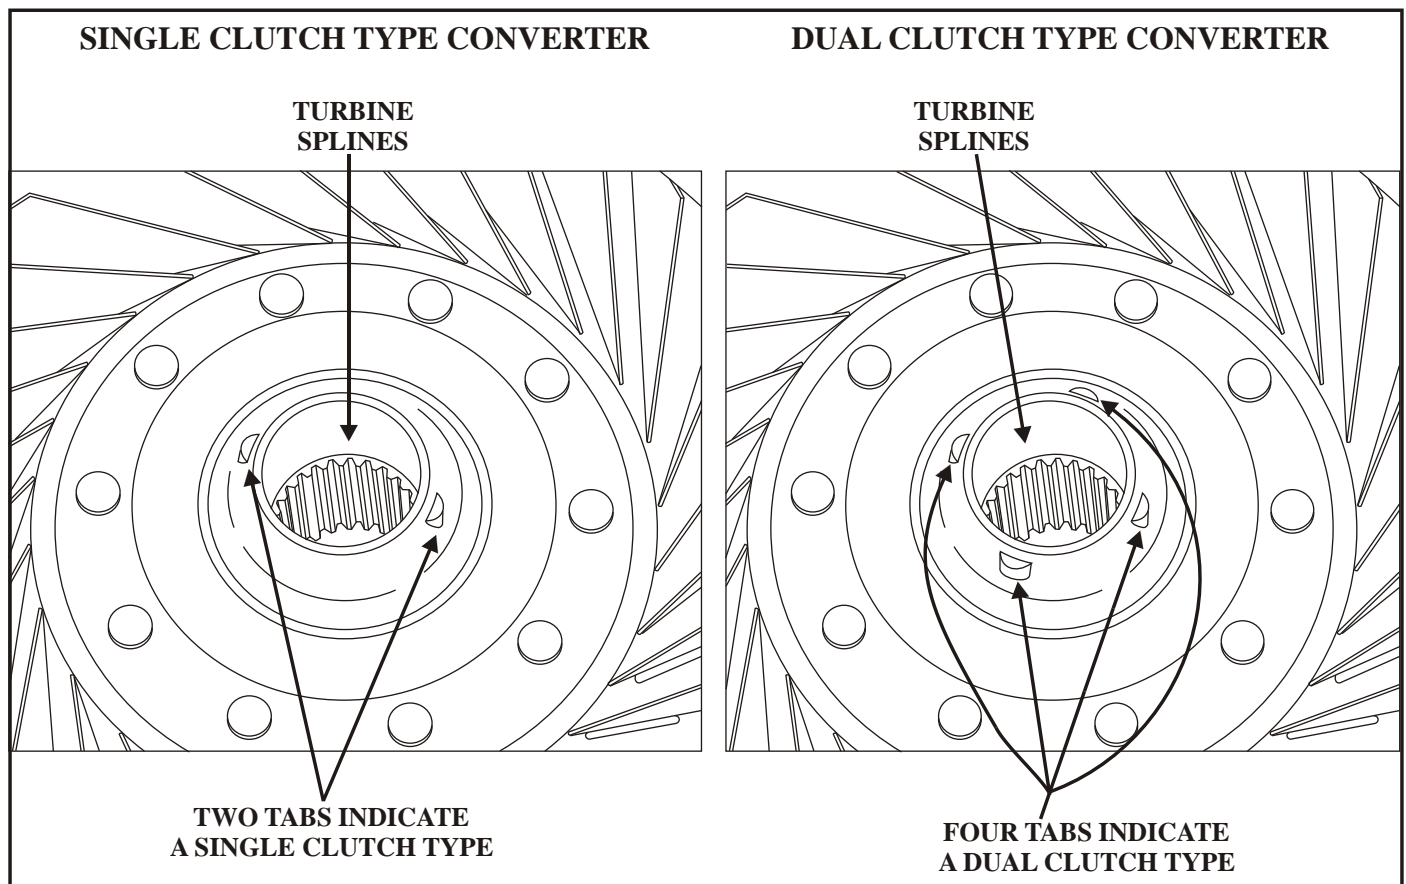
Figure 8

#2. The way to tell which converter you have, whether it is the original or the replacement converter, is to look down into the center of the converter just outside the turbine spline area and see if you have four tabs as seen in figure 8 or two tabs. Two tabs is a single clutch type converter, and four tabs is the dual clutch type.

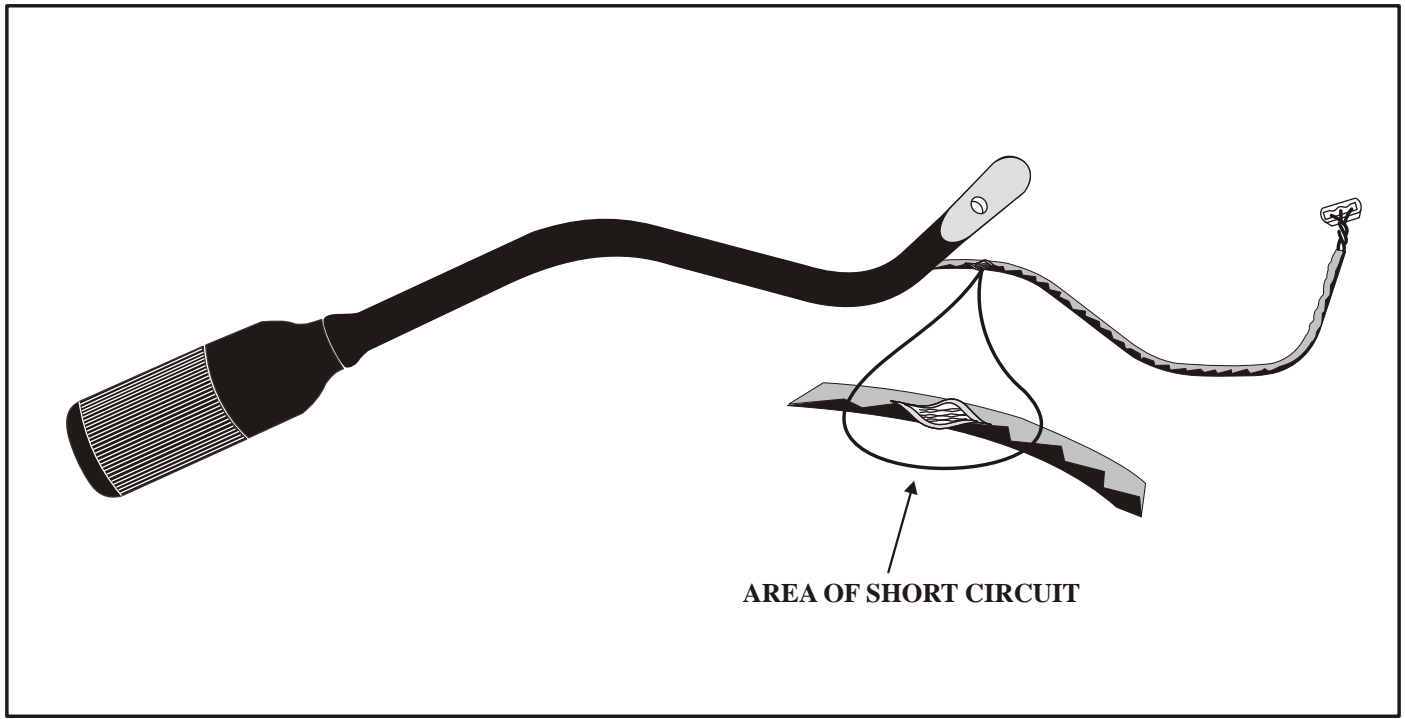
Figure 3

CAUSE: The wiring for the overdrive cancel switch is incorrectly routed and can come in contact with a steering column cover mounting screw. The most common location for the short to occur is near the shift lever pivot point, the location of which is shown in the illustration in Figure 3.

The resulting short circuit causes the #17 or #19 fuse to blow creating the above listed symptoms and the subsequent safety hazards due to the fact that these fuses power the PCM, which in turn power the electronically controlled throttle system as well as the overdrive cancel switch.

CORRECTION: Remove the shift lever and provide an extra piece of shrink wrap to the problem area, or replace the shift lever with a newly designed lever which has a longer wire harness for the overdrive cancel switch which avoids contact with the steering column cover mounting screw.

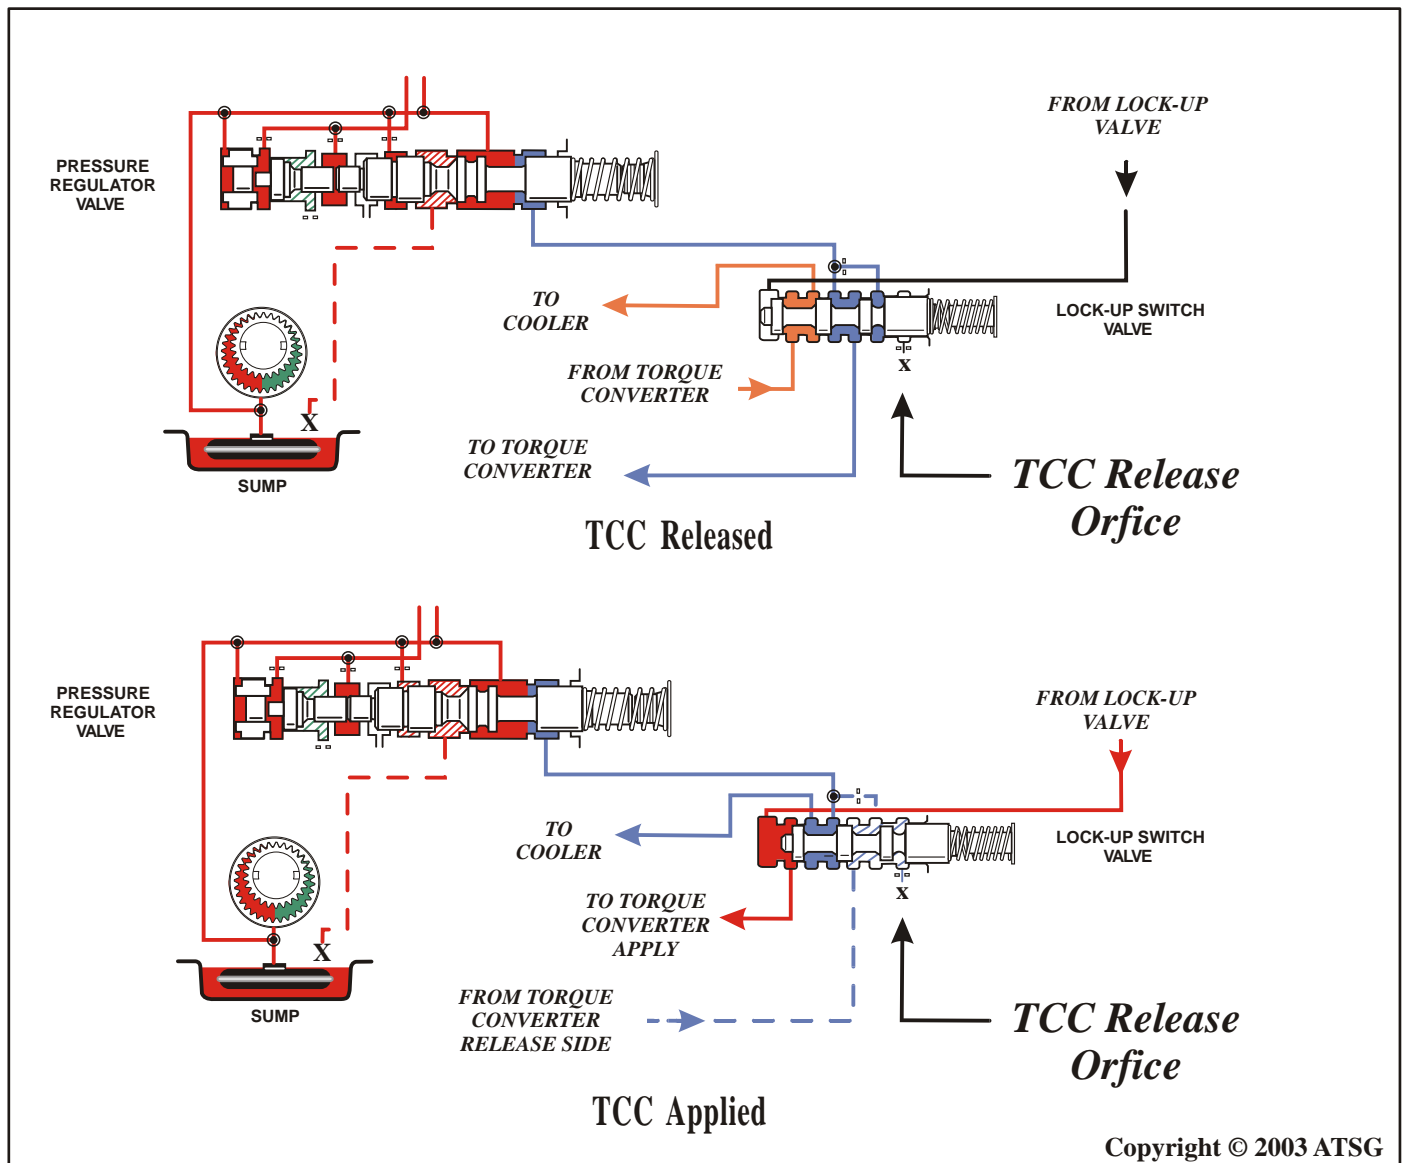
Figure 1

CAUSE: One cause may be, TCC release oil not exhausting quickly enough from the front side of the Torque Converter.(See Figure 1)

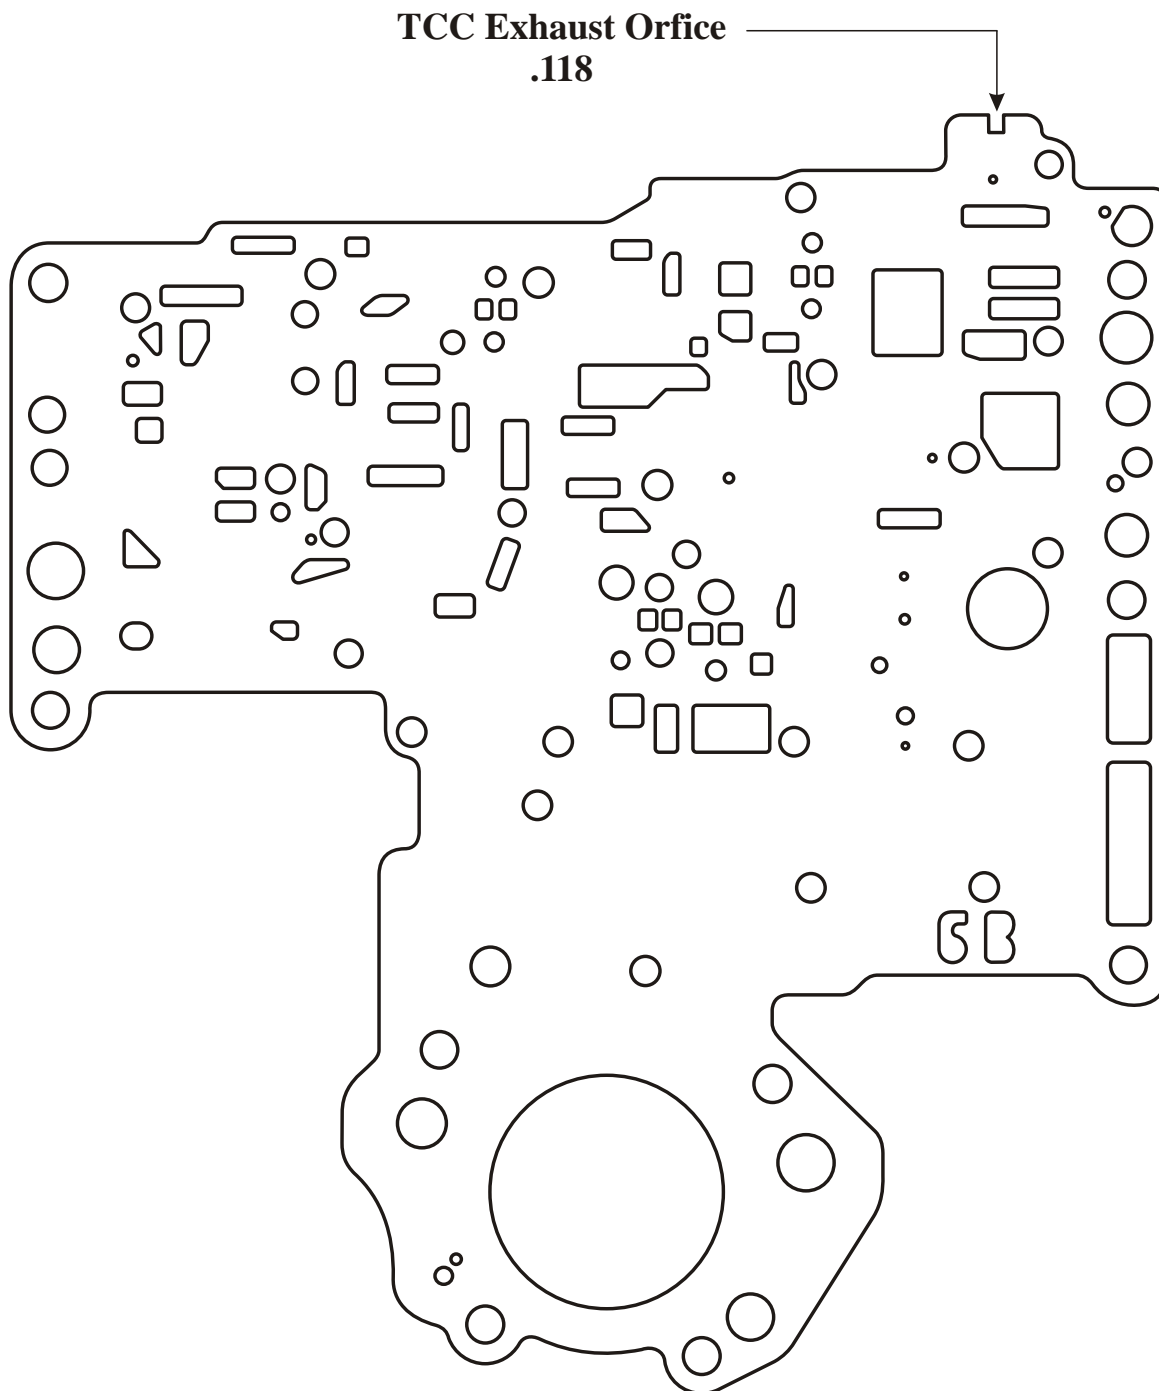
Figure 2

NARROW EXHAUST SLOT

CORRECTION: Change or modify the narrow slot separator plate(See Figure 2) to the wide slot separator Plate.(See Figure 3)

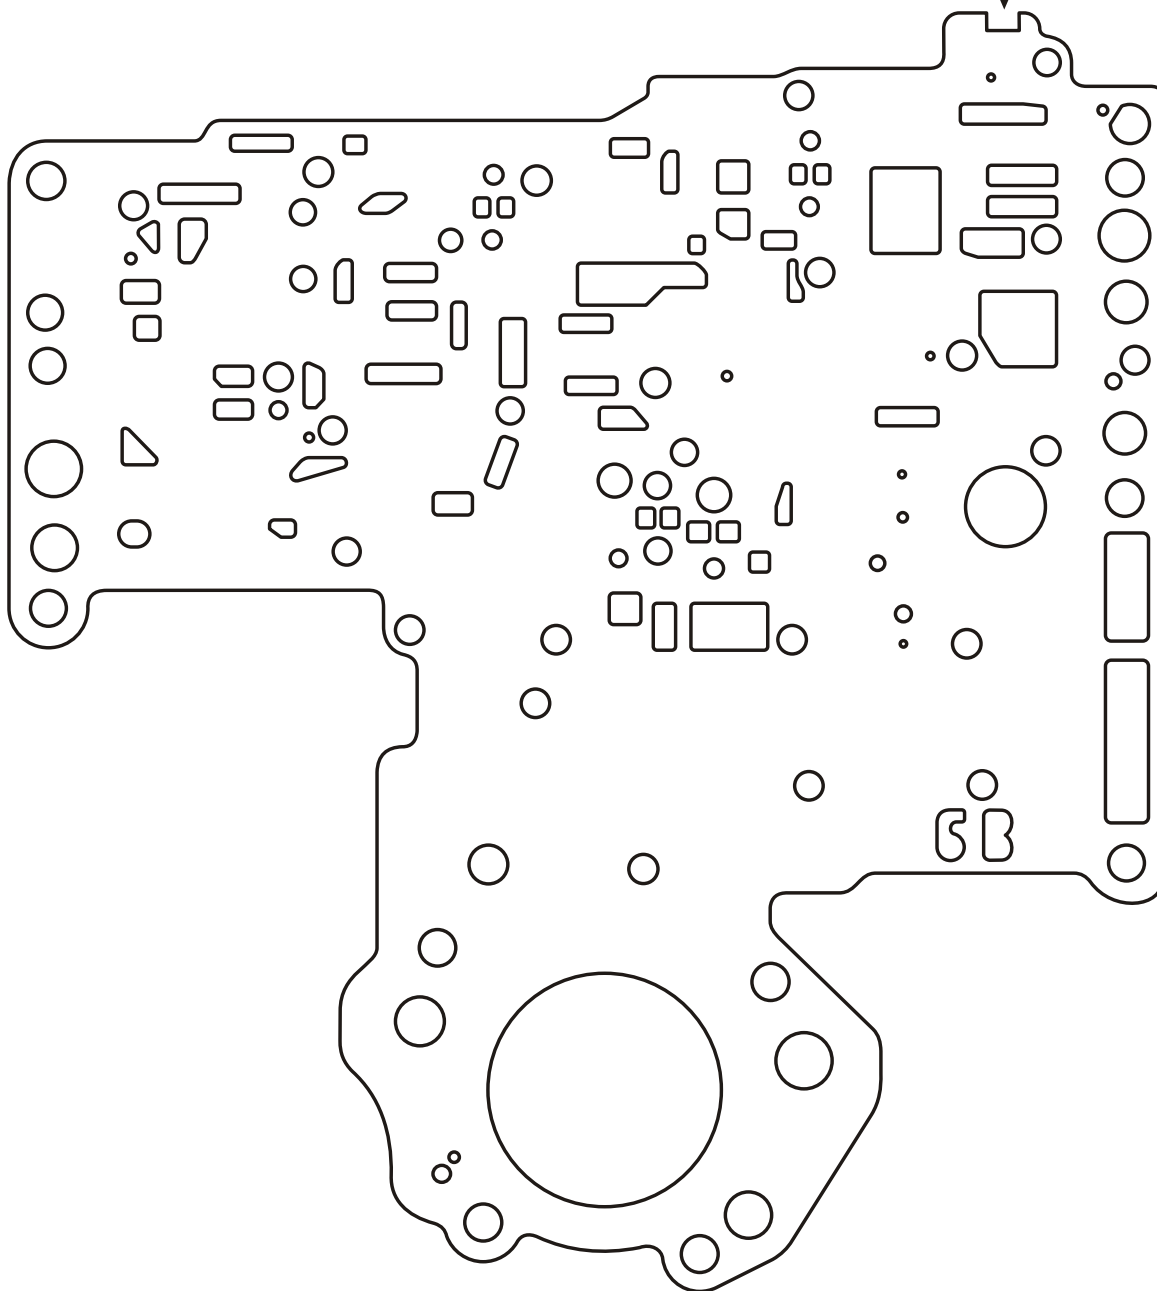
Figure 3

WIDE EXHAUST SLOT

TCC Exhaust Orifice
.243

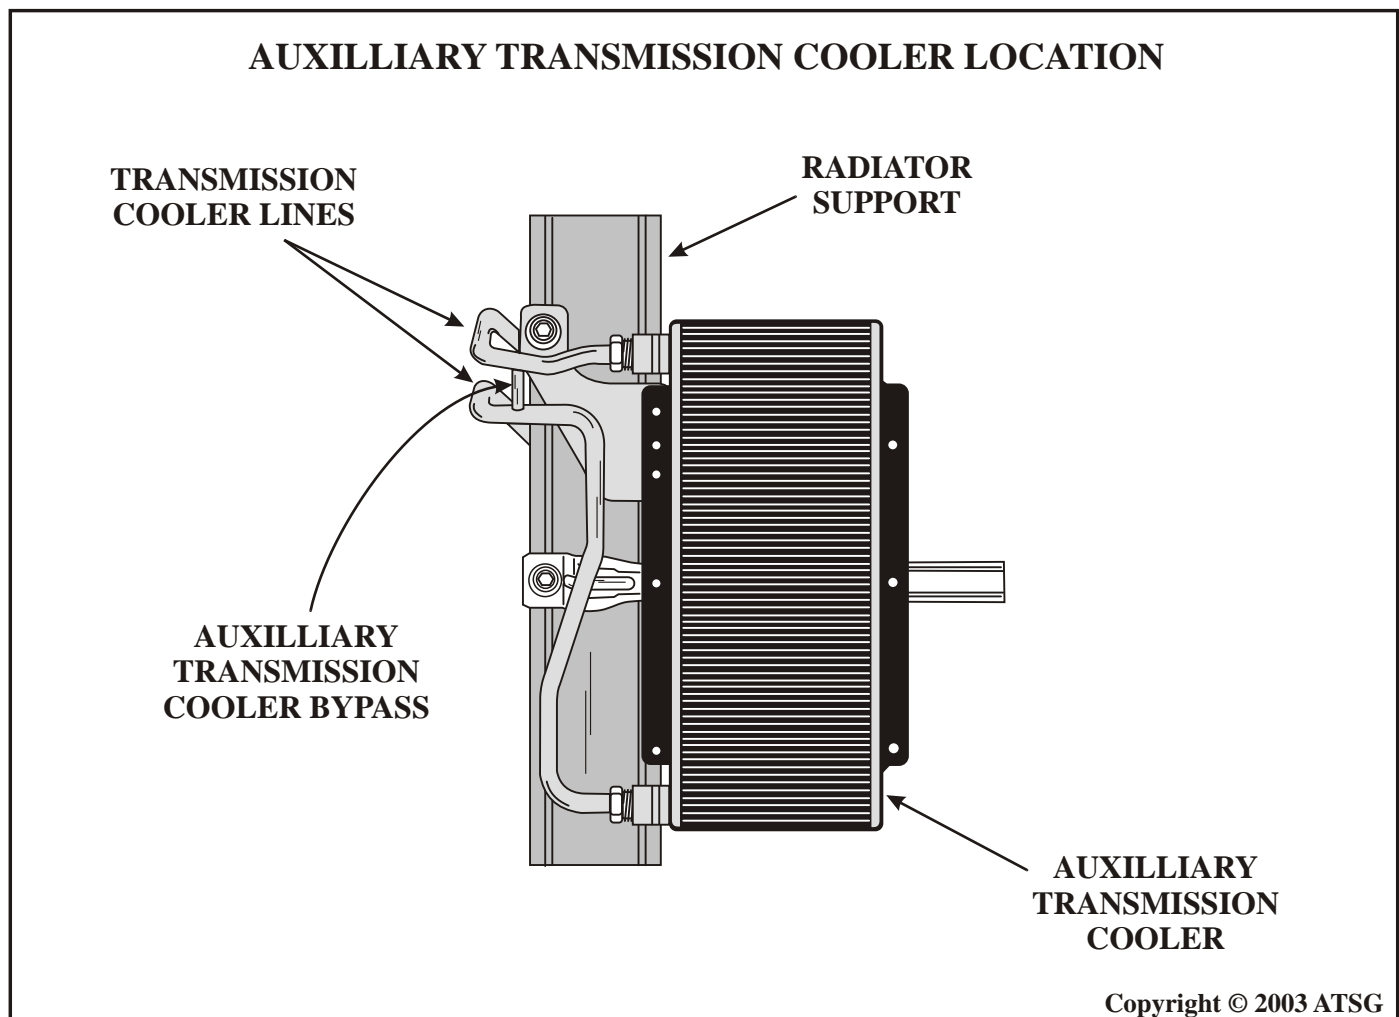
Figure 1

CAUSE: The cause may be, a restricted Auxillary Transmission Cooler. **NOTE:** During the "flushing" process, this may be overlooked because of a "Bypass" tube, as shown in Figure 1, that connects the two cooler lines together, mis-leading the technician into thinking that the Auxillary Transmission Cooler is clear. The Auxillary Transmission Cooler can not be flushed very easily because of its fin type construction, as shown in Figure 2 (*Note: the Auxillary Cooler has a thermal bypass that does not open until the fluid or cleaning solvent is at temperatures around 100° F*). This can also cause valves to hang as well as continual clogging of the Governor Solenoid Screen.

CORRECTION: Replace the Auxillary Transmission Cooler as needed.

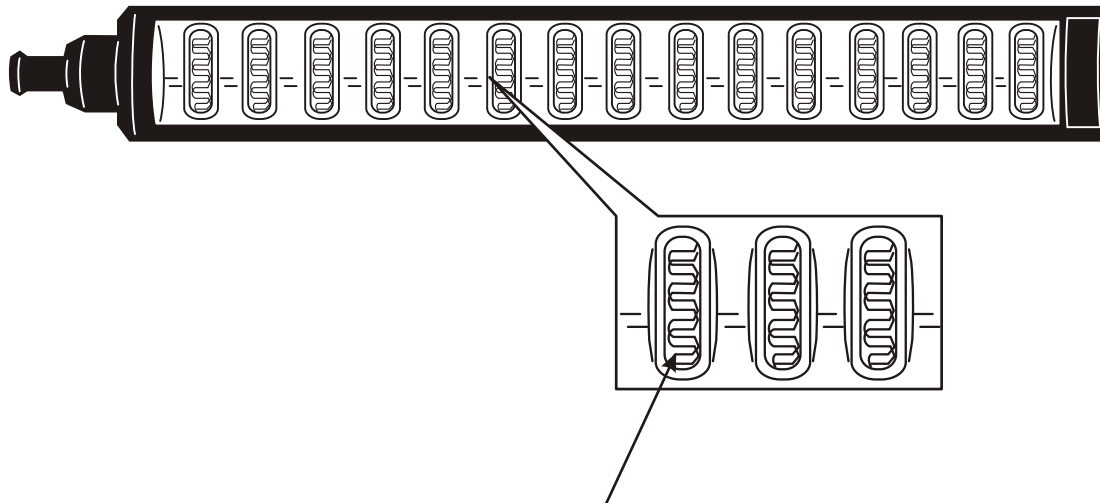
***THE AUXILLARY TRANSMISSION COOLER HAS
A FIN TYPE CONSTRUCTION WHICH MAKES
COOLER FLUSHING ALMOST IMPOSSIBLE***
