MAZDA F3A TRANSAXLE NO UPSHIFT AFTER REBUILD

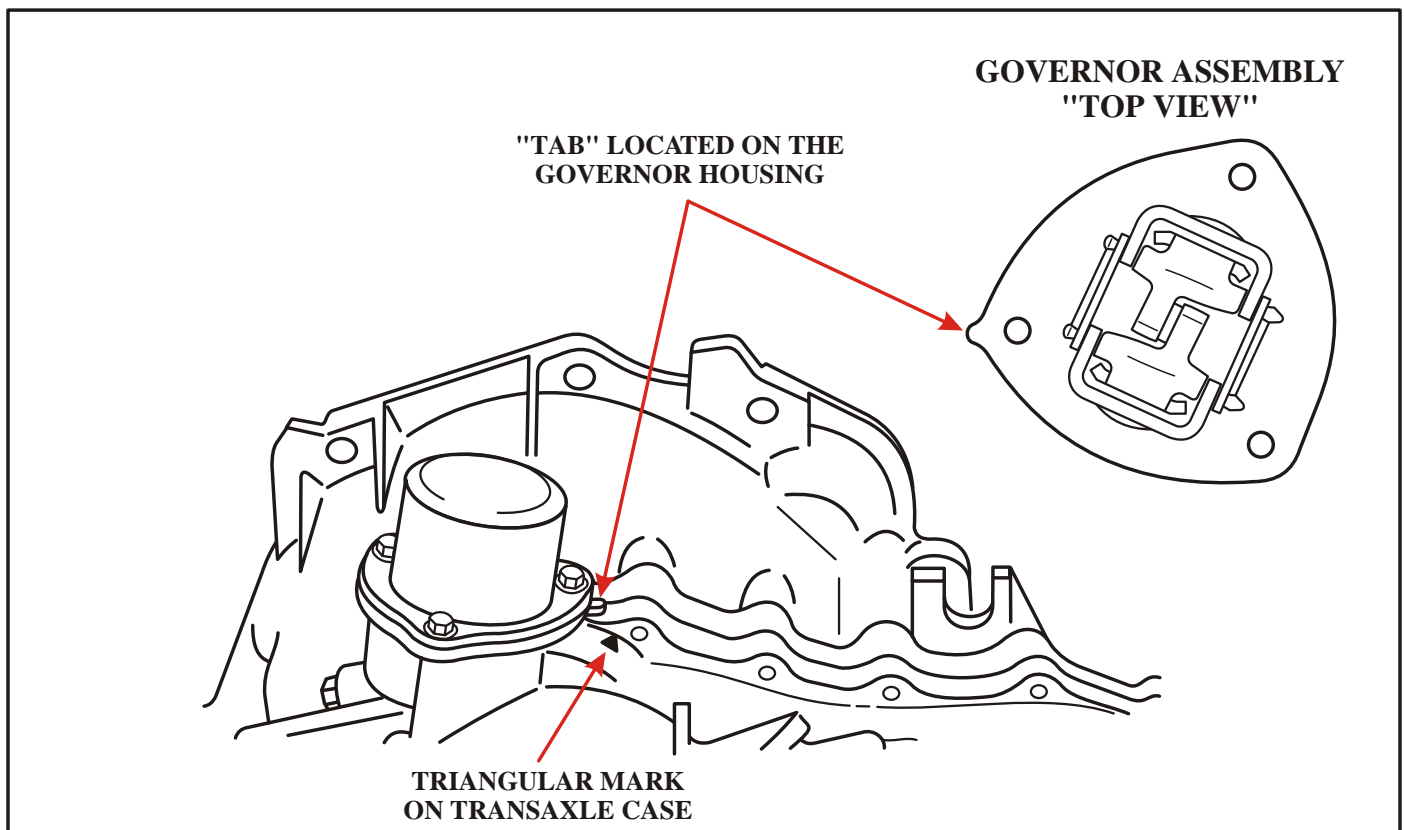
Figure 1

CAUSE: The cause may be, the governor and housing assembly installed into the case, oriented in the wrong direction, which will block governor feed oil.

CORRECTION: The F3A transaxle *must* have the governor and housing assembly oriented properly when it is installed into the transaxle case, to align the feed holes in the governor housing with the feed holes in the transaxle case. Most F3A transaxles have a small triangular mark on the transaxle case next to the governor, as shown in Figure 1. The "tab" on the governor housing must be pointed toward the triangular mark on the case which will align the feed holes properly, as shown in Figure 1.
