Technical Service Information

SATURN TAAT GRIND OR BIND IN REVERSE

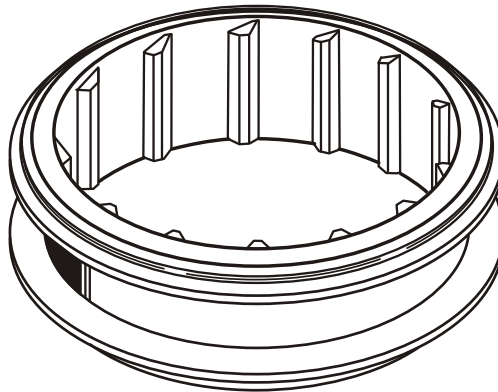
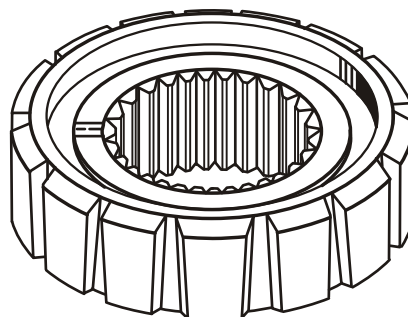
Figure 1

COMPLAINT: After overhaul, Saturn vehicles equipped with TAAT transaxles, may exhibit a grinding condition on Reverse application or a binding condition in Reverse.

CAUSE: The cause may be, during the rebuilding the Dog Clutch Sleeve or the Dog Clutch Hub, as shown in Figure 1, were installed incorrectly.

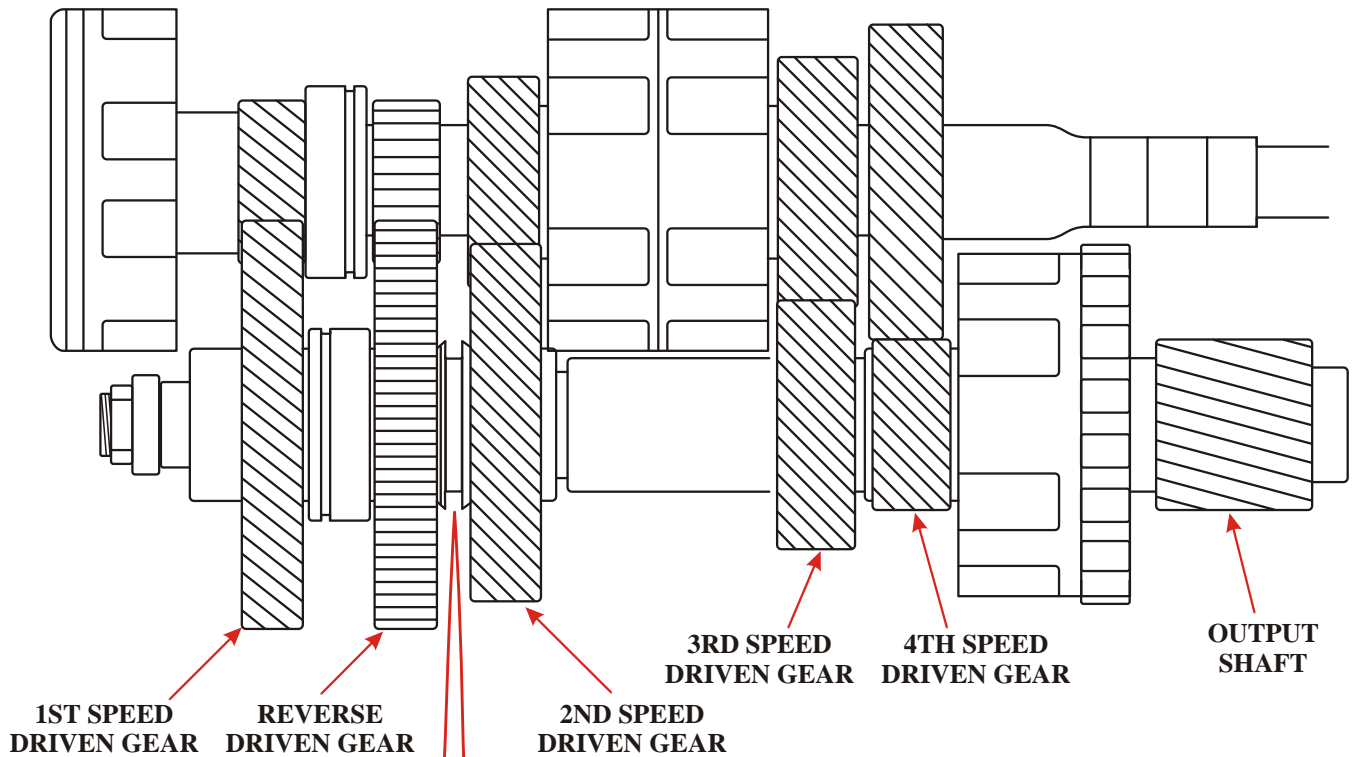
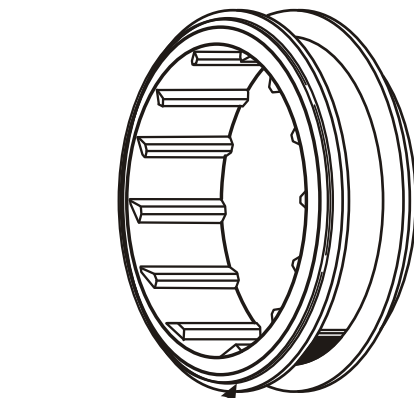
*I.D. GROOVE TOWARD
REVERSE DRIVEN GEAR*

*WIDE END OF SLOTS
GO TOWARDS THE
2ND DRIVEN GEAR*

CORRECTION: The Dog Clutch Hub **must** be installed with the "Wide" end of the "Slots" towards the 2nd Driven Gear, as shown in Figure 2.
The Dog Clutch Sleeve **must** be installed with the I.D. groove towards the Reverse Driven Gear, as shown in Figure 2.
