# Technical Service Information

## THM 4L60 (700-R4) NEW FRONT PUMP BODY

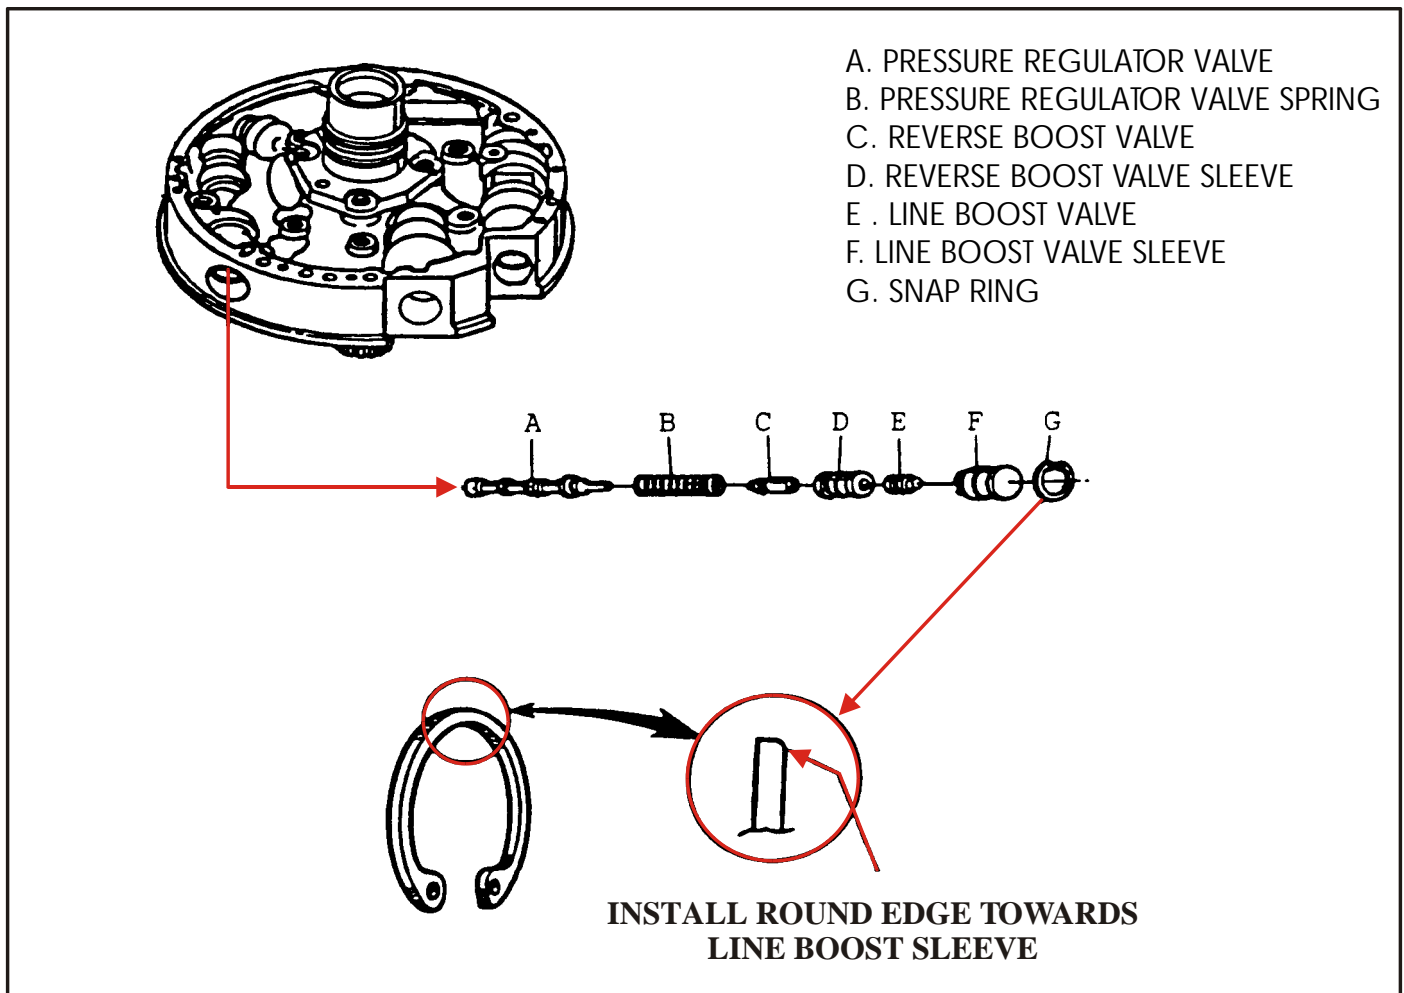
Figure 1

**COMPLAINT:** No or Low line pressure in all ranges on any THM 700-R4.

**CAUSE:** The cause may be the snap ring popped out of the pressure regulator valve train in the pump cover.

**CORRECTION:** Install the snap ring with the rounded edge towards the line boost sleeve (See Figure 1). This will prevent the snap ring from popping out again.
