# Technical Service Information

## CHRYSLER A604 DELAYED FORWARD ENGAGEMENT

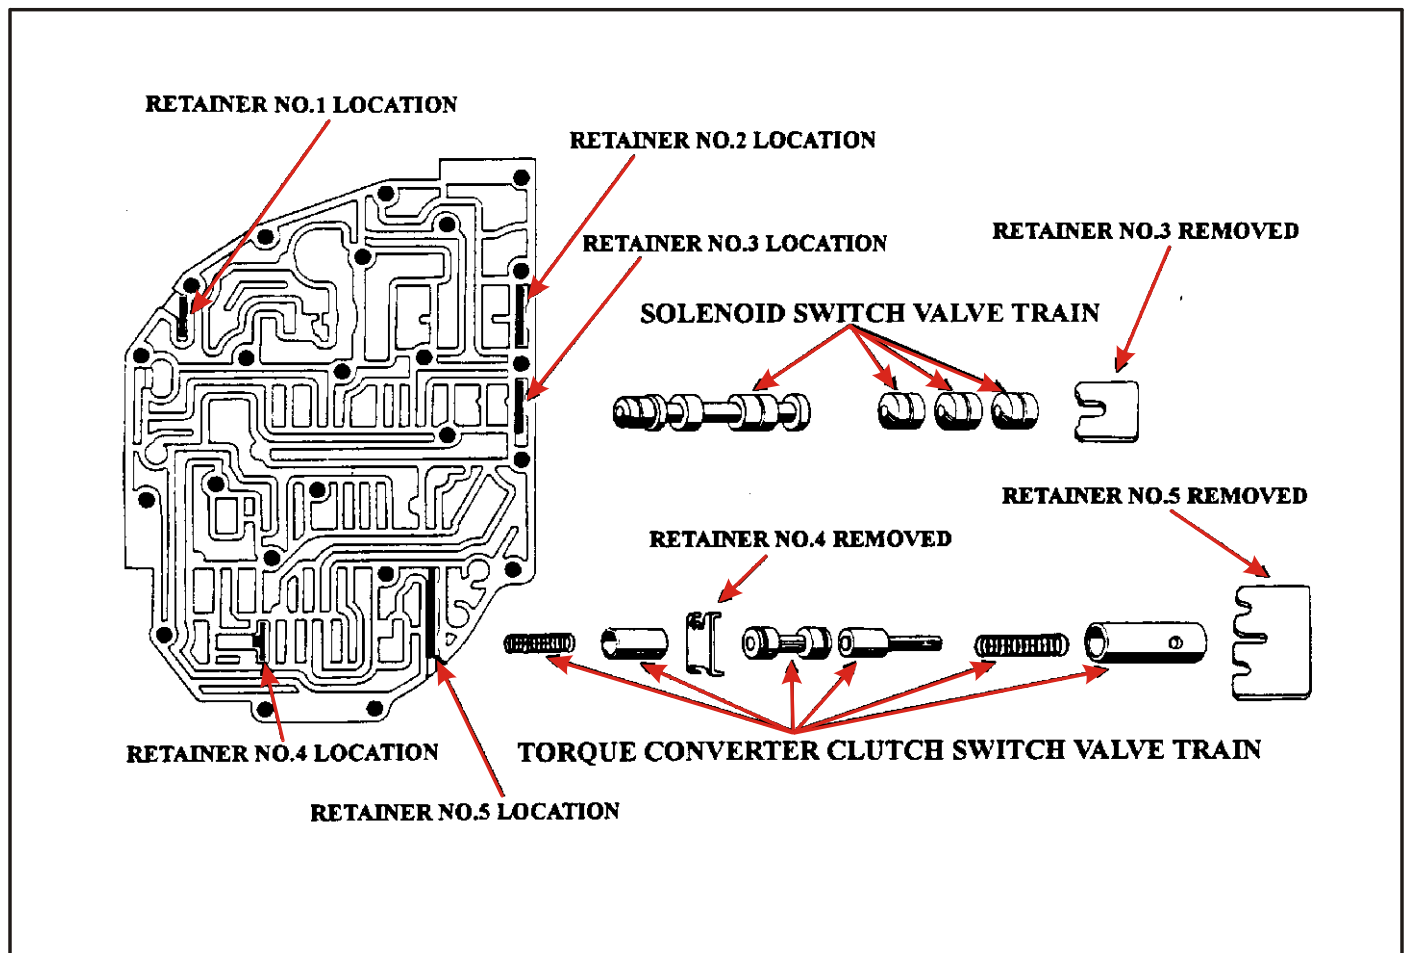
**COMPLAINT:** After overhaul vehicle exhibits delayed and/or a shuddering condition, when shift lever is engaged into any forward range, followed by an immediate abort to "Limp Mode."

**CAUSE:** The cause may be, that during the valve body cleaning process, retainer No.3 and/or one of the small "Buttons" in the solenoid switch valve train was not installed during reassembly. These parts can usually be found in the bottom of the solvent tank.

**NOTE:** Retainer location No. 4 and Torque Converter Clutch Switch Valve Train shown in Figure 1 are for '92 " and later only!

**CORRECTION:** Install the solenoid switch valve train and retainer No.3 as shown in Figure 1.
