MAZDA / FORD CD4E ERRATIC UPSHIFTS AND DOWNSHIFTS

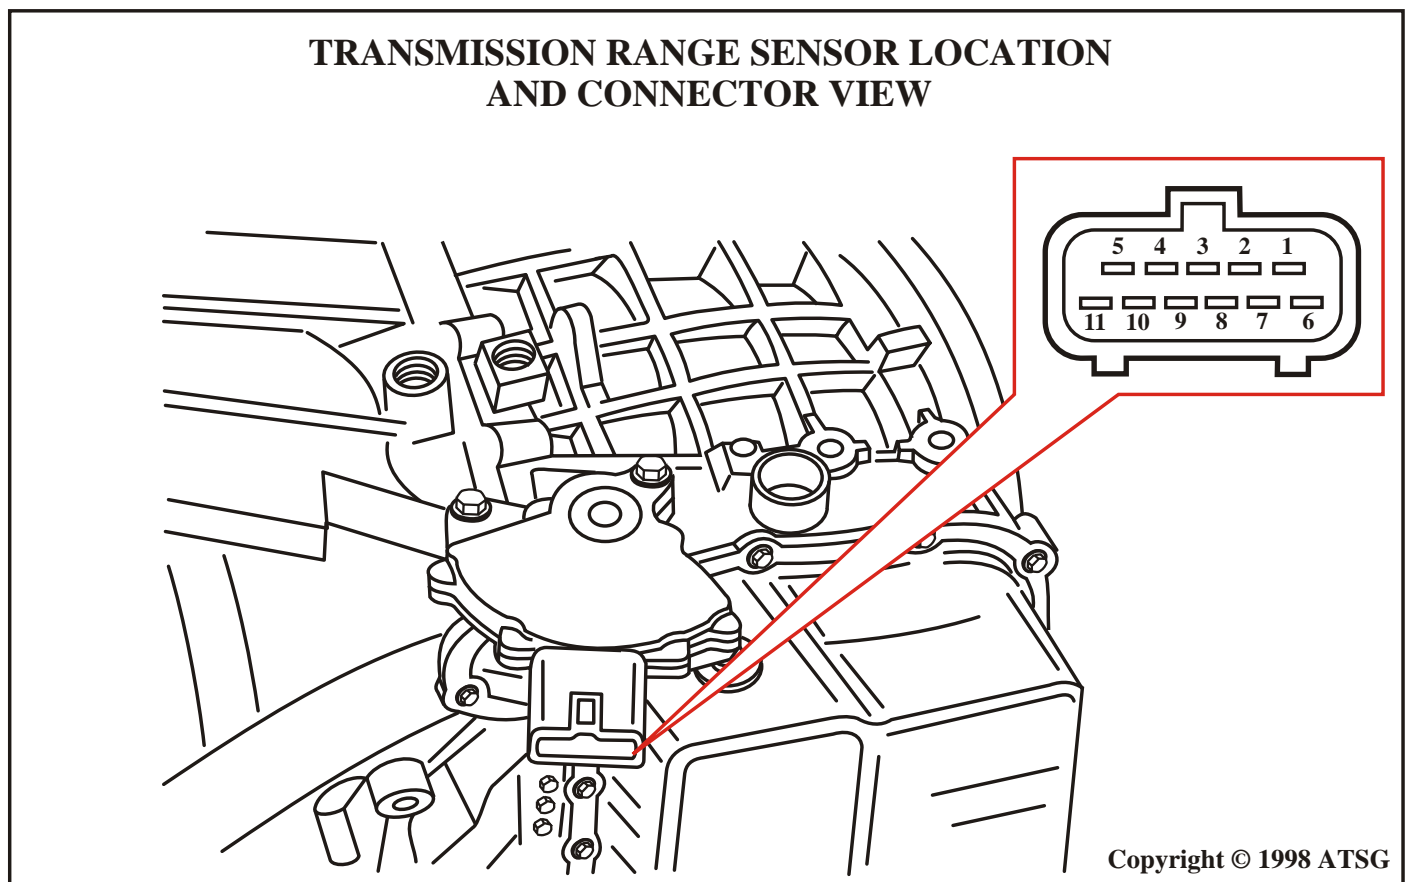
COMPLAINT: Vehicles equipped with CD4E transaxles may exhibit erratic upshifts or downshifts, wrong gear starts with no upshifts and/or no reverse with or without a flashing M.I.L (Malfunction Indicator Lamp). Upon trouble code retrieval, one or more of the following codes may be present: 522, 634, 659, 667, 668, 675.

CAUSE: The cause may be, a faulty Transmission Range Switch.

CORRECTION: Refer to Figure 1 for the location of the Transmission Range Switch and refer to Figure 2 for terminal I.D. and to test the switch in each range for the correct ohm and voltage value. Replace the switch if it fails this test.

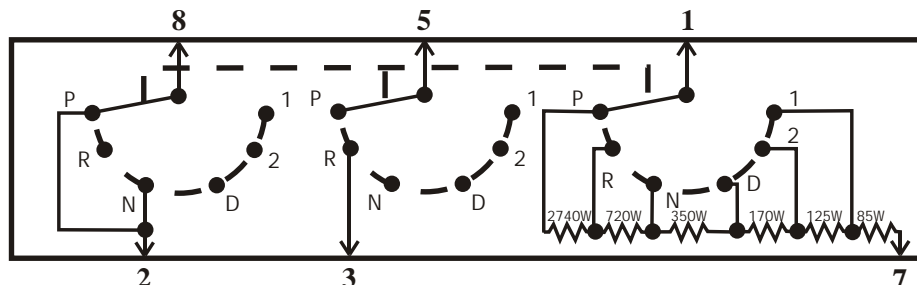
Figure 2

CONNECT OHM METER BETWEEN TERMINALS 1 & 7 TO CHECK RESISTANCE

BACK PROBE VOLTMETER LEADS INTO THE TWO WIRES IN TERMINALS 1 & 7 TO CHECK VOLTAGE
