FORD/MERCURY CD4E ERRATIC AND/OR NO VEHICLE SPEED

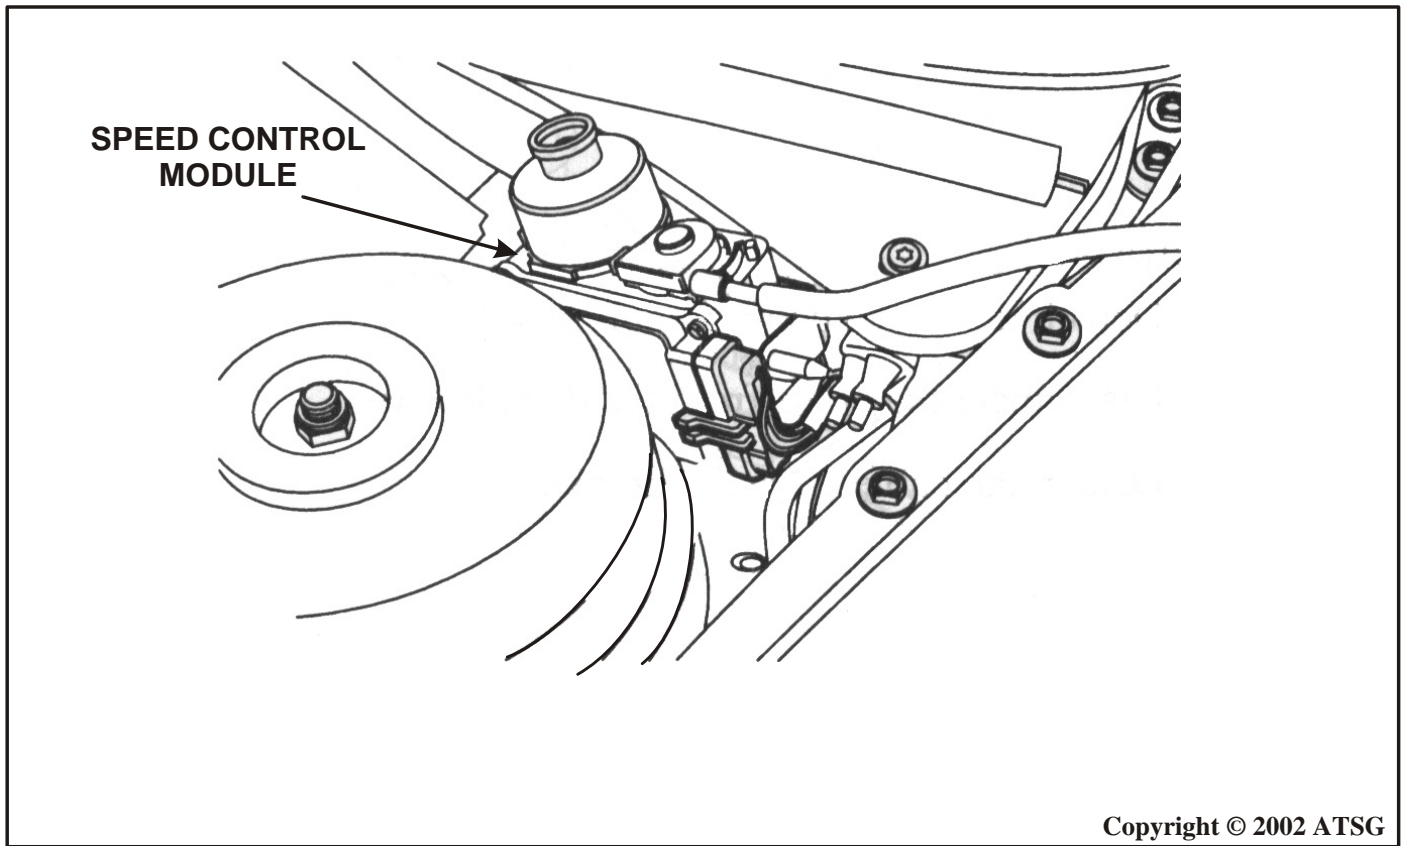
Speed Control Module Refer to Figure 4
Junction Connector Number C141 Near Instrument Cluster and Fuse Block
