Technical Service Information

FORD AODE/4R70W 3-NEUTRAL SHIFT AND FORWARD CLUTCHES BURNT

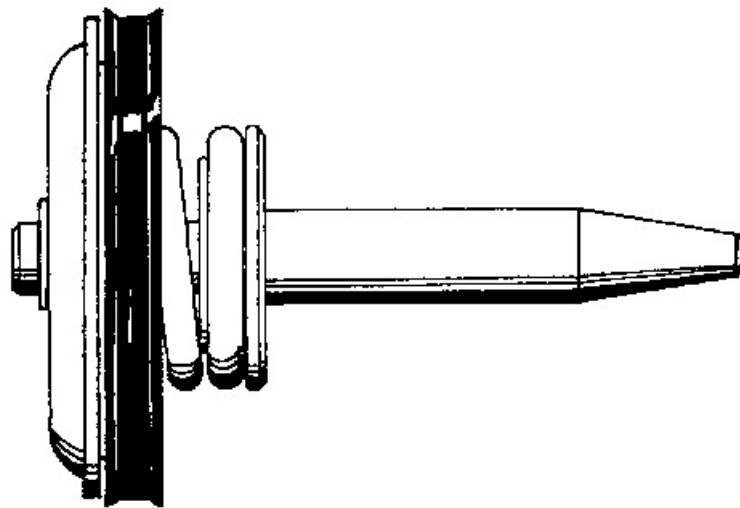
DIMENSION “A” = 2.470 (4R70W PISTON)
DIMENSION “A” = 2.680 (AOD-E PISTON)

CORRECTION: Install the “Rubber Coated Sleeve” in the Overdrive Servo Assembly, as shown in Figure 2. If your rubber coated sleeve is missing or lost, you **MUST** buy the complete Overdrive Servo Assembly, available under OEM part number F3LY-7H188-A. It is not available individually. Overdrive servo piston dimensions are shown in Figure 1, to identify the two different overdrive pistons

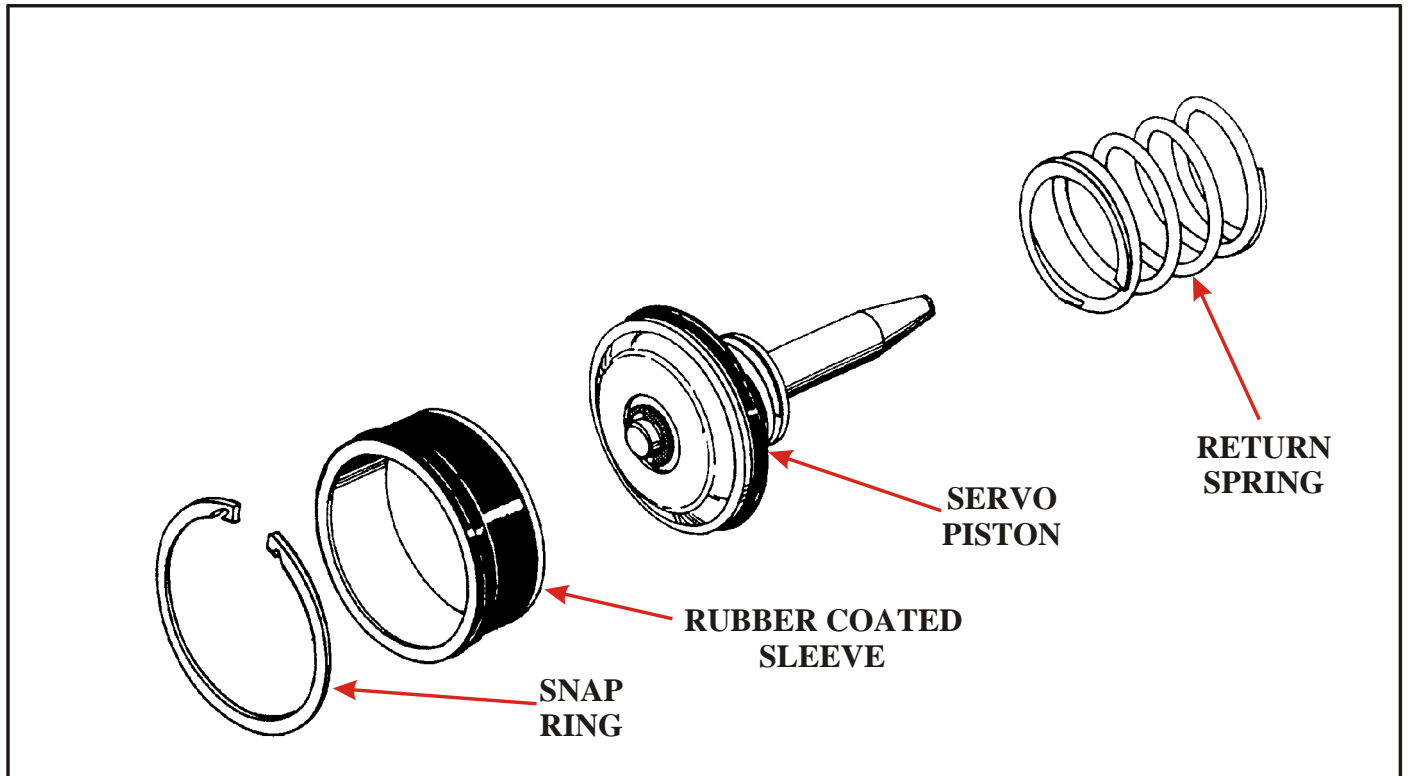
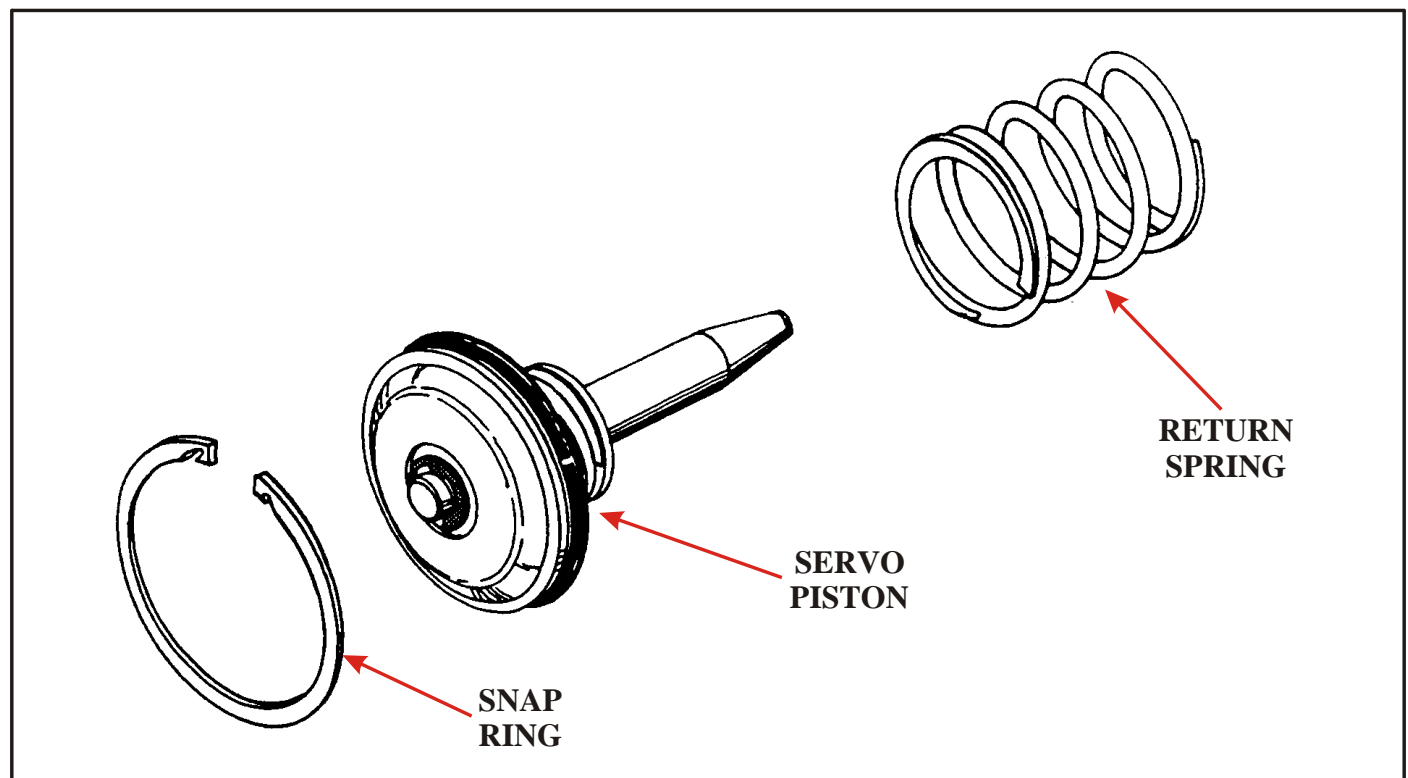
COMPLAINT: After overhaul, the 4R70W transmission displays a 3-neutral upshift, and upon disassembly you find the forward clutches burnt.

CAUSE: The cause may be a mis-assembled Overdrive Servo Assembly, with the “Rubber Coated Sleeve” omitted. The 4R70W transmission is calibrated with a smaller diameter overdrive servo piston than is the AOD-E transmission. To retain a common case between the two transmissions, an additional “Rubber Coated Sleeve” is required on the 4R70W Overdrive Servo Assembly, as shown in Figure 2.

4R70W Overdrive Servo Assembly (Includes Sleeve)	F3LY-7H188-A
AOD-E Overdrive Servo Assembly	F2VY-7H188-A
