# Technical Service Information

## **THM 4L60 (700-R4) PREMATURE FORWARD CLUTCH FAILURE**

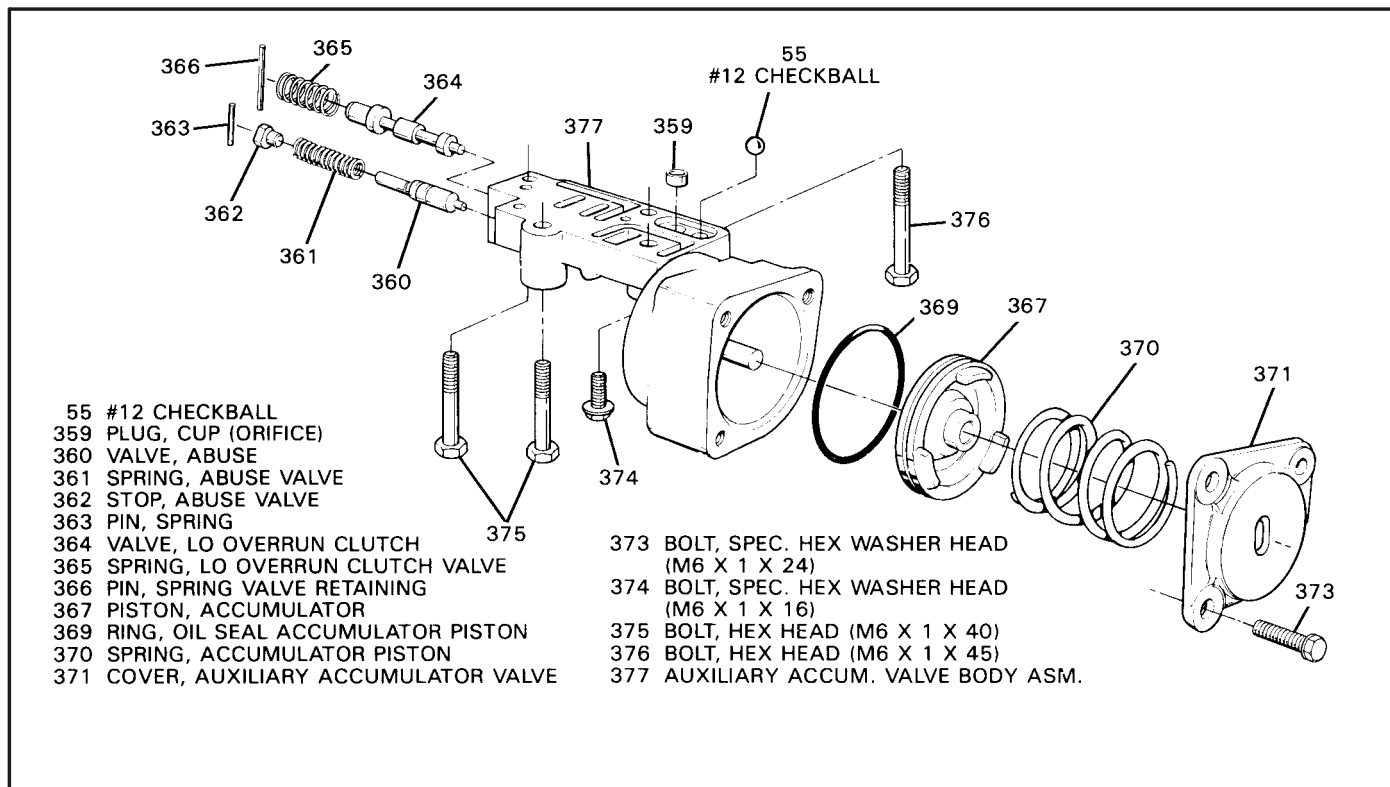
**Figure 1**

**CAUSE:** The cause could be the forward clutch accumulator pin in the auxiliary valve body moving out thru the hole in the center of the 1st design accumulator cover, and creating a loss of forward clutch oil. The original press fit of the pin was not sufficient to retain the pin in the auxiliary valve body casting.

**CORRECTION:** If you have the 1st design cover, braze shut the hole in the center of the cover and drill a 3/16" hole off center. (See Figure 1). The 2nd design cover with the oblong hole in the center is OK to use as is. If the pin has moved out the back side of the auxiliary valve body, a simple "staking" process will prevent it from moving that direction again. The 2nd design auxiliary valve body casting has a step machined in that area to prevent the pin from moving.
