Technical Service Information

CHRYSLER A518/A618 DRIVESHAFT YOKE DOES NOT FIT OUTPUT SHAFT

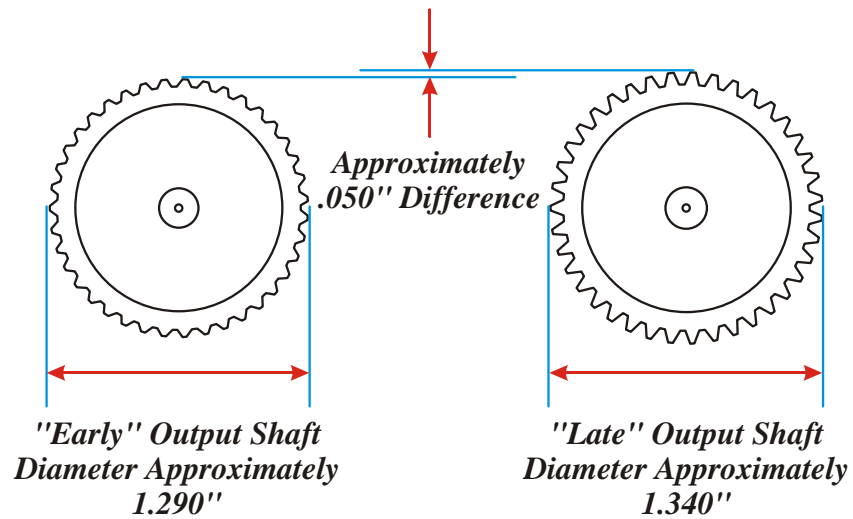
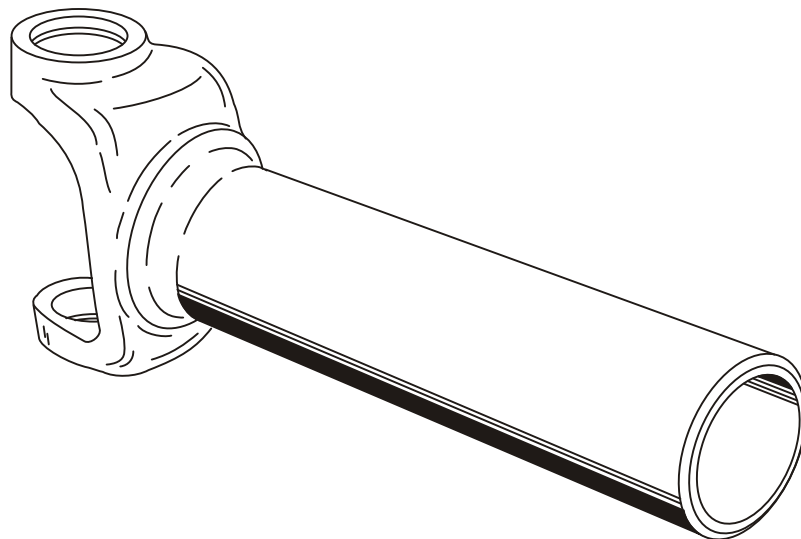
Figure 1

CAUSE: *Late* output shaft in the transmission with *early* driveshaft yoke in vehicle.
Explanation: Chrysler Corporation changed the outside diameter of the output shaft in the spline area, which increased the contact area of the yoke splines for improved durability, and of course the yoke changed at the same time to accommodate the output shaft change, as shown in Figure 1.

OUTPUT SHAFT DIFFERENCES

CORRECTION: There are two ways to correct this concern. If it is after installation, the easiest way to correct this is to purchase and install the late driveshaft yoke, available under OEM part number 4384437, as it will fit both early and late output shafts.
The only other option is to make yourself a Go-No Go gauge to fit the early output shaft diameter, and remove approximately .050" from the outside diameter of the spline area, if the Go-No Go gauge will not go over your output shaft, and do this before the output shaft is installed into the transmission. This will ensure that the driveshaft yoke will go on the output shaft as you have now made it an early shaft, which either driveshaft yoke will fit.

***"LATE" DRIVESHAFT YOKE
PART NUMBER 4384437 FITS
BOTH EARLY AND LATE SHAFTS***
