Technical Service Information

MERCEDES 722.3 /.4 BURNT FLUID (BELLVILLE PLATE INTERFACE)

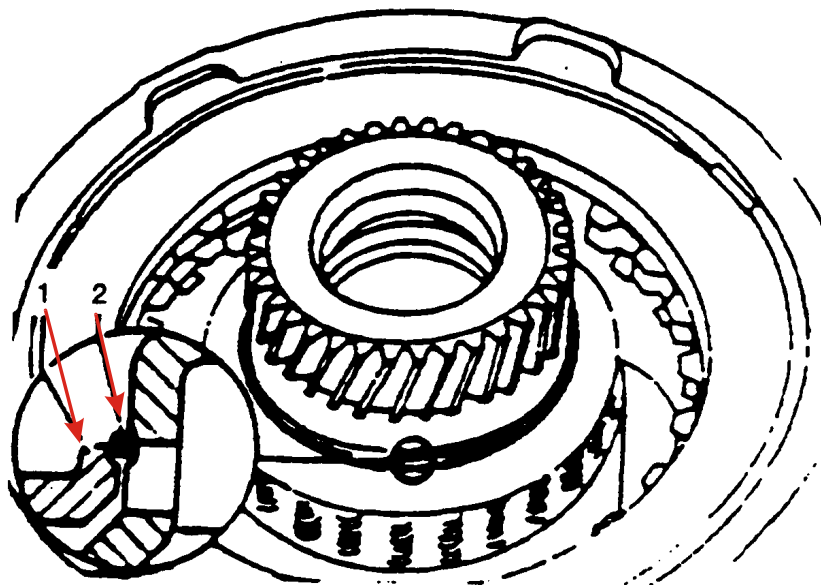
1 - BELLVILLE WASHER
2 - RETAINING RING

COMPLAINT: Transmission fluid is very dark or black, but does not smell burned. From 7/86 to 2/87 Production.

CAUSE: The bellville washer of the K-1 clutch rubs against the planetary-gear carrier of the front planetar

CORRECTION: Replace steel disks K-1, bellville washer, and retaining ring (Figure 1).

NOTE: If the transmission is disassembled for repairs, check to be sure the retaining ring sits properly in it's groove, or if the bellville washer already is pushed over the retaining ring. In this case, replace steel disks K-1, retaining ring, and bellville washer.
