# Technical Service Information

## FORD AX4N HARSH REVERSE ENGAGEMENT

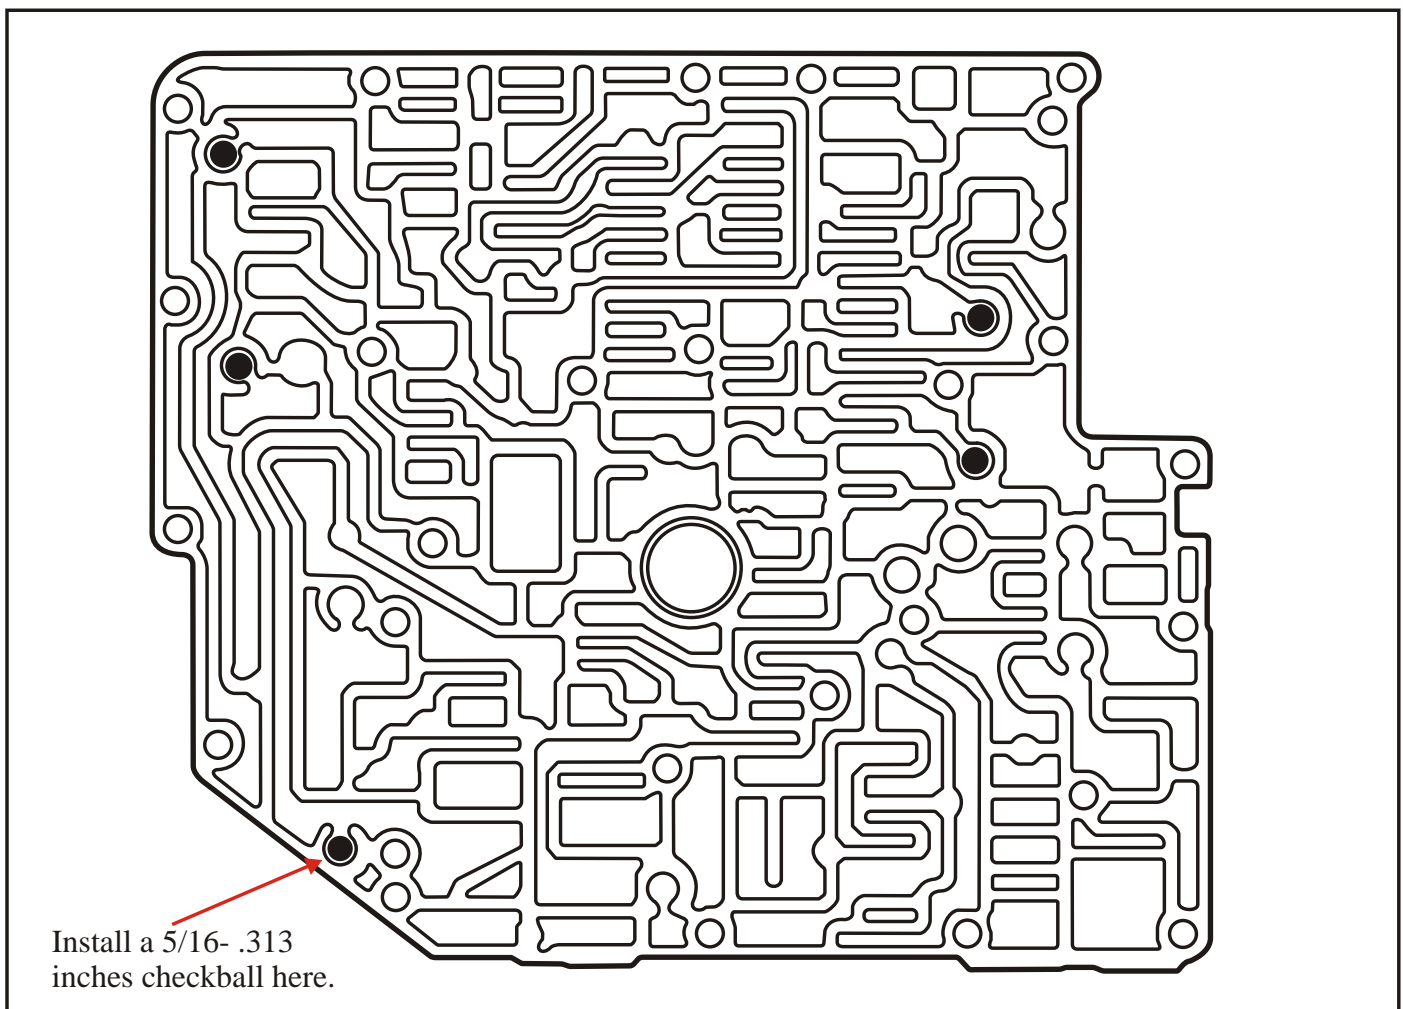
Figure 1

**COMPLAINT:** Before and/or after rebuild, the vehicle may exhibit a harsh Reverse Engagement.

**CAUSE:** The cause may be a missing B1 checkball from the valve body. A missing B1 checkball will allow Reverse Clutch oil to flow un-orificed into the Reverse Clutch, causing the engagement to be harsh.

**CORRECTION:** To correct this condition, install a 5/16 - .313 inches checkball at the B1 location. See Figure 1.
