Technical Service Information

THM 440-T4 WELDED 4TH CLUTCH

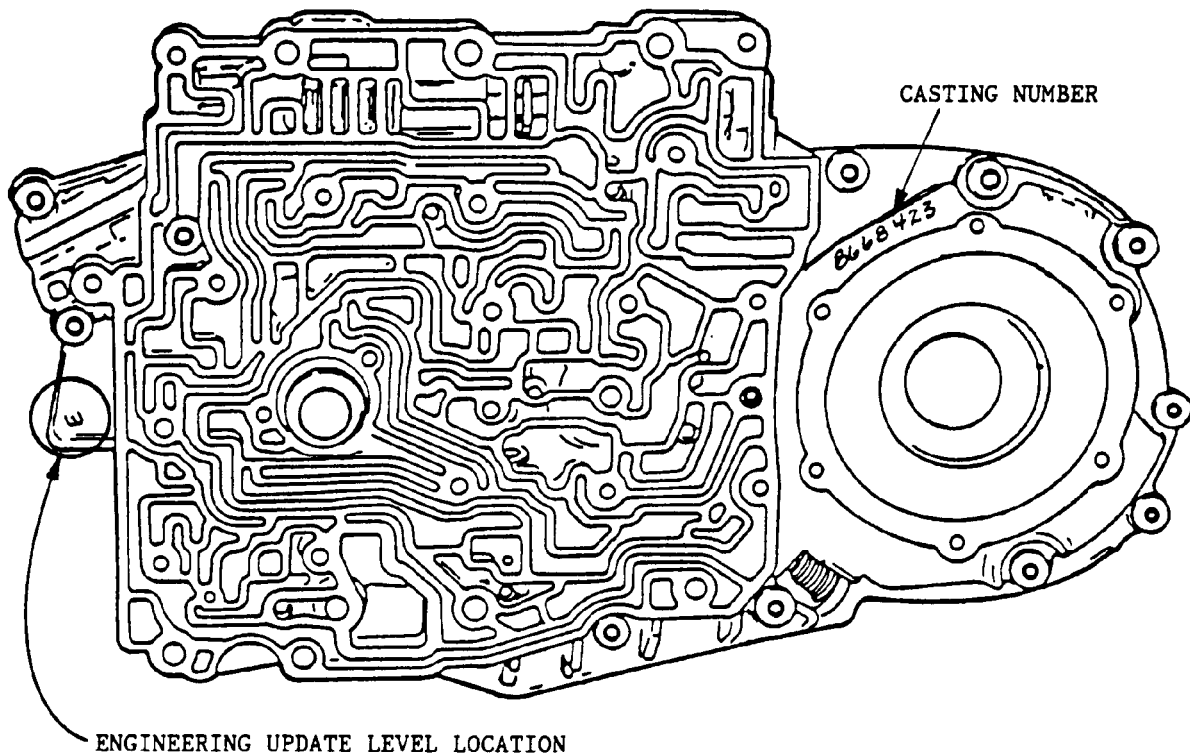
Figure 1
AUTOMATIC TRANSMISSION SERVICE GROUP

CAUSE The cause may be the manual valve being positioned between the neutral and D4 position, which would allow the input clutch to be applied in 4th gear. This was created by a change in the channel plate porting, in the manual valve area. The questionable channel plate can be identified by the casting number "8668423", with engineering update level "E". Refer to Figure 1 for locations. Casting number "8668423" with engineering update levels "A", "B", "C", and "D" are OK to use. **DO NOT USE CASTING NO. "8668423" WITH ENGINEERING UPDATE LEVEL OF "E" OR HIGHER - REFER TO FIGURE 1 FOR LOCATIONS.**

CORRECTION: Install an earlier model channel plate that does not have the questionable casting number 8668423. There is also a new service package available from OEM, to address this condition. The new service package contains the following:

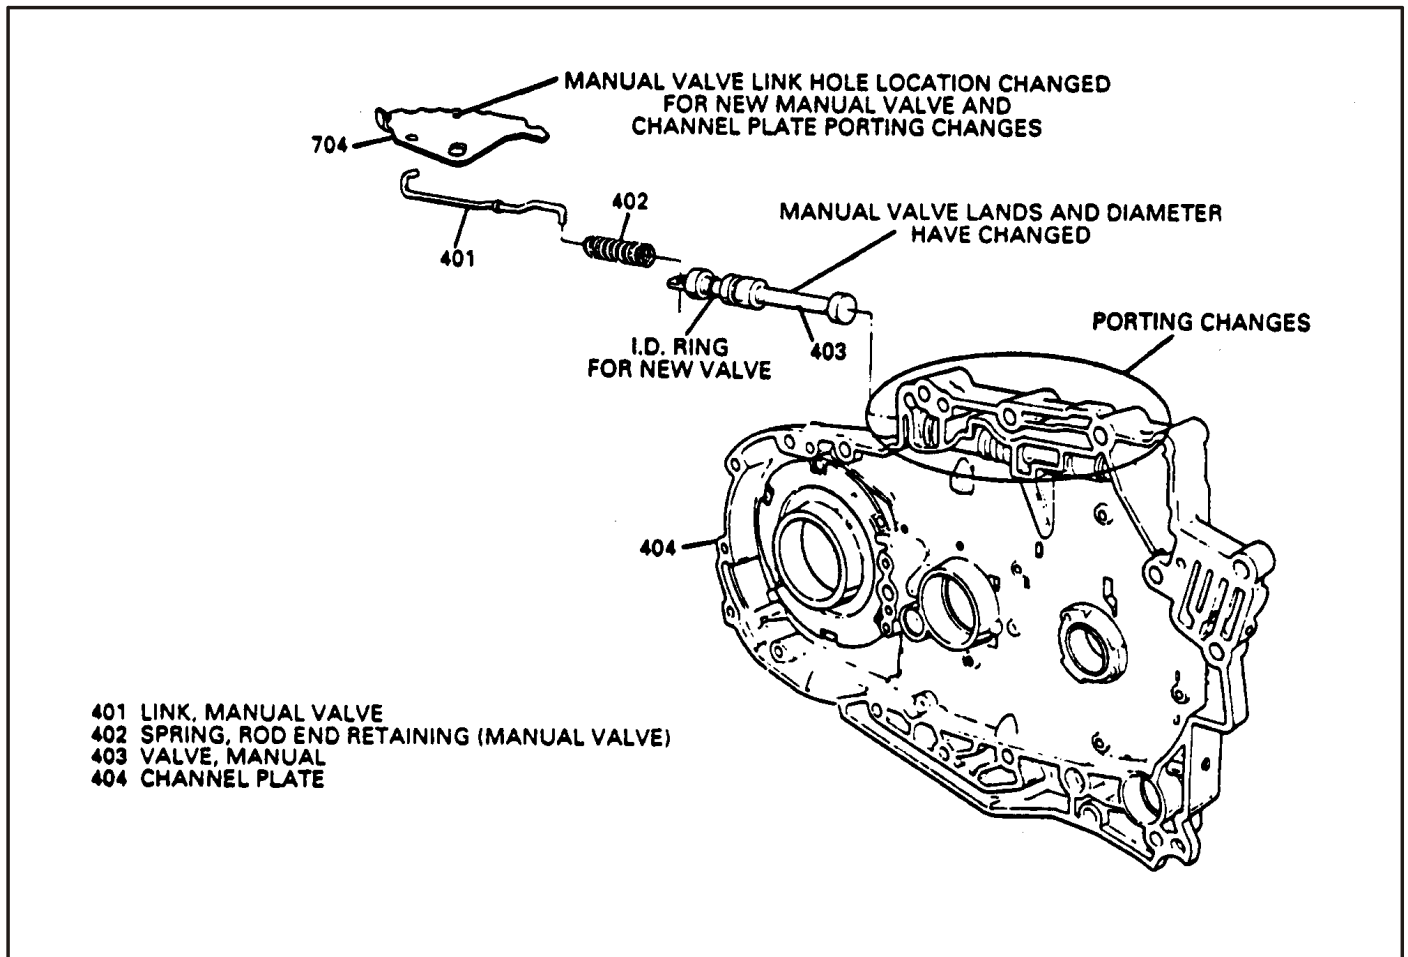
Figure 2

NEW CHANNEL PLATE - Will have porting changes for the new manual valve and new inside detent lever. The porting changes will help ensure that two ports will never be opened at once to cause burnt 4th clutch assembly. The bore for the new manual valve will be reduced by .010" to accommodate the new manual valve. This will make the previous and new parts non-interchangeable. (See Figure 2).

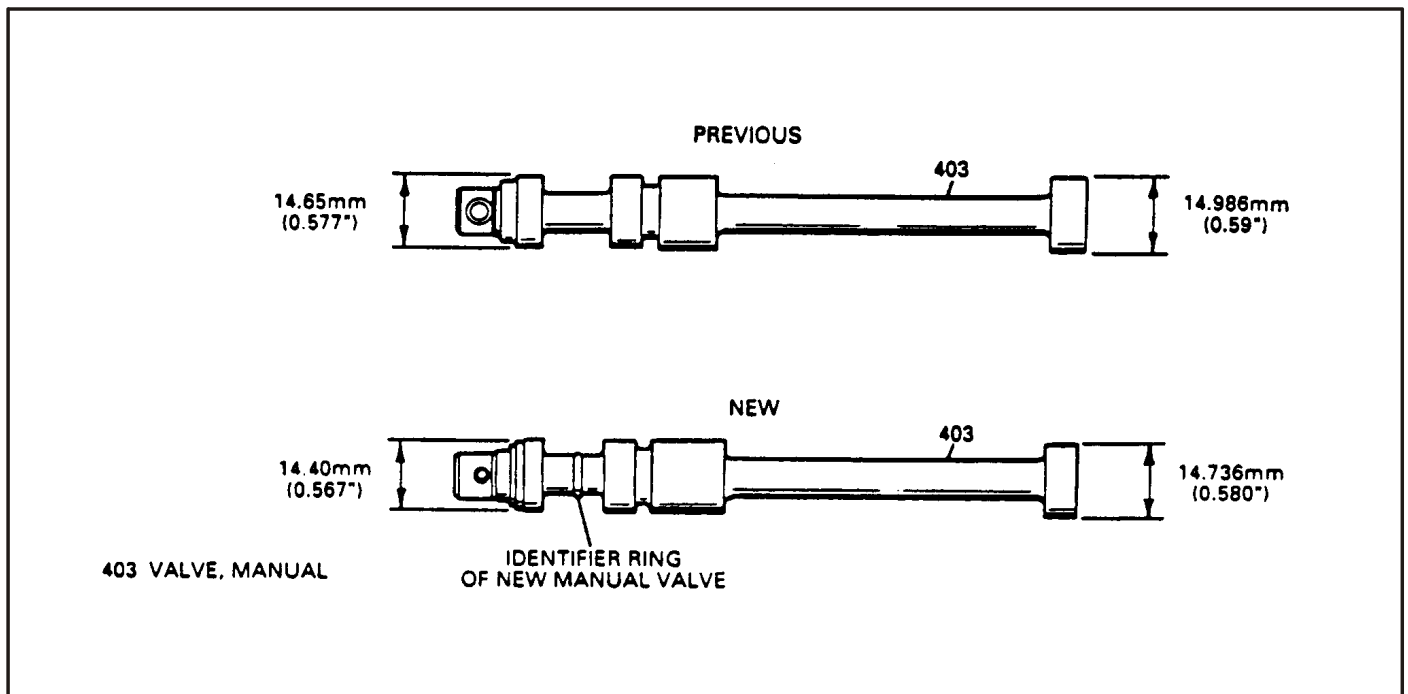
Figure 3

NEW MANUAL VALVE - Will have changes to the valve lands and reduced .010" in diameter for the new porting changes in the channel plate. The previous and new manual valves are not interchangeable. The new manual valve can be identified by a ring between the first two lands as shown in Figure 3.

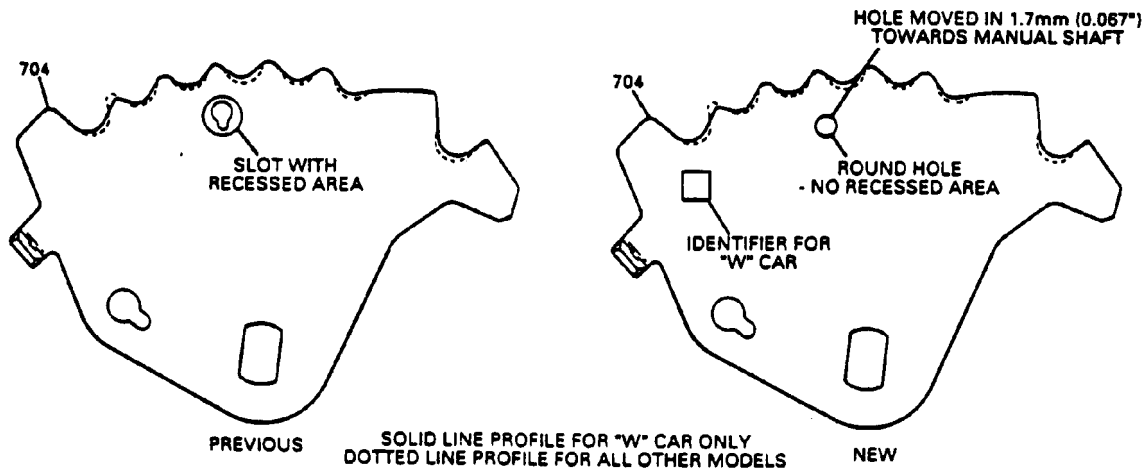
NEW INSIDE DETENT LEVER - Will have the manual link hole location changed to provide a different "Throw" of the manual valve, and the hole is now round instead of "Key Hole" shaped. Since the "W" car detent lever is different than all others, it will have a square identification hole punched in it. The previous and new inside detent levers will not interchange. See Figure 4 for identification.
