Technical Service Information

NISSAN SENTRA RE4FO3A HARSH SHIFTS

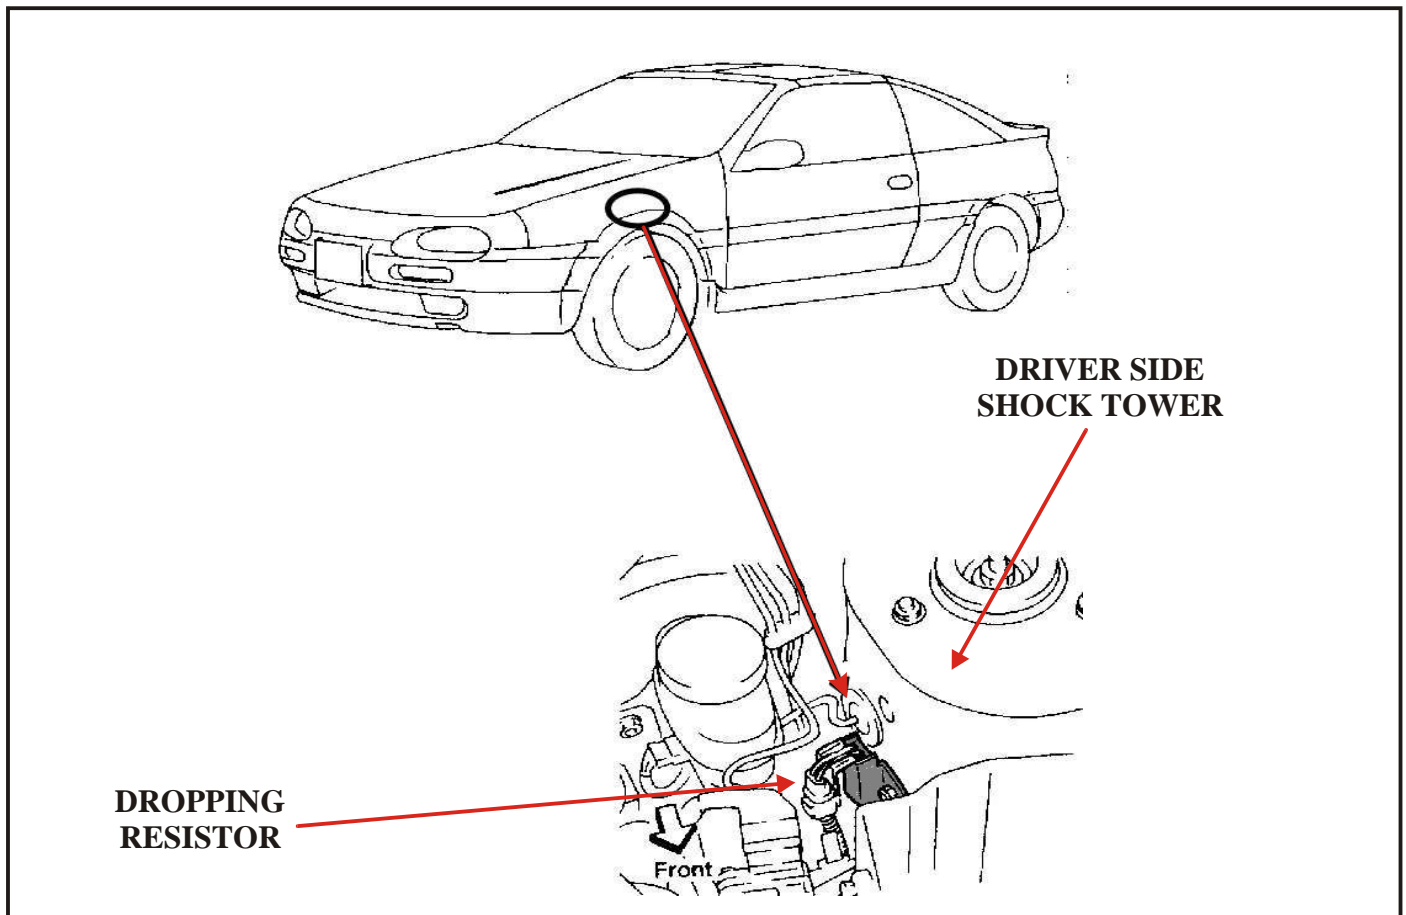
Figure 1

- COMPLAINT:** 1993-94 Nissan Sentra vehicles equipped with the RE4FO3A transaxle may exhibit a condition of harsh upshifts and down shifts. When line pressure is checked it is found to be at or near maximum.
- CAUSE:** The cause may be, a damaged dropping resistor, due to water intrusion from a leaking hood seal due to an accident or gasket deterioration. The 1993-94 Nissan Sentra has the dropping resistor mounted on the drivers side shock tower, as shown in Figure 1, which allows water from a leaking hood seal to fall on the resistor and create corrosion.
- CORRECTION:** Replace the dropping resistor as necessary, and relocate or weather proof the new one to prevent this condition from occurring again.
