"2001" SEMINAR INFORMATION "PRACTICAL TECH"

AUTOMATIC TRANSMISSION SERVICE GROUP

"FIXES THAT WORK"

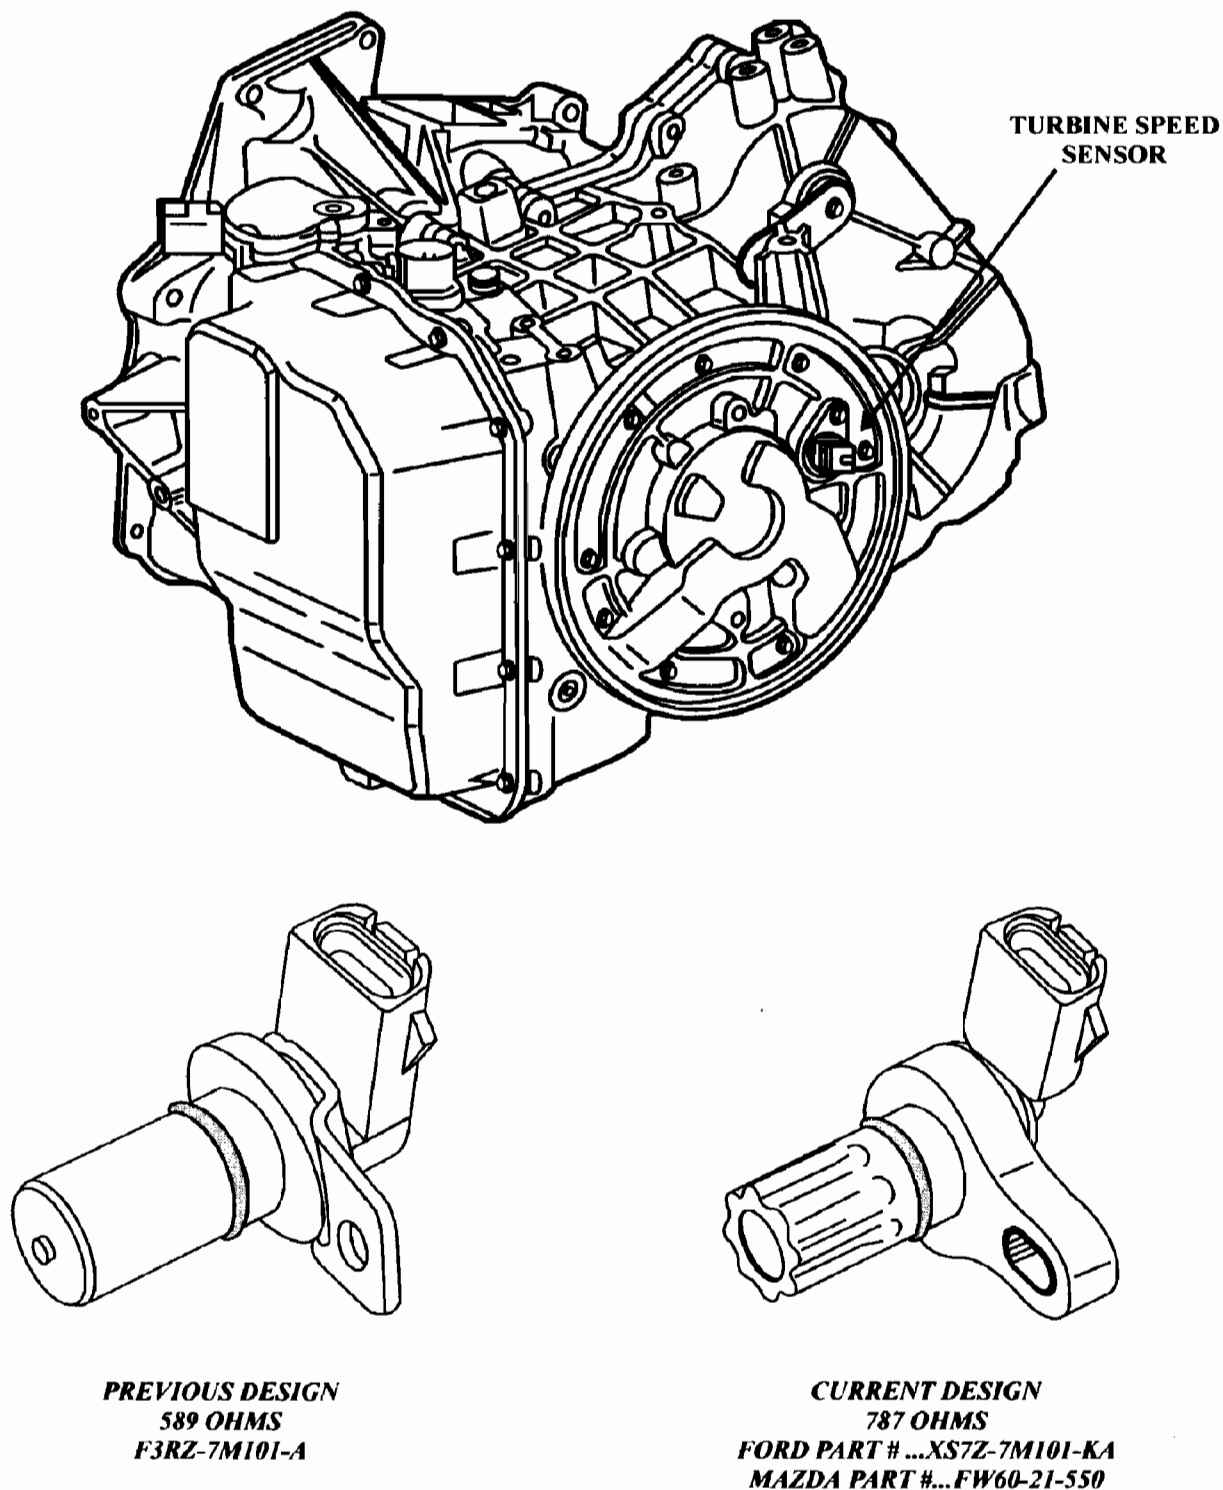
Figure 1

COMPLAINT: After Turbine Speed Sensor (TSS) replacement, TCC slip codes 628 or P1744 maybe stored. Gear ratio error codes 645, 646, 647, 648, PO731, PO732, PO733 or PO734 may also be stored. After clearing these codes, they immediately return during the road test. No matter what parts are replaced, or what procedure is followed, these codes keep returning.

CAUSE: *The cause, believe it or not, is the replacement Turbine Speed Sensor.* The replacement TSS was redesigned and has an enclosed pickup as seen in figure 1. The previous design TSS has an exposed pickup also seen in figure 1. It seems, when the pickup was enclosed, the air gap between the TSS and the reverse clutch hub was increased. When the signal was checked and compared to the previous sensor signal, the new sensor signal exhibited a voltage difference but, when checked with an oscilloscope the previous sensor puts out a wider pattern than the current design sensor which means, the computer has more time to read the signal with the previous design sensor. In other words, with the current design turbine sensor, the computer does not have enough time to read the signal and may miss alternate signal pulses which causes the above complaint.

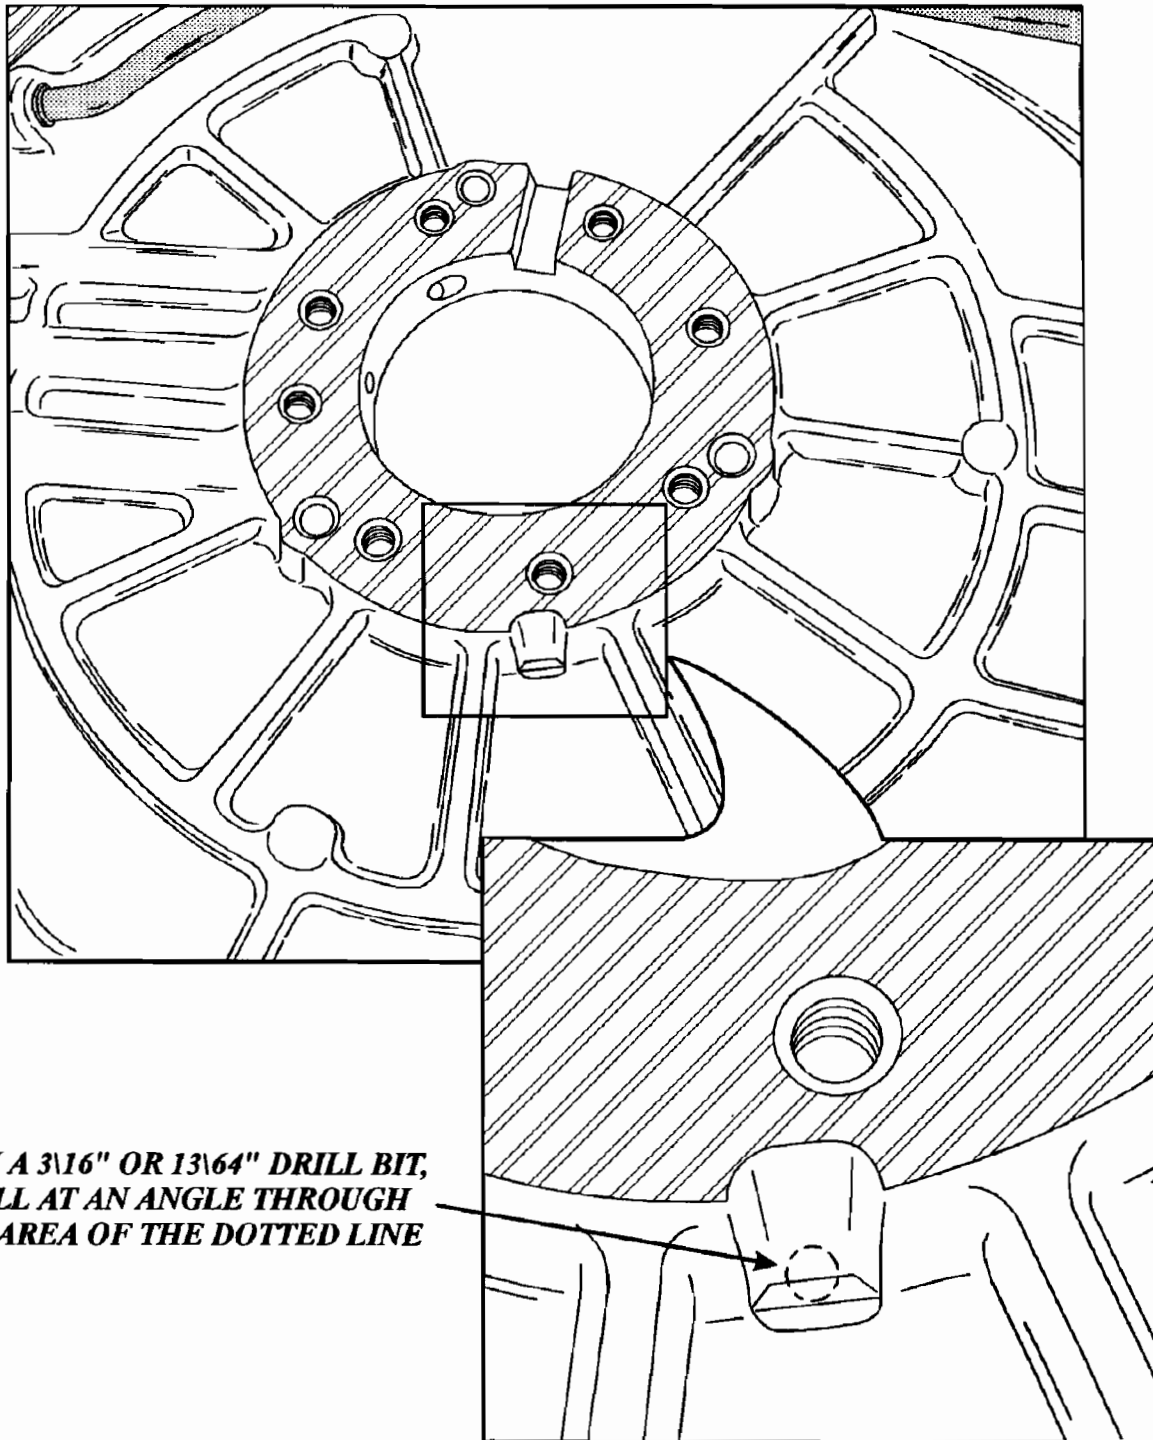
Figure 2

CAUSE: The cause may be, an undersized drain back passage in the bellhousing.

**WITH A 3/16" OR 13/64" DRILL BIT,
DRILL AT AN ANGLE THROUGH
THE AREA OF THE DOTTED LINE**

2. With a 3/16" or 13/64" drill bit, drill at an angle through the area shown in Figure 2.
3. Refer to Figure 3 to see the modified drain back passage from the front side of the bellhousing.
4. Apply Loctite ® to the front seal before installing it into the bellhousing as shown in Figure 1.

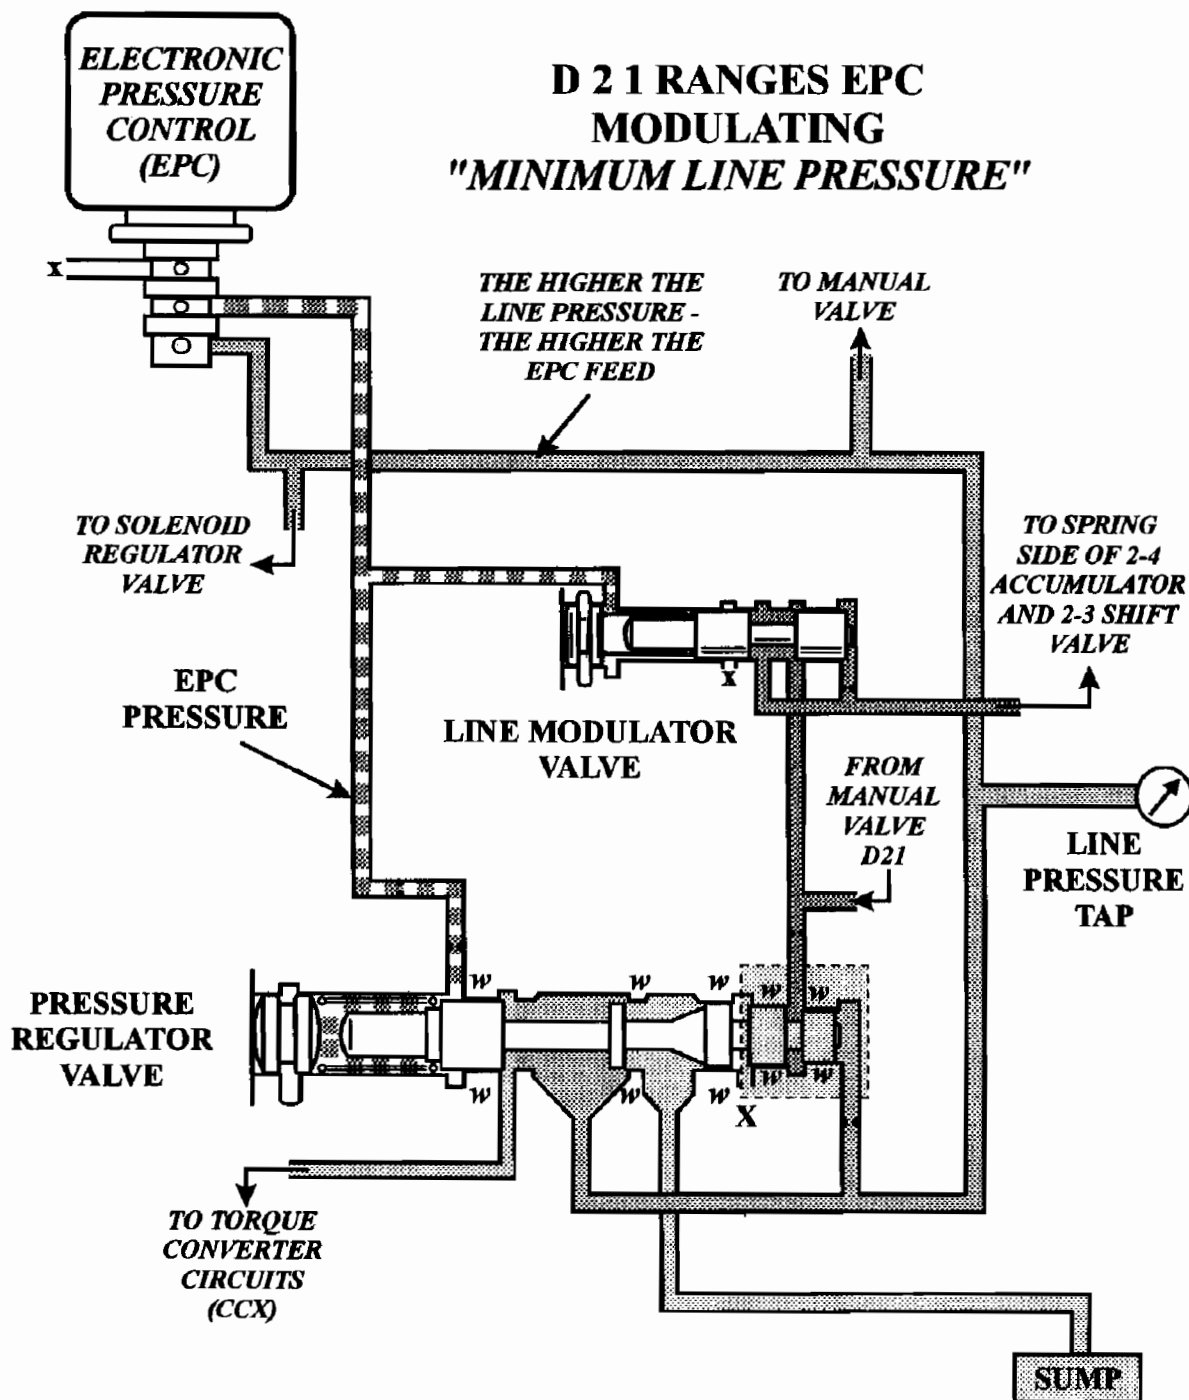
Figure 3

- C. A mis-aligned pump cover to pump body causing the drum to be off center.
- D. A worn Pressure Regulator Bore in the valve body, as shown in Figure 3, causing line pressure to be over the maximum amount which in turn causes convertor charge and cooler pressure to be minimal.

- A. A worn Pressure Regulator Bore in the valve body, as shown in Figure 3, causing line pressure to be in excess of 500psi. which in turn breaks parts!

w = Wear areas in the valve body bore

Wear in the area highlighted with the dotted line will create a loss of balance feed oil resulting in extremely High Line Pressure. Without balance feed, reducing line pressure, it will take very little EPC pressure to create 400-500 psi.

- D. Refer to Figures 5 and 6 to check for bore wear. Remove the Pressure Regulator valve and inspect it for wear which normally shows up as brown lines. Re-install the Pressure Regulator valve back into its bore and check for wobble from side to side. Fill the cavity shown in Figure 6 with ATF. Place a suitable block over the passage shown in Figure 6 and torque the hold down bolt too 8ft. lbs. Apply 70psi. of air pressure to the hole in the block so the cavity is full and ensure there is no leakage between the block and the valve body. There should be no leakage between the first land of the Pressure Regulator Valve and the wall shown in Figure 6 for approximately 25-30 seconds. A new valve body will hold air pressure for 45-50 seconds. If the valve body in question leaks at 25 seconds or less, the bore is worn and the valve body will require replacement or Sonnax part no. 73840-RK regulating valve kit installed. **Note: requires reamer Sonnax part no. 73840-RTL.**

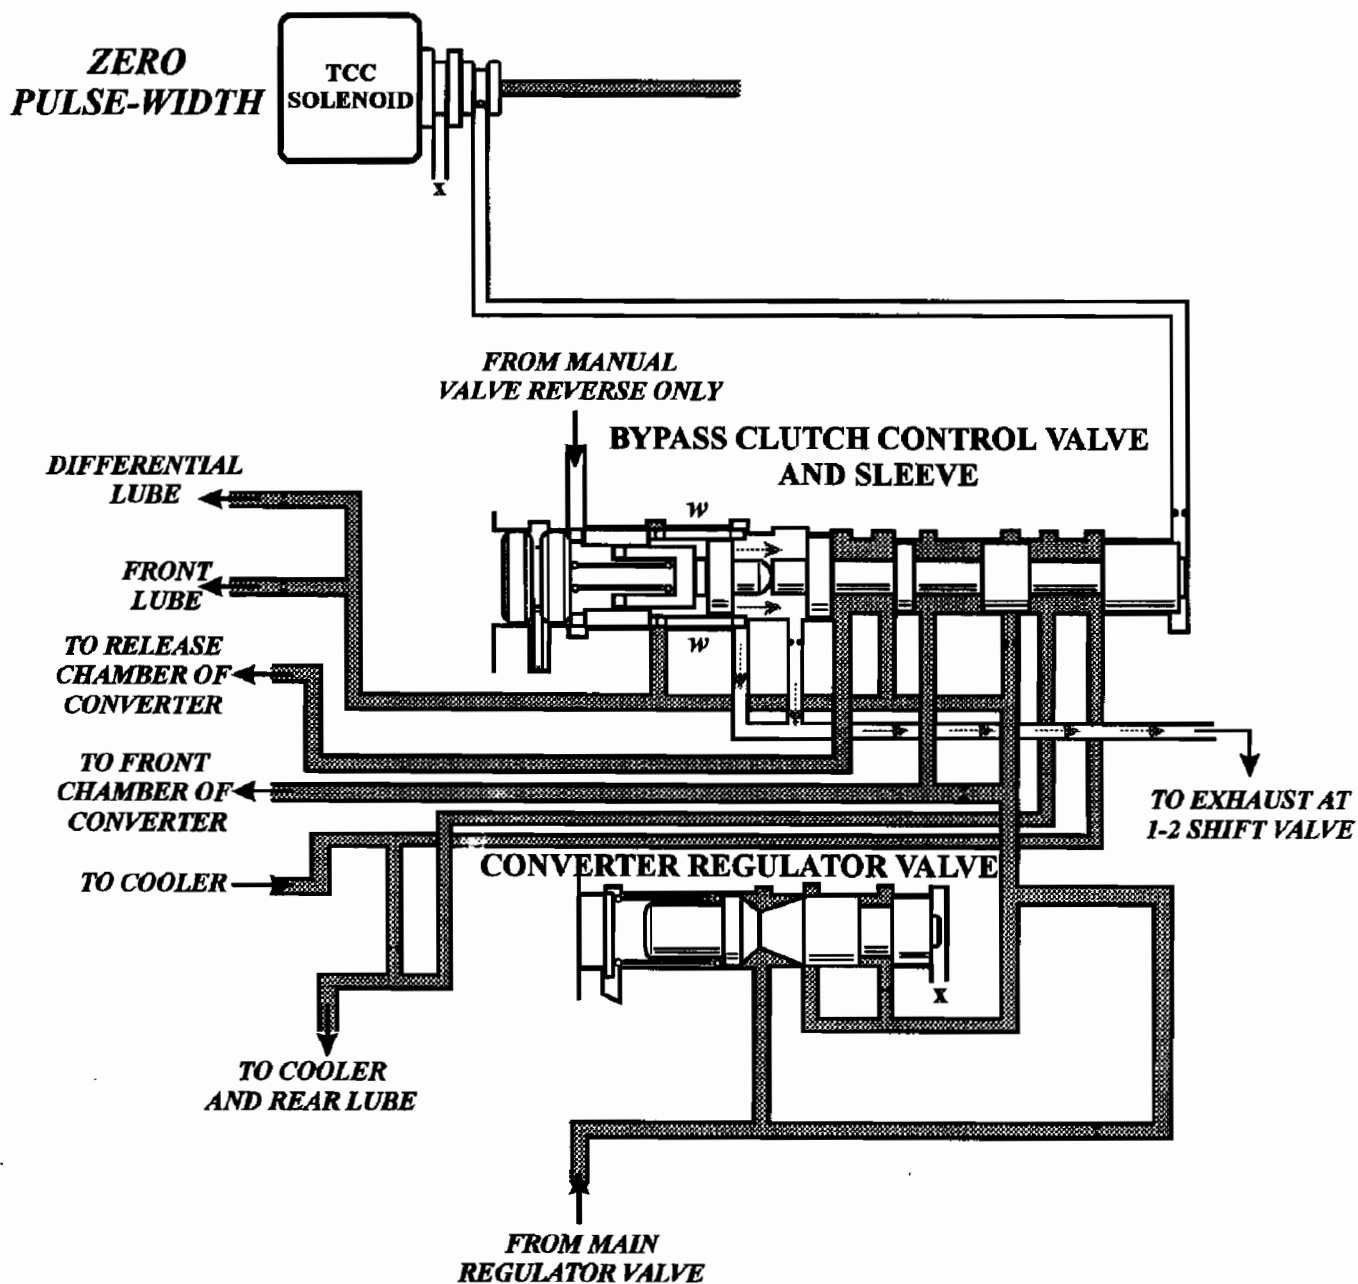
- E. A worn Bypass Clutch Control Valve sleeve, as shown in Figure 4, causing a loss of convertor regulator valve oil feeding front and differential lube.

Wear in the areas of the sleeve can cause a loss of converter regulator oil feeding front and differential lube

- E. Remove and inspect the Bypass Clutch Control Valve Sleeve as shown in Figure 5. If the sleeve is worn the valve body will require replacement as the sleeve is not available from Ford separately, or Sonnax Part no. 73840-BK Bypass Clutch Control Valve Kit installed to renew the sleeve and valve bore. *Note: Requires Sonnax 73840-BTL reamer.*

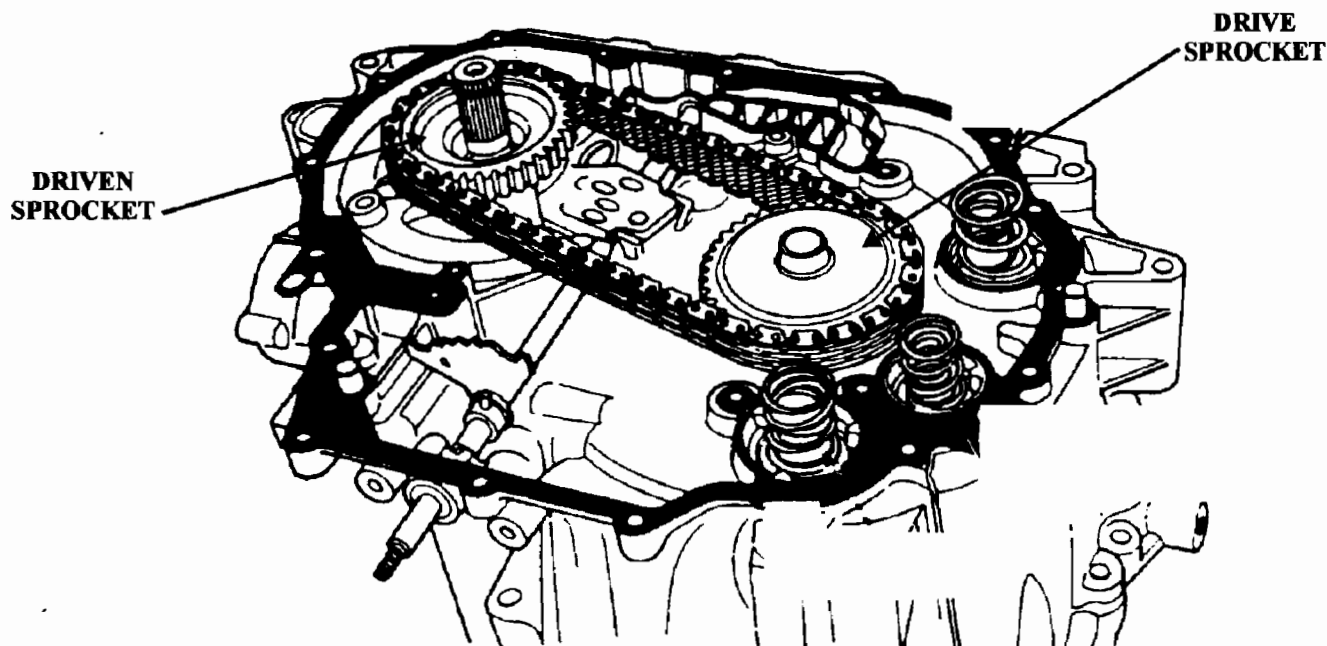
Figure 1

COMPLAINT: After overhaul, during the road test, the Malfunction Indicator Lamp (MIL) begins to flash and the system faults to Failure Mode Effects Management (FMEP). When code retrieval is completed, code 628 for TCC slippage, code P0741 for TCC Stuck Off or code P1744 for a TCC Performance fault may be stored. After diagnosis of the TCC system is performed, no faults are found. When these codes are cleared, they return on the next road test.

CAUSE: These complaints can be caused by installing the incorrect drive and/or driven sprockets (Refer to Figure 1) or by installing an exchange unit that has the incorrect sprocket tooth count. It is the sprocket tooth count that determines the target gear ratio that the PCM should see. Because the PCM is comparing the engine rpm signal to turbine speed sensor (TSS), the PCM assumes the converter clutch is slipping and stores the above codes due to an incorrect gear ratio caused by the incorrect sprocket tooth count.

CORRECTION: Use the charts in figures 2 and 3 to insure that the sprocket tooth count matches the vehicle application. It is also a good practice to tag exchange units so that the sprocket tooth count is known to insure that the correct transmission for that vehicle is installed.

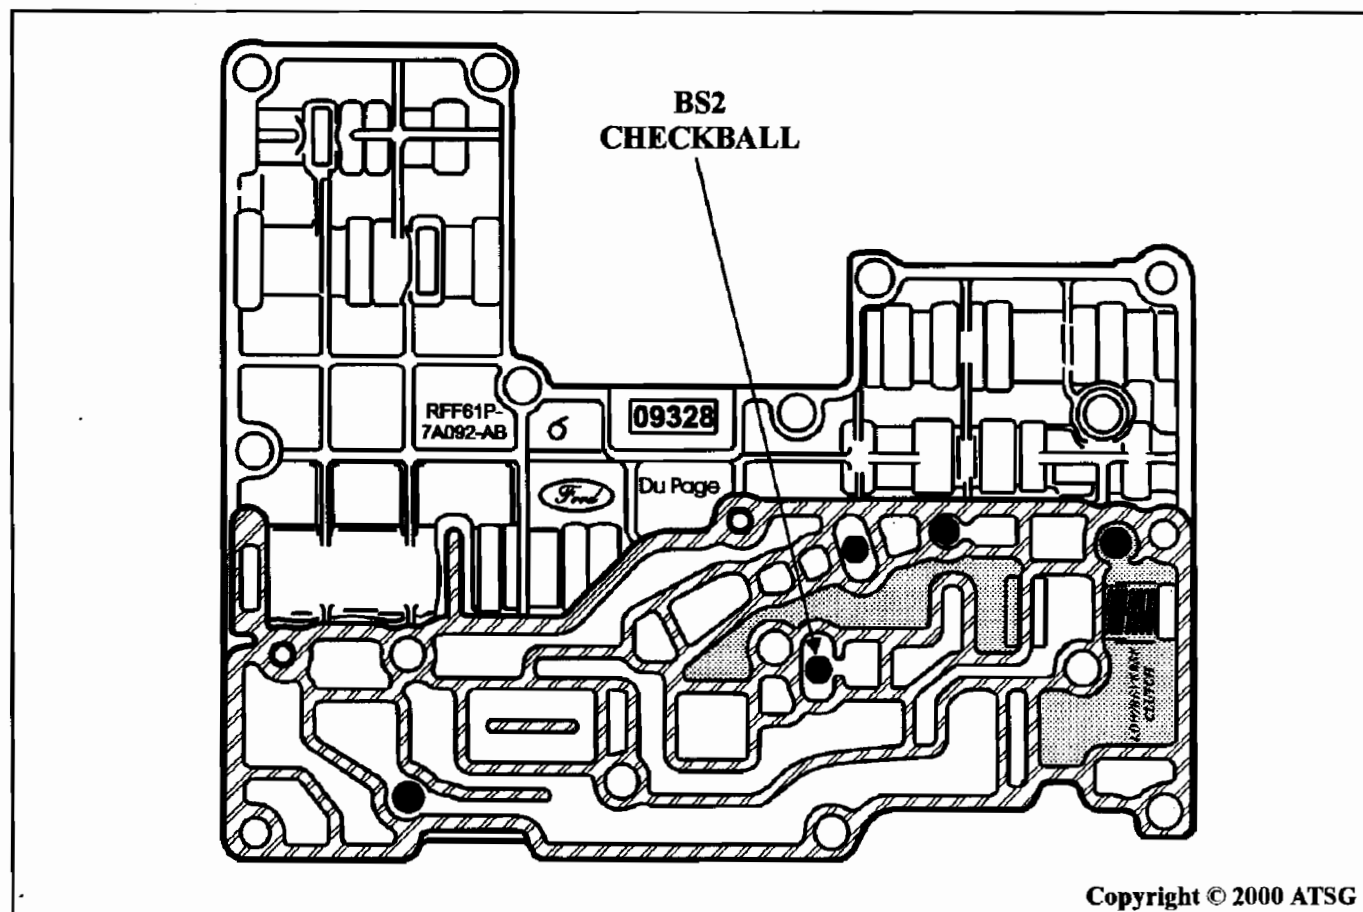
Figure 1

COMPLAINT: Some 1996 and later Ford Motor Company vehicles that are equipped with the E40D Transmission, before or after overhaul may exhibit a no upshift condition with the shift selector in Drive.

CAUSE: After determining that the PCM is commanding the transmission to make the upshifts, the cause may be that the BS2 Checkball, located in the Main Valve Body is missing. See Figure 1.

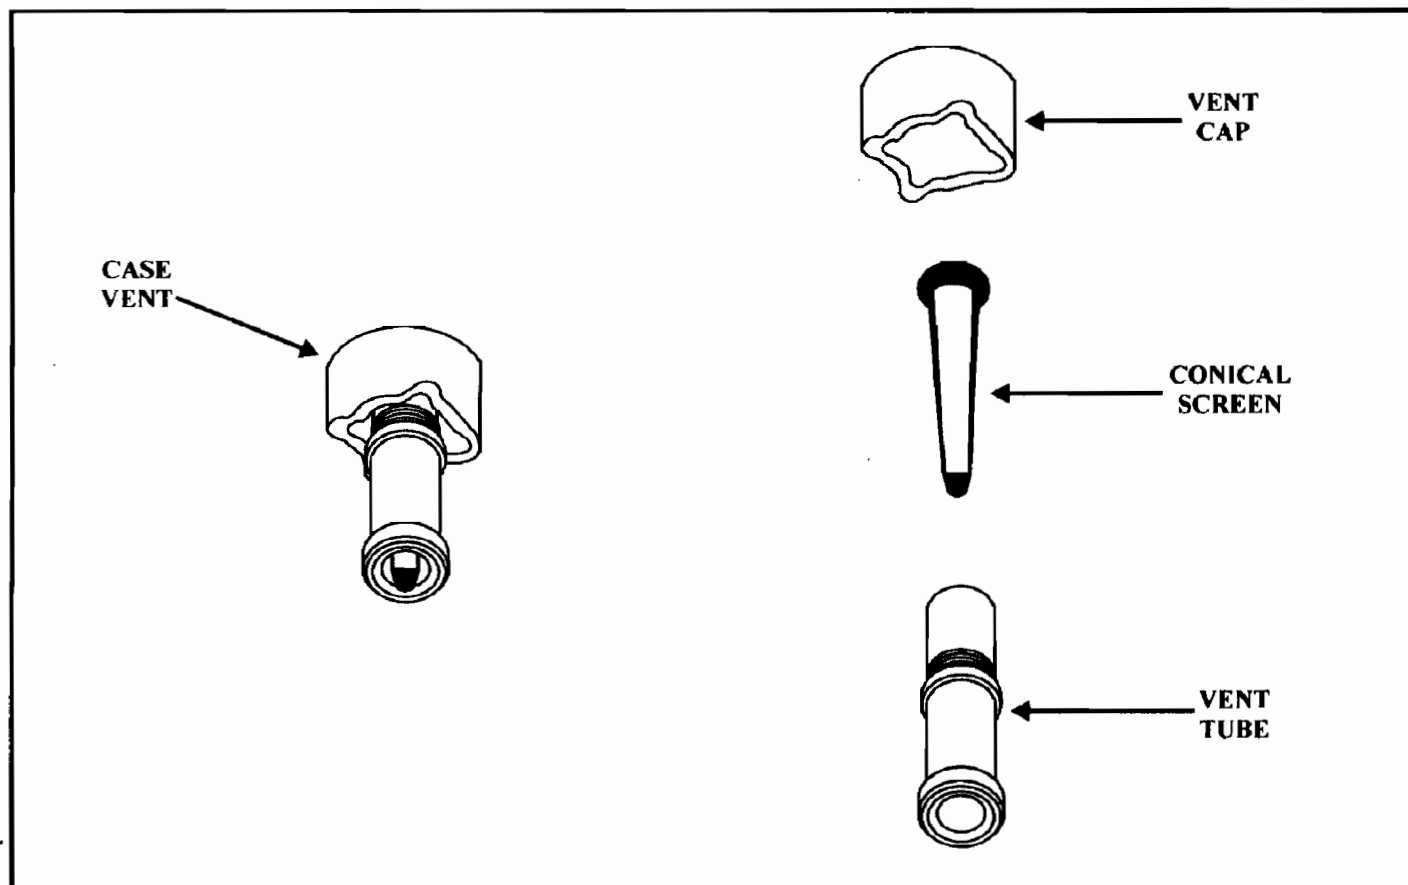
Figure 1

COMPLAINT: After installation of the overhauled transmission, as oil is being pumped into the filler tube, it becomes difficult for the transmission to accept oil. As the transmission warms, oil begins venting from the filler tube. This problem was NOT an original complaint. A front seal leak may also develop.

CAUSE: Located in the transmission case vent is a conical filter screen as shown in figure 1. During the time the case was in the cleaning machine, cleaning soap residue or other contaminants became lodged in the screen thereby restricting the screen located in the vent resulting in the above complaints.

CORRECTION: When air blowing the case after it comes out of the "cooker", be sure to blow air into the vent to insure that the vent is clear, if it is not clear, either remove the screen or replace the vent assembly. It is recommended that the screen in the vent always be removed.

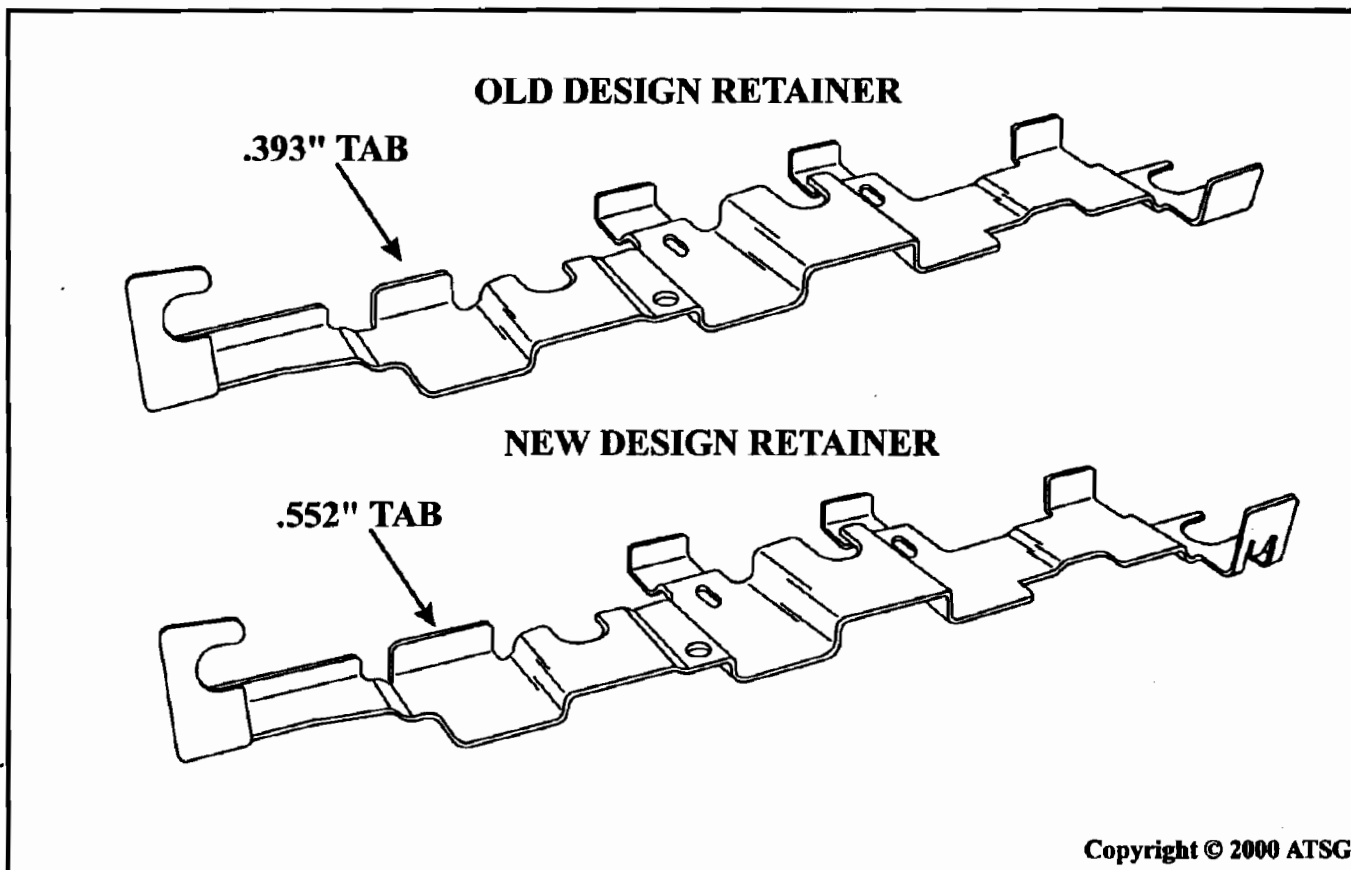
Figure 1

COMPLAINT: Vehicles equipped with 4R44E / 4R55E may exhibit a slipping condition, along with erratic or no line pressure rise.

CAUSE: The cause may be the EPC solenoid has blown out of the valve body due to a broken solenoid retainer holding in the EPC solenoid.

CORRECTION: Replace the early style solenoid retainer with the new design retainer as shown in figures 1 & 2.

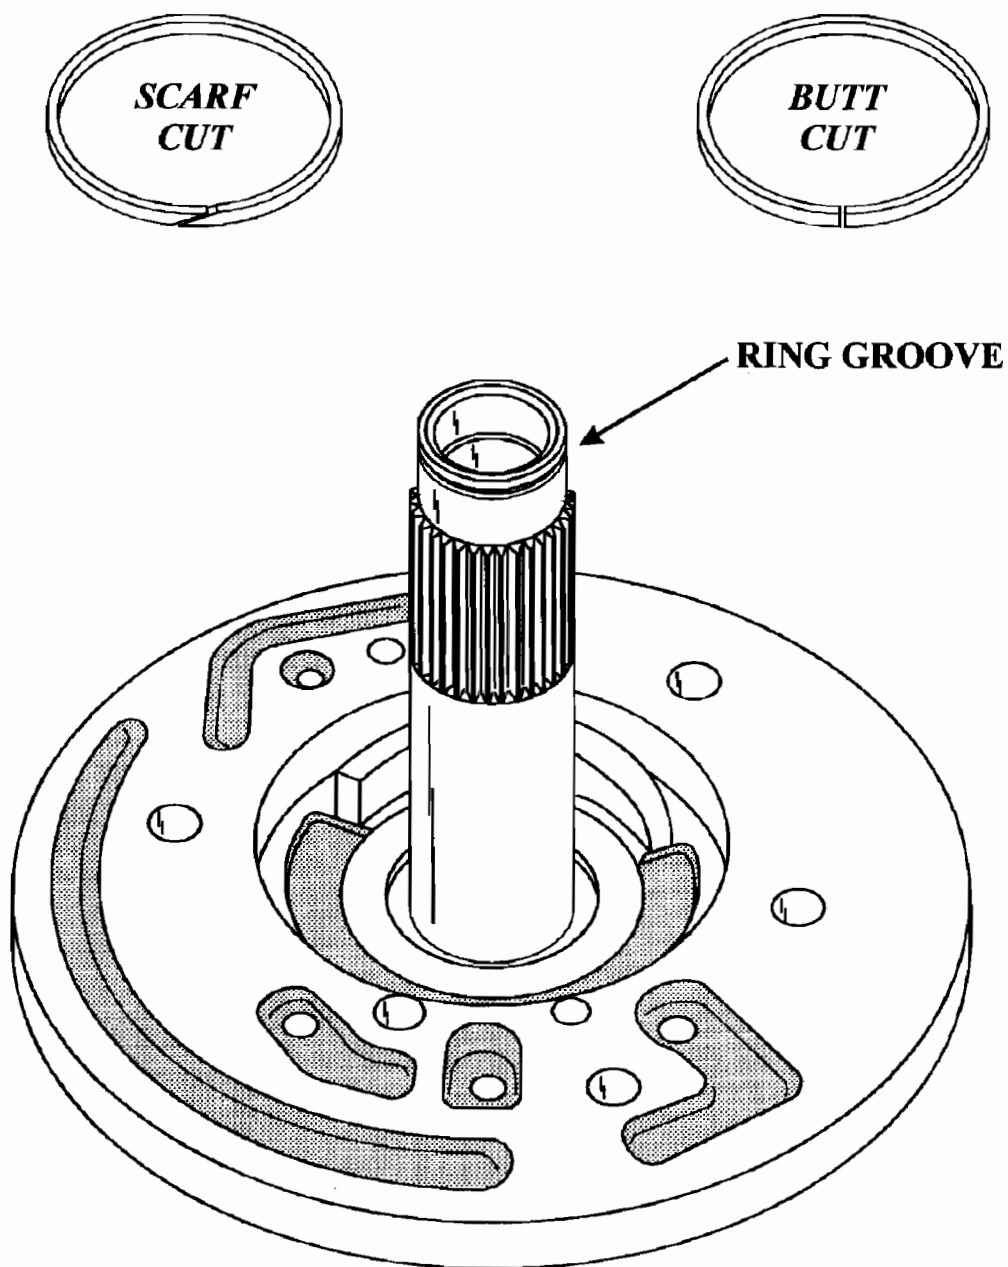
Figure 1

- (1) The incorrect "Scarf Cut" sealing ring was installed on the pump stator (Refer to Figure 1).
- (2) An A4LD inner pump gear used in a 4R44E/4R55E pump body as shown in Figure 2.
- (3) The "O" ring inside the 4R44E/4R55E inner pump gear may be missing or damaged.

- (1) Replace the early style "Scarf Cut" sealing ring with the new design "Butt Cut" sealing ring, as shown in Figure 1.
- (2) Ensure that the inner pump gear is a 4R44E/4R55E gear, as shown in Figure 2.
- (3) During rebuild make sure the "O" ring on the inside diameter of the inner pump gear is replaced and use care not to damage the "O" ring when installing the converter.

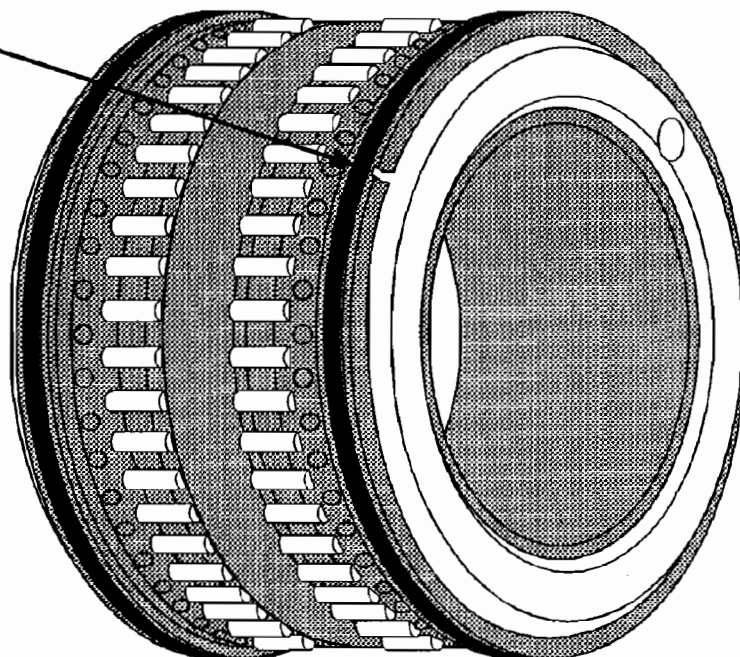
Figure 1

CAUSE: One cause may be the inner race for the center support caged needle bearing has developed a crack allowing the forward and direct clutches to be applied at the same time as shown in Figure 1.

**INSPECT INNER
RACE FOR CRACKS**

CORRECTION: Air pressure check the forward and direct clutches thru the center support, as shown in Figure 3, and ensure air does not mix between the two separate circuits. If the air check does not pass, inspect the inner race for a crack, as shown in Figures 1 and 2. If a crack is found replace the center support.

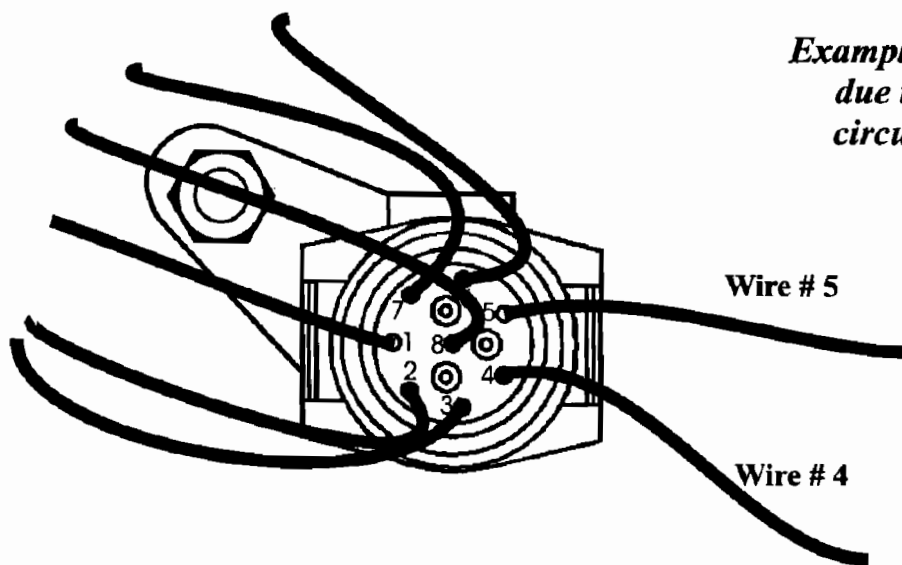
*Example of a no up shift condition
due to a leak in the governor
circuit or a clogged inlet port
to the solenoid*

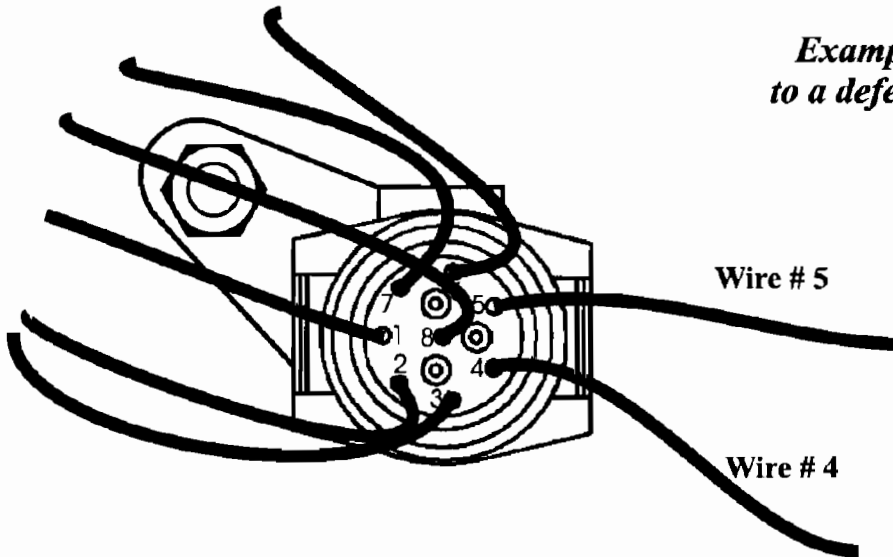
Example of a 3rd Gear Start due to a defective solenoid mechanically
