MAZDA/FORD GF4A-EL SOLENOID AND TERMINAL I.D.

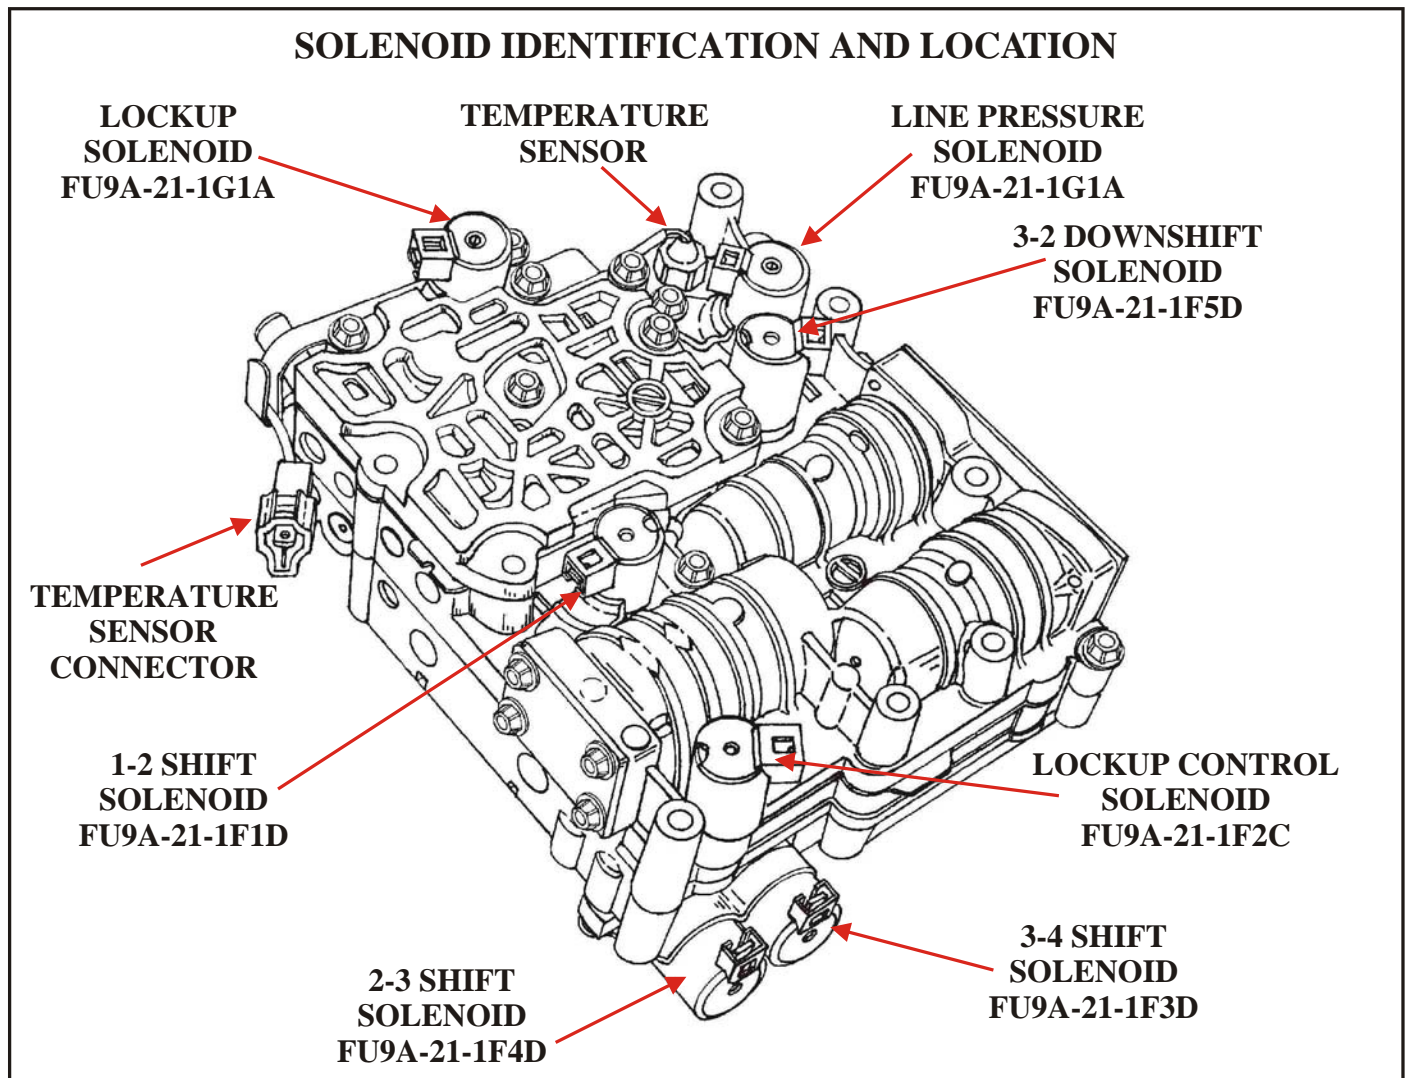
COMPLAINT: After overhaul, vehicles equipped with GF4A-EL may exhibit a pulsating sensation on forward application, wrong gear starts, downshift's to 1st at higher speeds or no Reverse. The

CAUSE: The cause may be that the wire harness conduit, or protective coating, was removed and solenoid harness connectors may now be attached to the wrong solenoid.

CORRECTION: Refer to Figure 1 for solenoid identification and location on the valve body, and the Mazda part numbers. Refer to Figure 2 for wire color, harness and solenoid connector color and terminal identification.
