Technical Service Information

4L60-E

STACKED SHIFTS / EARLY TCC / 1995 - 2000 T SERIES TRUCKS

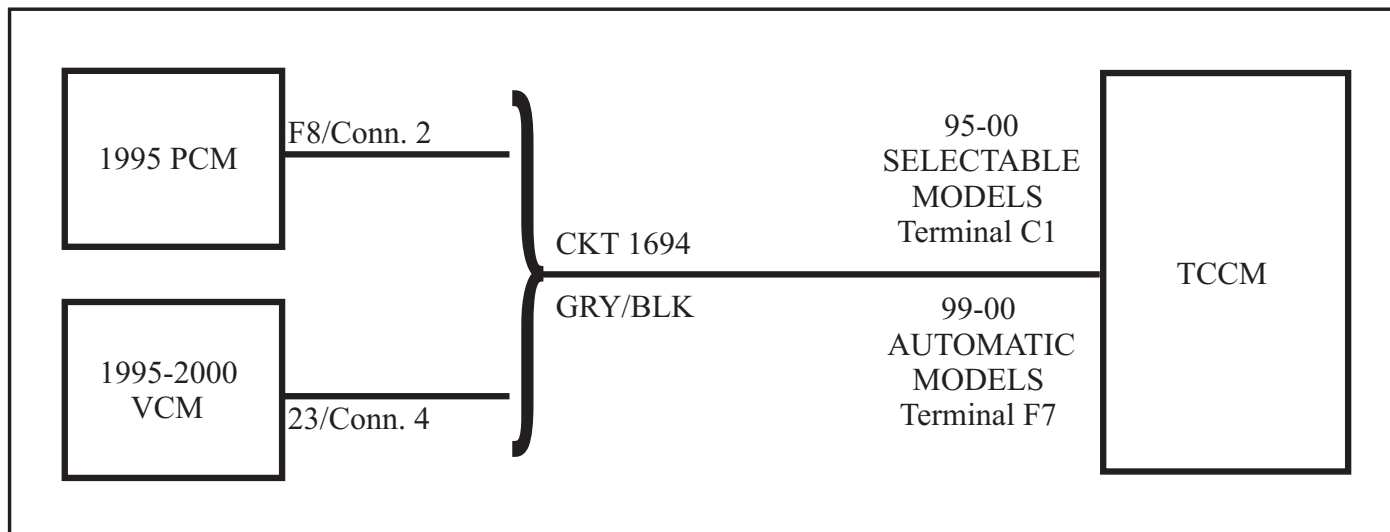
Figure 1

CORRECTION: The PCM (Powertrain Control Module) for some 1995 models, or the VCM (Vehicle Control Module) for most 1995 and all 1996 to 2000 model year trucks, provides 12 volts from the engine computer to the transfer case shift control module via circuit 1694. (See wire diagram in figure 1) When the driver selects 4 wheel drive low range, the TCCM internally grounds circuit 1694 and the voltage on circuit 1694 drops to zero. The PCM/VCM uses this information to alter shift scheduling while the vehicle is in 4 wheel drive low range to prevent an engine over speed condition.
