CHRYSLER LH VEHICLES

42LE CODE 1391 INTERMITTENT LOSS OF CRANK OR CAM

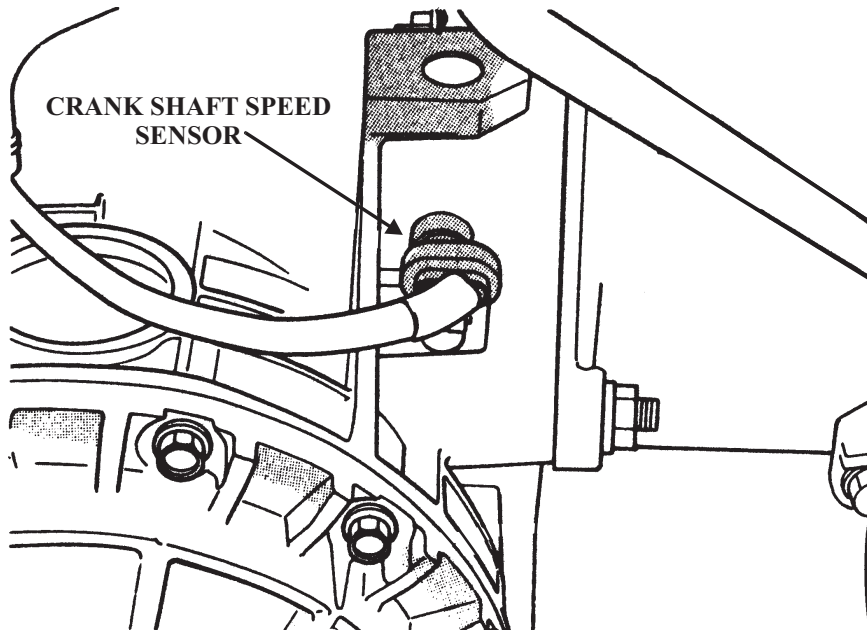
Figure 1

COMPLAINT: LH vehicles such as LHS, Concorde, Intrepid, New Yorker and Vision with a 3.5 L engine may experience a code 1391 "Intermittent Loss of Crank or Cam Signal" after the transmission has been replaced. This will be accompanied with a rough running engine which cannot remain at idle for more than 4 to 6 seconds. The vehicle ran smoothly before the needed transmission work was performed. The Crank Shaft and Cam Shaft Speed Sensor were replaced without any success. The Crank Shaft Speed Sensor located in the converter housing (See Figure 1), is not adjustable with 3.5L applications so the sensor exciter ring on the flywheel (See Figure 2) may be suspect. But after an inspection it proves to be good.

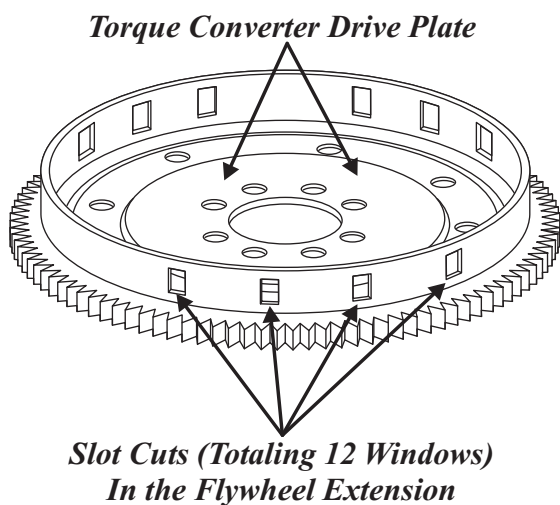
Figure 2

The crankshaft position sensor detects slots cut into the transmission drive plate (flywheel) extension. There are 3 sets of slots with 4 cuts (windows) in each set totaling 12 windows. Basic timing is set by the position of the last slot in each group. Once the PCM senses that last slot, it determines crankshaft position (which piston will be next at TDC) from the camshaft position sensor input. The 4 pulses generated by the crankshaft position sensor represents the 69°, 49°, 29° and 9° BTDC marks. It may take the PCM one engine revolution to determine crankshaft position.

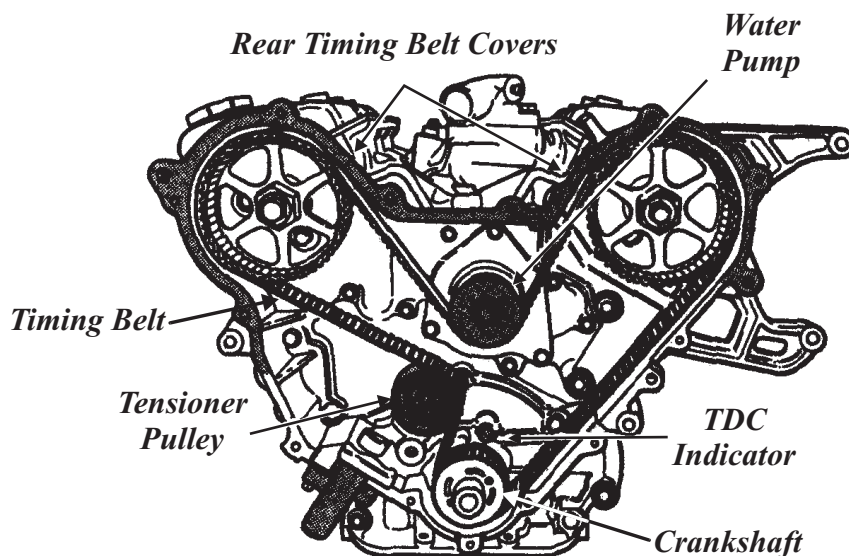
Figure 3

CAUSE: One such known cause has been that during the removal or installation process of the transmission, while turning the torque converter, the crankshaft kicked back from compression in the engine causing the timing belt to skip one cog, or the crankshaft was turned opposite to normal engine rotation causing the skip (See Figure 3). This incident had occurred with a vehicle that had 80,000 plus miles. So the belt was worn.

CORRECTION: Re-position or replace the timing belt. .
