Technical Service Information

THM 4T60-E PREMATURE 2ND CLUTCH FAILURE

99-23
Page 1 of 2

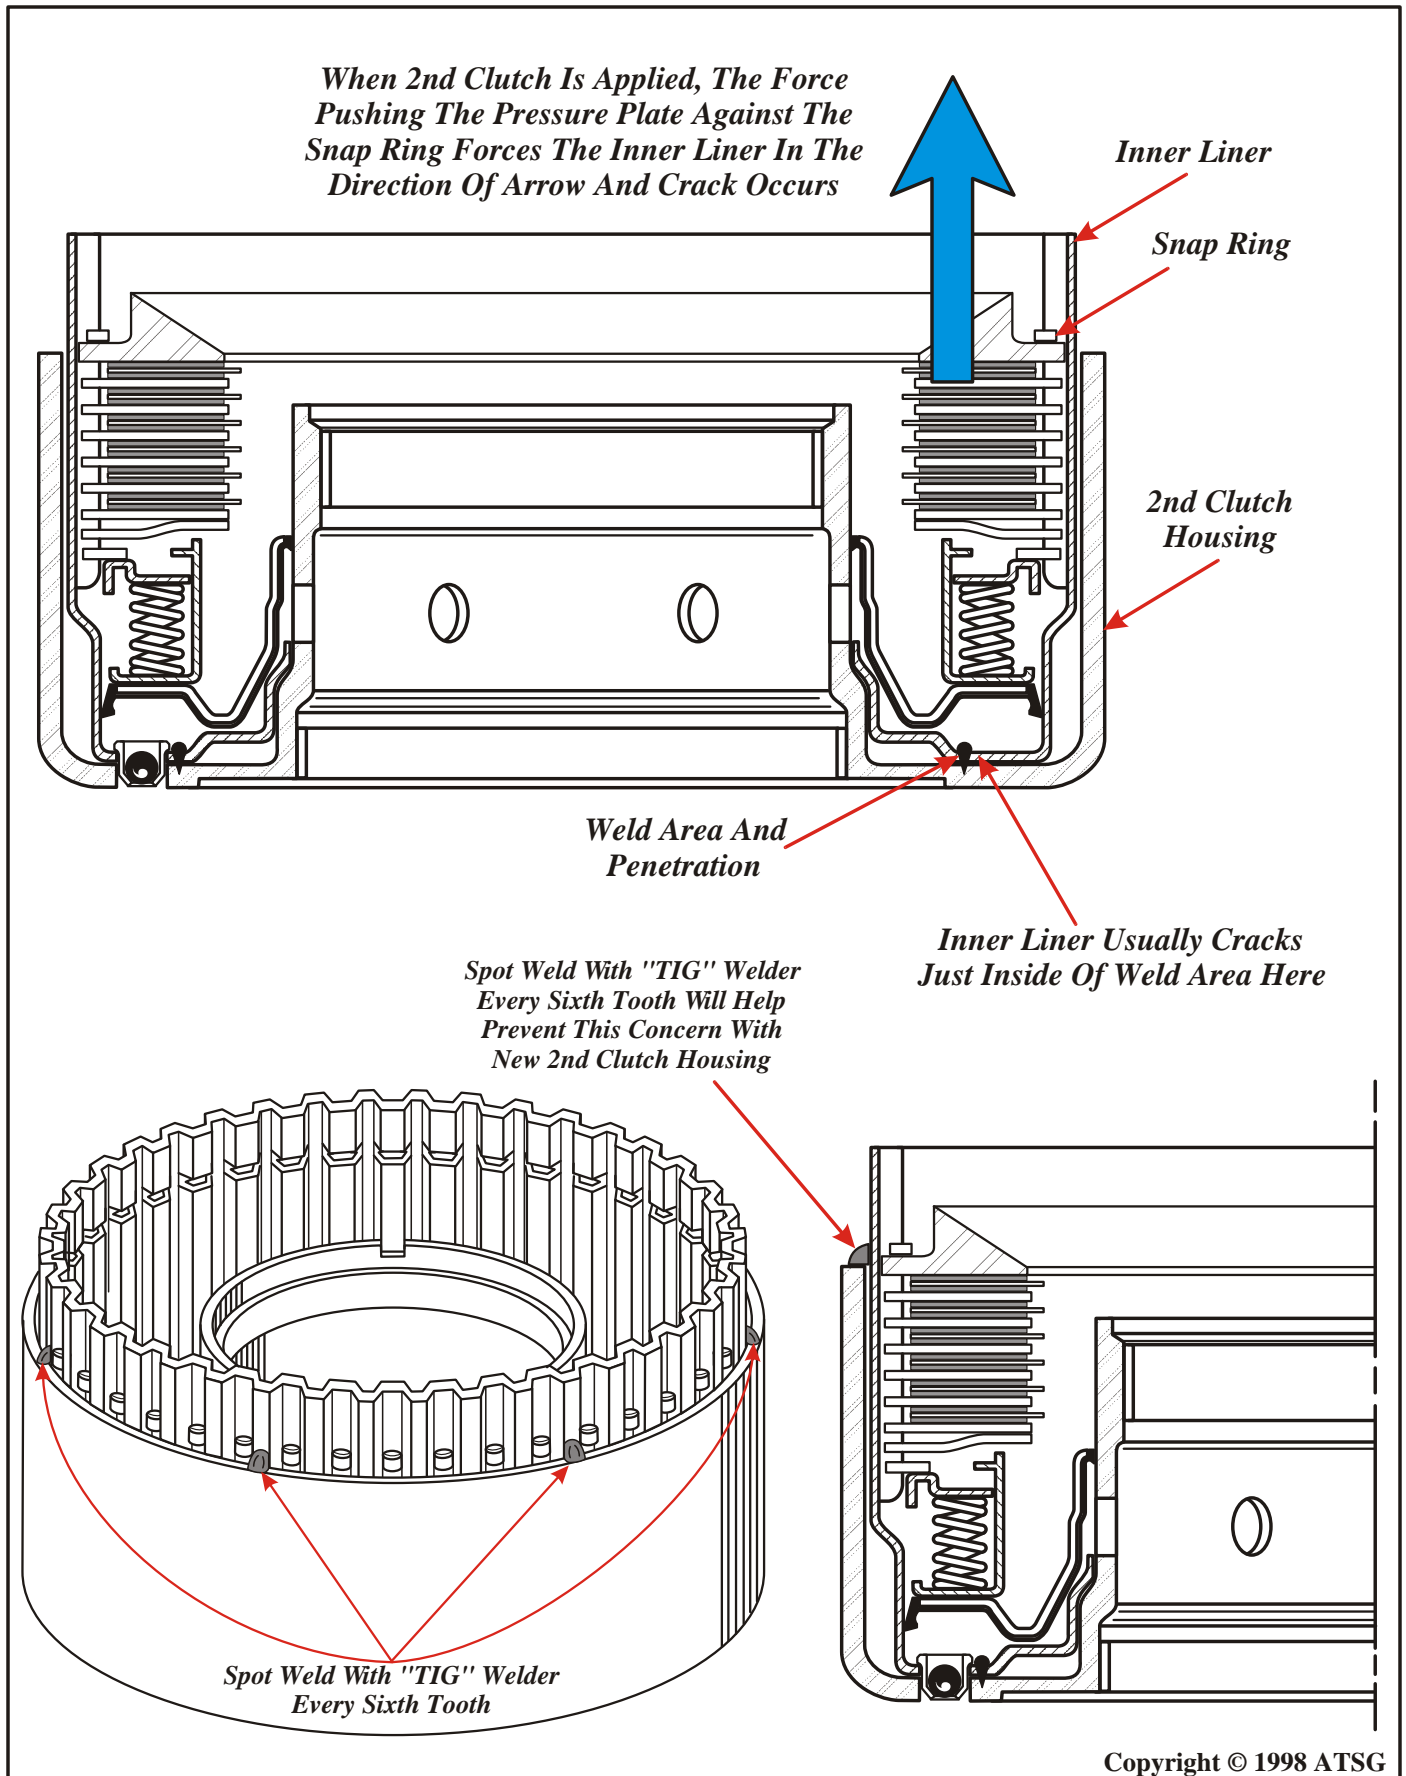
Figure 1

CAUSE: The cause may be, the 2nd Clutch Housing Inner Liner is cracked. When this inner liner, that is "TIG" welded into the housing, is cracked it is impossible to detect with an air check of the 2nd clutch housing. The inner liner is cracked because of second clutch pressure applying force against the pressure plate snap ring. With the weld point being much inboard of the pressure point the inner liner will crack just outside of the weld, as illustrated in Figure 1. The only successful way to determine if the drum is cracked, is to pry upward on the inner liner using a screwdriver, with a *very small* amount of oil left in the bottom of the housing.

CORRECTION: There *must* be a new 2nd Clutch Housing installed into the unit, as the cracked one cannot be successfully repaired. To prevent this from occurring again, spot weld the inner liner to the on the new second clutch housing with a "TIG" welder every sixth tooth around the housing, as illustrated in Figure 1.
