## *"The Seminar to See for 2003" Technical Seminar*

### ***AUTOMATIC TRANSMISSION SERVICE GROUP***

## *“The Seminar to See for 2003”*

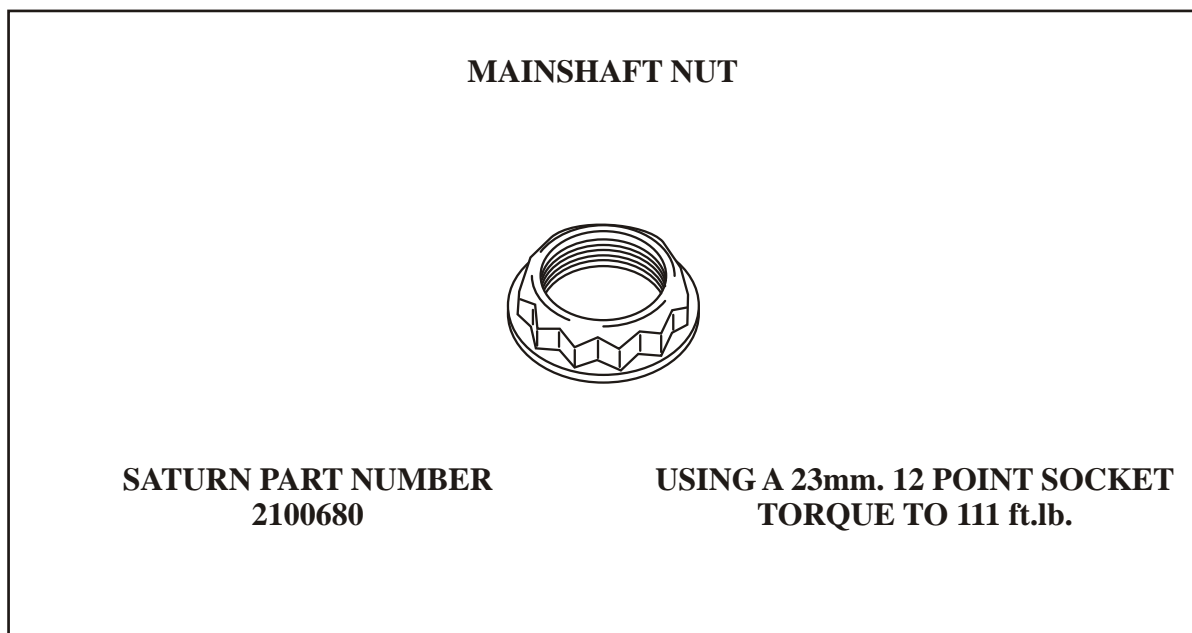
Figure 1

**COMPLAINT:** Before or after overhaul, Saturn vehicles equipped with the MP6 or MP7 transaxle may exhibit a delayed and or no Reverse condition when *hot*. This condition is usually accompanied with a soft or flared 2nd gear upshift.

**CAUSE:** The cause may be, a loose Mainshaft Nut, as shown in Figure 1, causing a leak in the 2nd clutch circuit. When the nut loosens the mainshaft tends to walk back and forth in the mid case. This causes a gap between the 1st Clutch and the nut, which is where the leak in the 2nd Clutch circuit appears. In Figure 2 the cutaway shows how the 2nd Clutch is fed around the outside of the feed pipe for the 3rd clutch. **Notice** that the area over and under the nut are all part of the 2nd Clutch circuit.

**CORRECTION:** Install a new Mainshaft nut, which has a factory thread locker, as part of every repair. Using a 23mm. 12 point socket torque the new nut to 111 ft.lb.

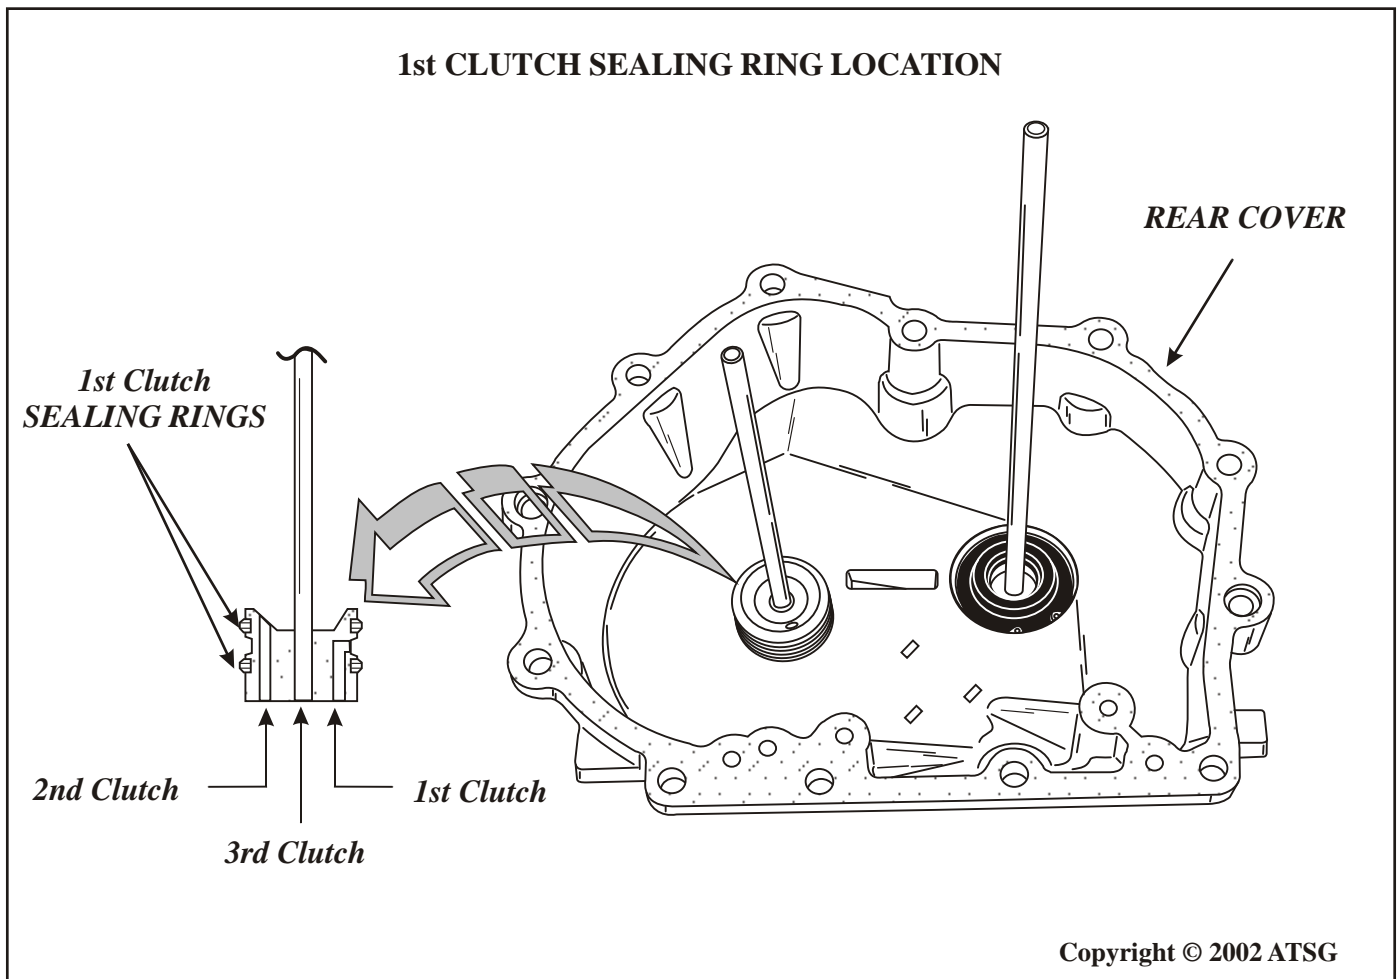
Figure 3

**COMPLAINT:** Before or after overhaul, Saturn vehicles equipped with the MP6 or MP7 transaxle, may exhibit a slight engagement delay in "D" and / or a binding condition in Reverse.

**CAUSE:** The cause may be, shrunken or damaged 1st Clutch sealing rings, as shown below in Figure 3. When these rings leak they can cause a slow fill of the 1st Clutch, which results in a delayed engagement in "D." The first sealing ring also separates the 2nd clutch from the 1st Clutch. When this ring leaks while in the Reverse range, the 1st Clutch can now be applied with 2nd clutch pressure, which results in a bind-up. See Figure4 for a cross-sectional view of the Main shaft .

**CORRECTION:** Replace the 1st Clutch sealing rings as part of every overhaul.

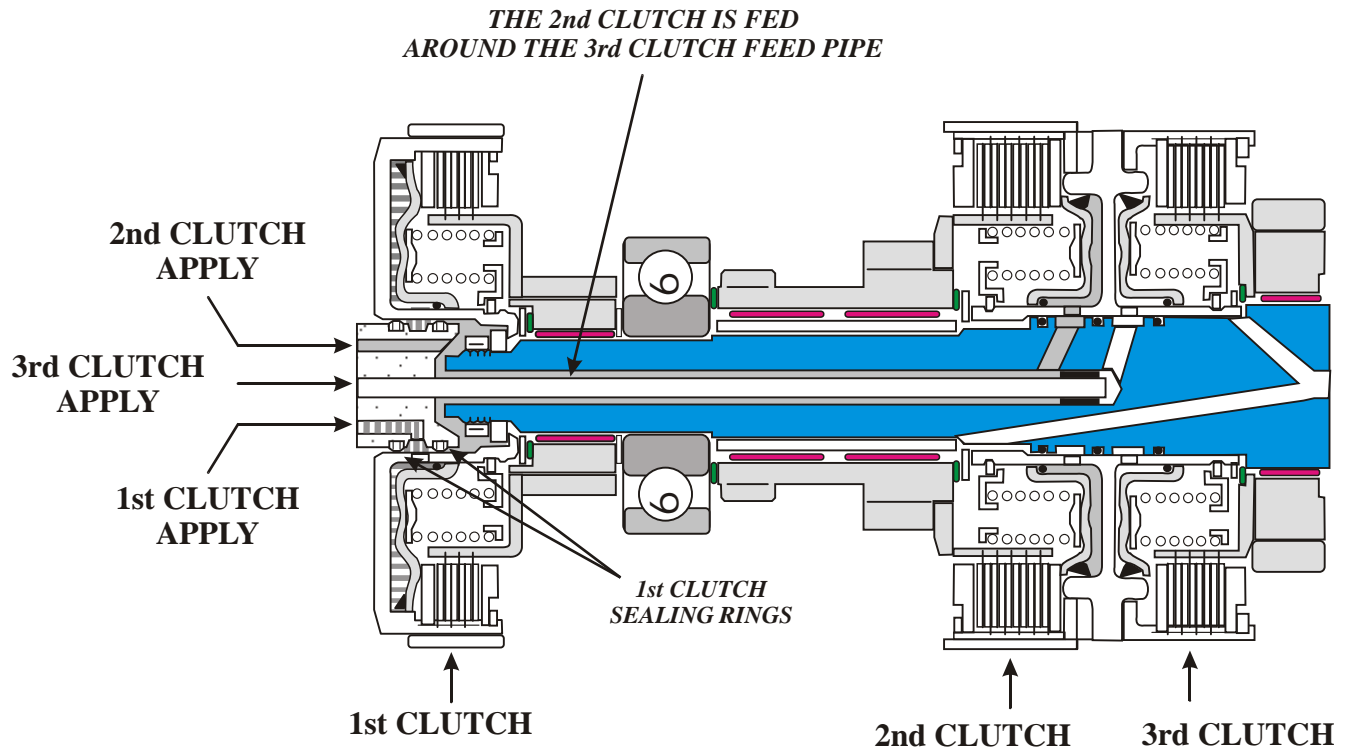
Figure 4

*Summary: When the 2nd Clutch is applied in Reverse, shrunken 1st Clutch sealing rings may allow the 1st Clutch to be applied at the same time, causing a bind-up*

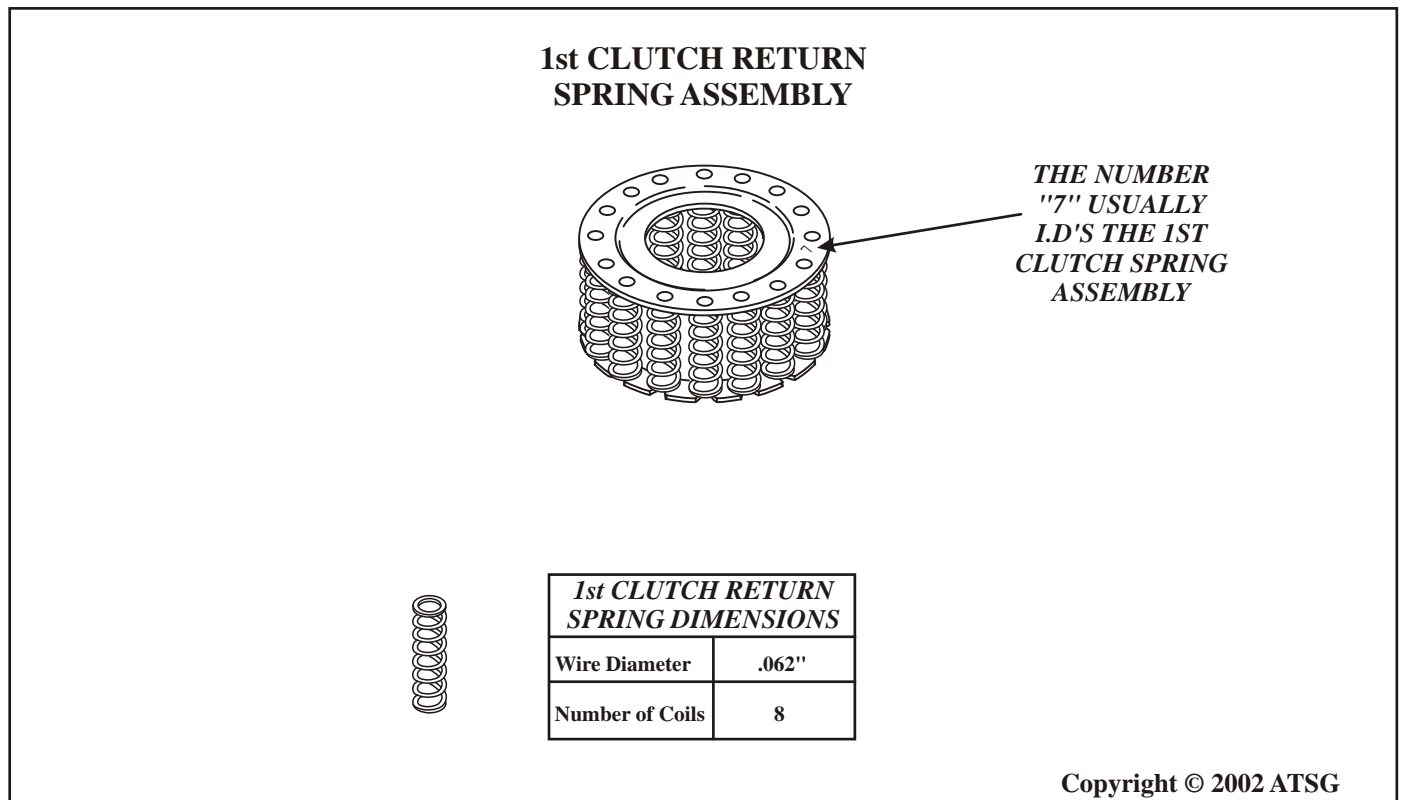
**COMPLAINT:** After overhaul, Saturn vehicles equipped with the MP6 or MP7 transaxle, may exhibit a complaint of falling out of "Drive" at a stop, or a slipping condition on take off.

**CAUSE:** The cause may be, that during overhaul, the 2nd, 3rd or 4th Clutch return spring assembly was mistakenly used in place of the 1st Clutch spring assembly. When this happens, the 1st Clutch can not fully engage until line pressure is increased. Refer to Figure 5 and 6 to compare the 1st Clutch return spring assembly to the 2nd, 3rd and 4th. Notice that the coil diameter of the springs, on 2nd, 3rd and 4th are approximately .010" larger and the number of coils are one more than the 1st which makes them stronger.

**CORRECTION:** Refer to Figure 5 to identify the 1st Clutch return spring assembly, and ensure it is in the correct location.

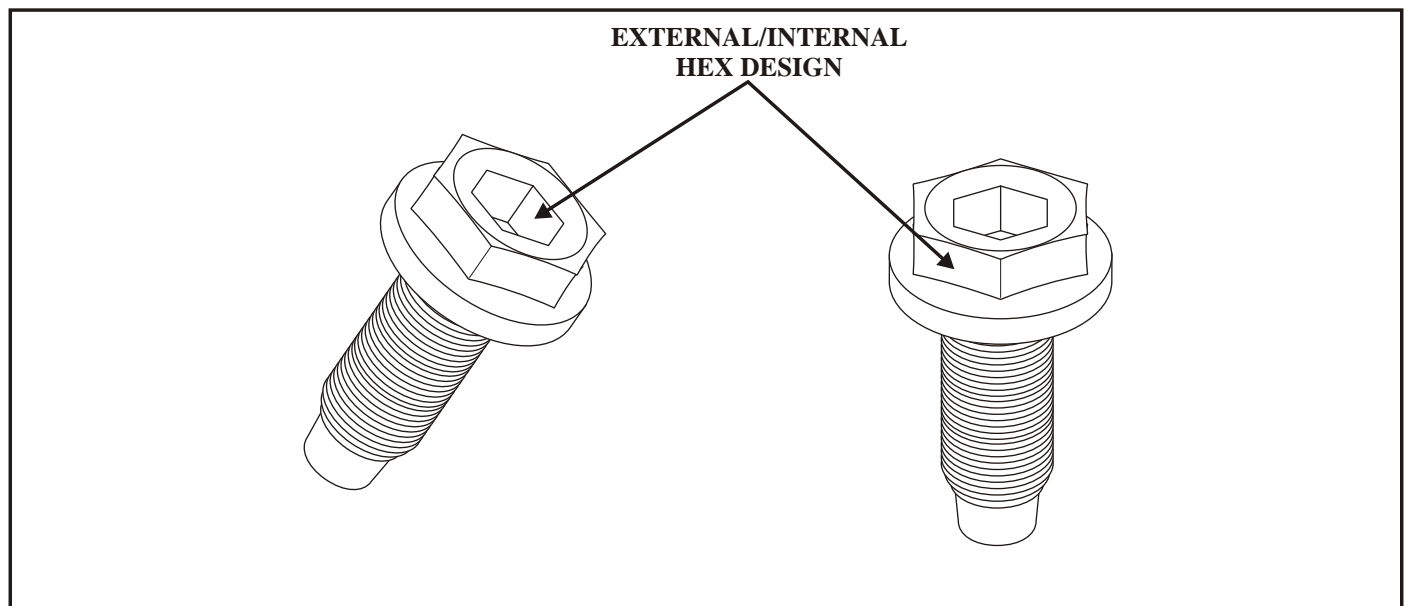
Figure 1

**CAUSE:** A combination of bolt design and exposure to the elements.

**CORRECTION:** GM has released a new style internal/external hex head design bolt to replace the previous design, shown in figure 1.

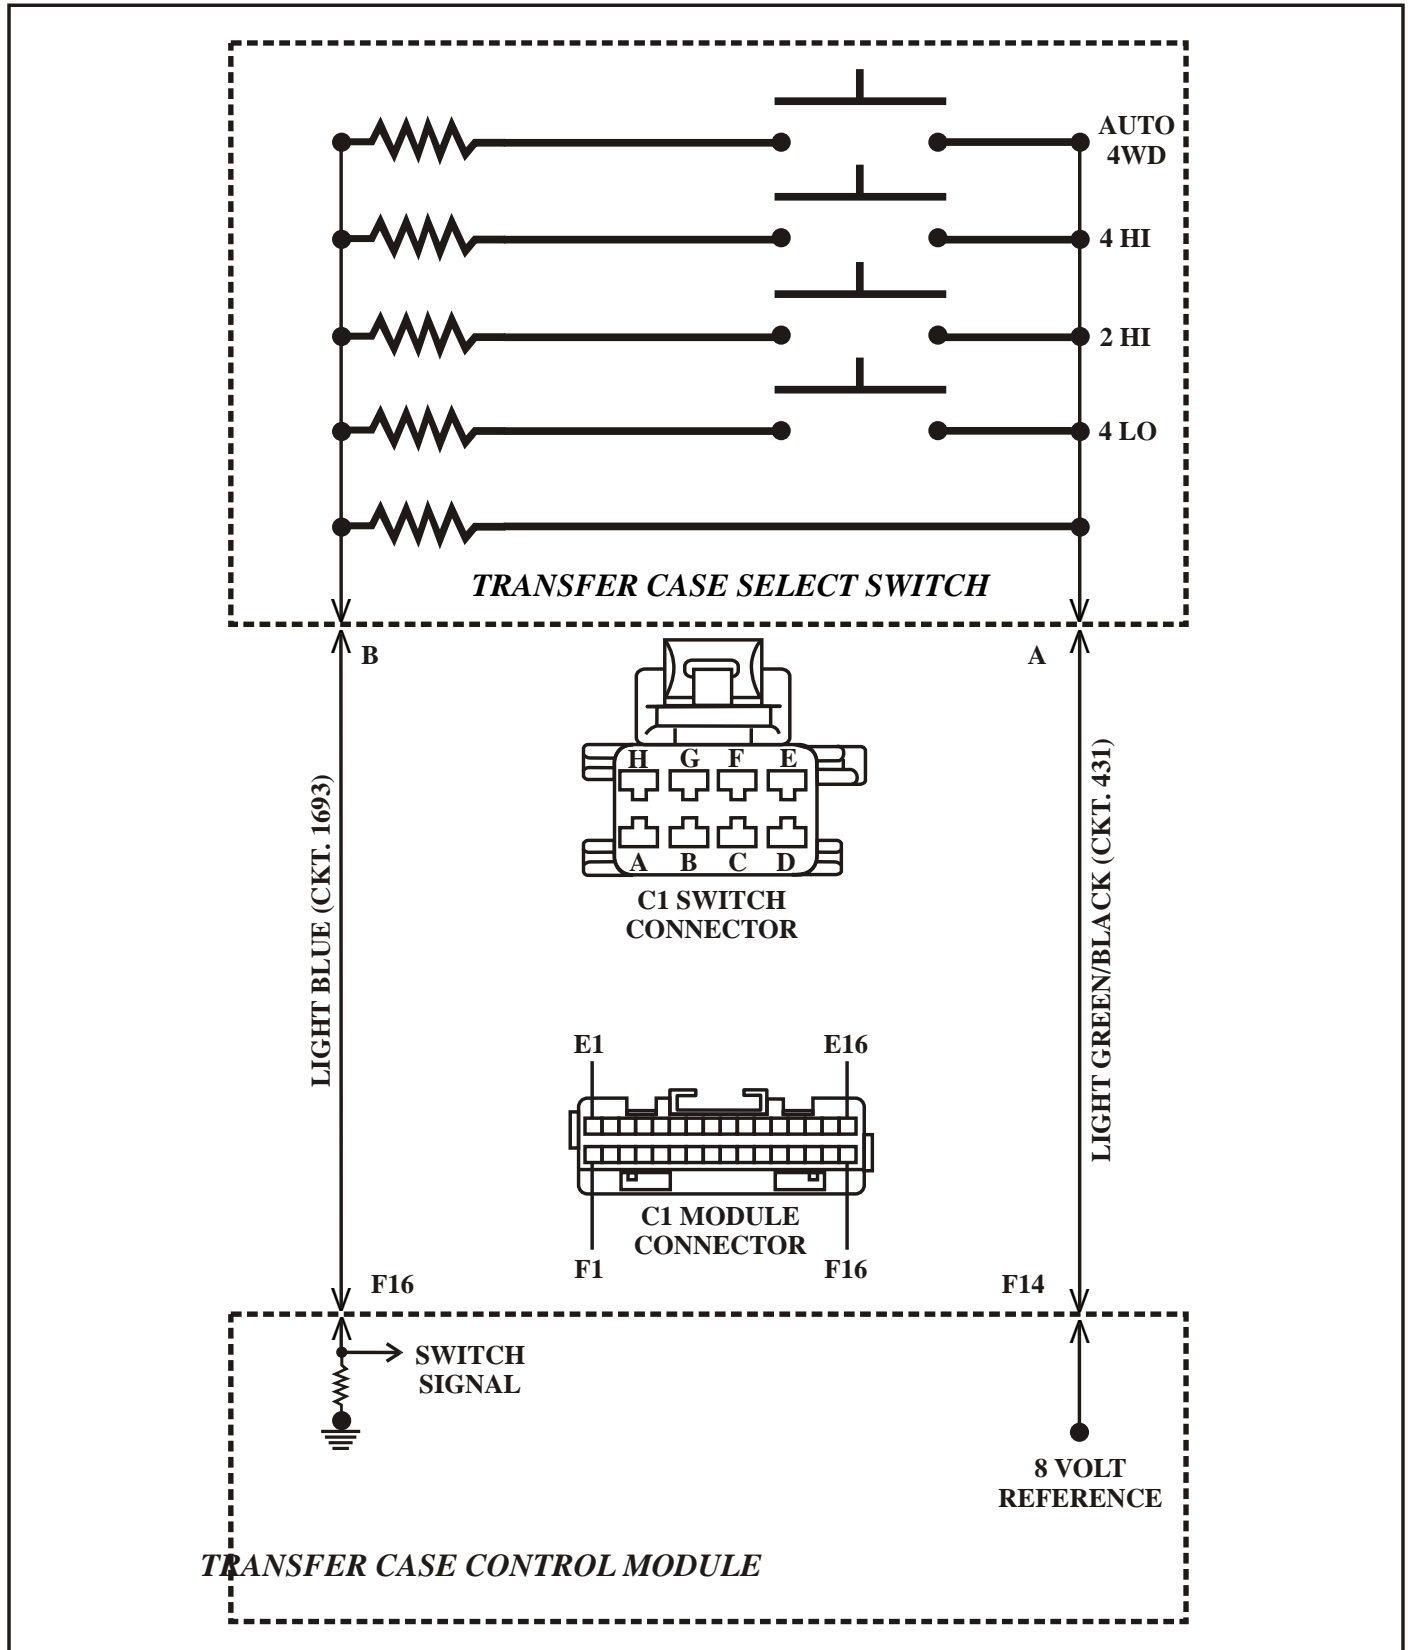
Figure 1

**COMPLAINT:** 1999 to 2002 four wheel drive trucks with a New Venture Gear 236/246 Transfer Case (RPO NP8) may experience a "Service 4WD" Indicator light that remains on. A Service Code B2725, ATC Mode Switch Circuit Malfunction, may be found accompanying this concern.

**CAUSE:** An intermittent fault in the Transfer Case Select Switch may be causing this condition. The Transfer Case Control Module should not be immediately suspected or replaced unless it has been determined to be faulty.

**CORRECTION:** Replace the Transfer Case Select Switch or the Transfer Case Control Module (TCCM), only if necessary.

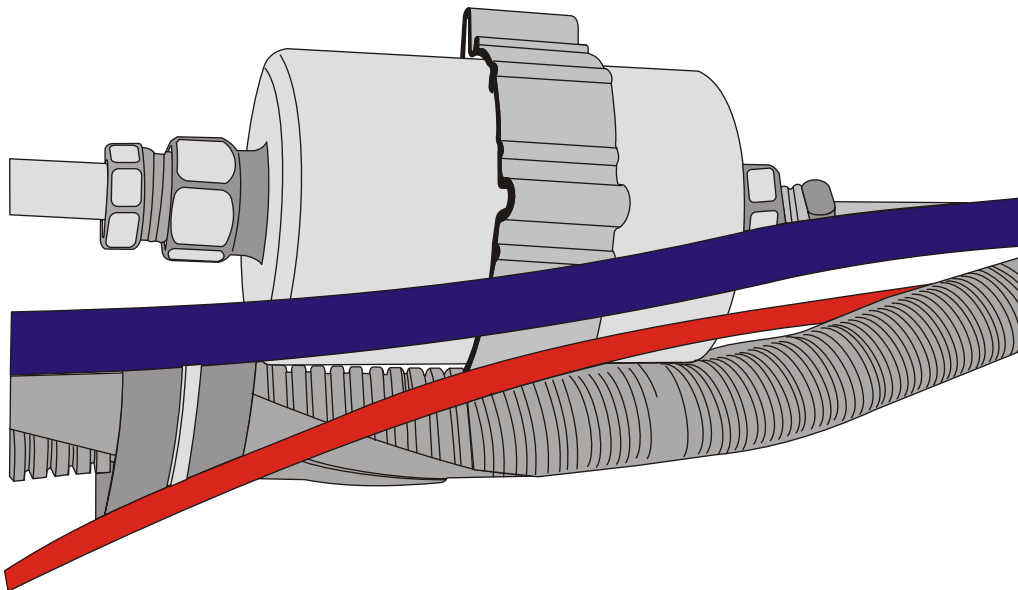
Figure 1

**COMPLAINT:** The transmission exhibits a late 2-3 and 3-4 shift under heavy throttle conditions but seems to operate properly under normal throttle conditions. The transmission also has an elongated forced detent shift with no increase in vehicle speed which may require the driver to back off the throttle to complete the shift.

**CAUSE:** The cause may be a restricted fuel filter (See Figure 1) rather than an actual transmission problem.

**CORRECTION:** Have a fuel flow and fuel pressure test performed and replace fuel filter if results are below specs.

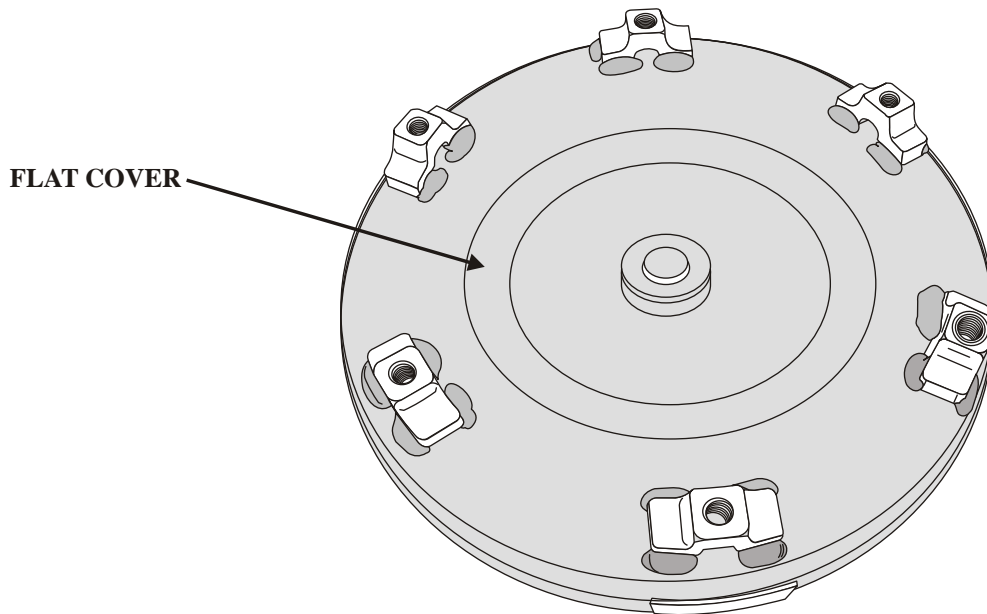
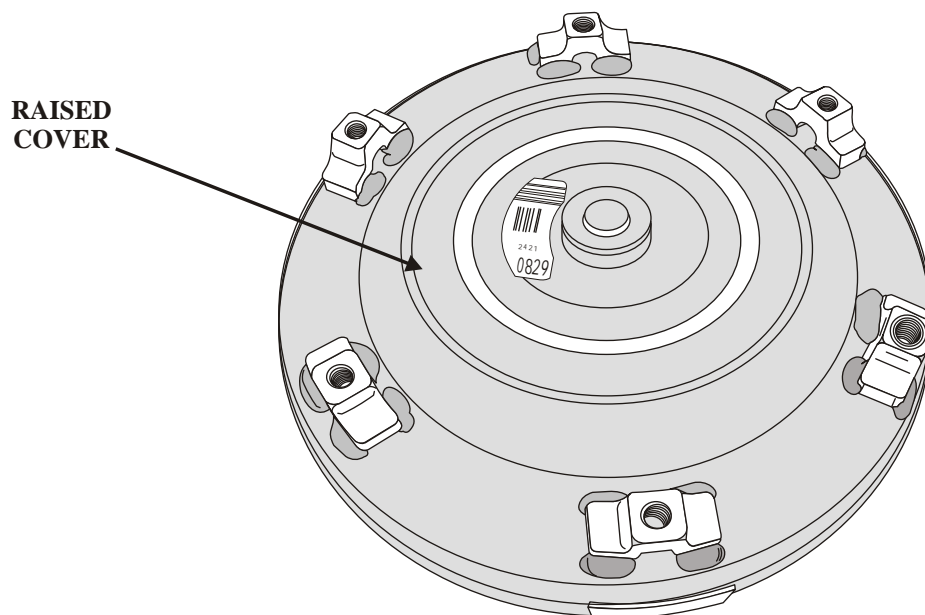
Figure 1

- COMPLAINT:** The truck comes into the shop with a "Component Slipping" P1870 code stored. No slip is felt when the code is cleared and the truck is driven, but, when the transmission data is viewed, maximum "TCC Duty Cycle" is indicated but the "TCC Slip" is excessive. When the transmission is disassembled, it appears the transmission is in perfect condition. The pump and stator bushings as well as the TCC Regulator Valve, the TCC Enable Valve and the TCC Shift Valve are all in perfect condition.  
*The transmission is reassembled, and because the vehicle has relatively low mileage, the converter is reused.*

- CAUSE:** **The converter is the reason code P1870 is being stored.** Beginning with the 2000 model year, the torque converter received a design change which can be seen in figure 1. Notice that the front cover of the 1991-99 converter is flat, while the front cover of the 2000 and later converter is raised up. This increase in angle also included the converter clutch plate as seen in figure 2. Because of this increased angle and the fact that the two piece converter clutch plate is riveted together, is what causes the converter clutch plate to separate which causes a leak in converter clutch apply oil, finally resulting in the P1870 slip code being stored.

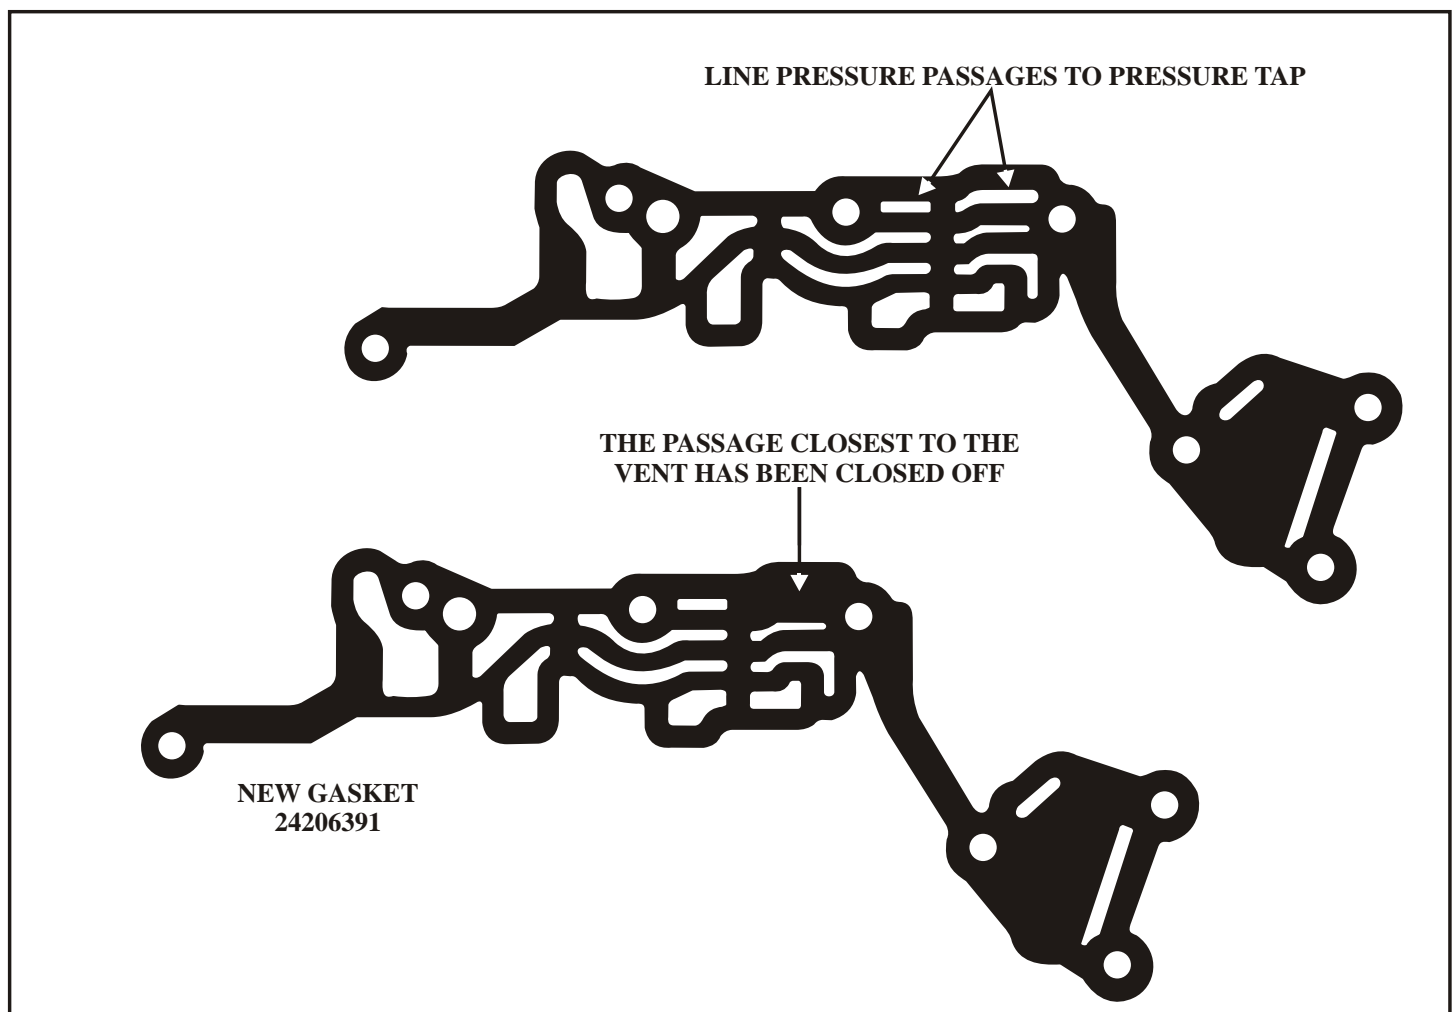
Figure 1

**COMPLAINT:** Vehicles with the Hydra-Matic 4T65E transaxle having RPO codes MN3, MN7, M15 and M76 may experience chronic transmission fluid leaks coming from the breather (vent) on top of the transaxle before and/or after rebuild.

**CAUSE:** The line pressure which passes through the upper channel plate gasket to reach the pressure tap is blowing past the gasket into the vent circuit and exiting the vent.

**CORRECTION:** Replace the Upper Channel Plate Cover Gasket with an updated gasket issued by General Motors or when using an aftermarket overhaul kit, insure correct gasket usage by referring to this service information. The most susceptible area of the gasket which the line pressure was able to blow across has been closed off allowing for greater retention eliminating the leak (See Figure 1).

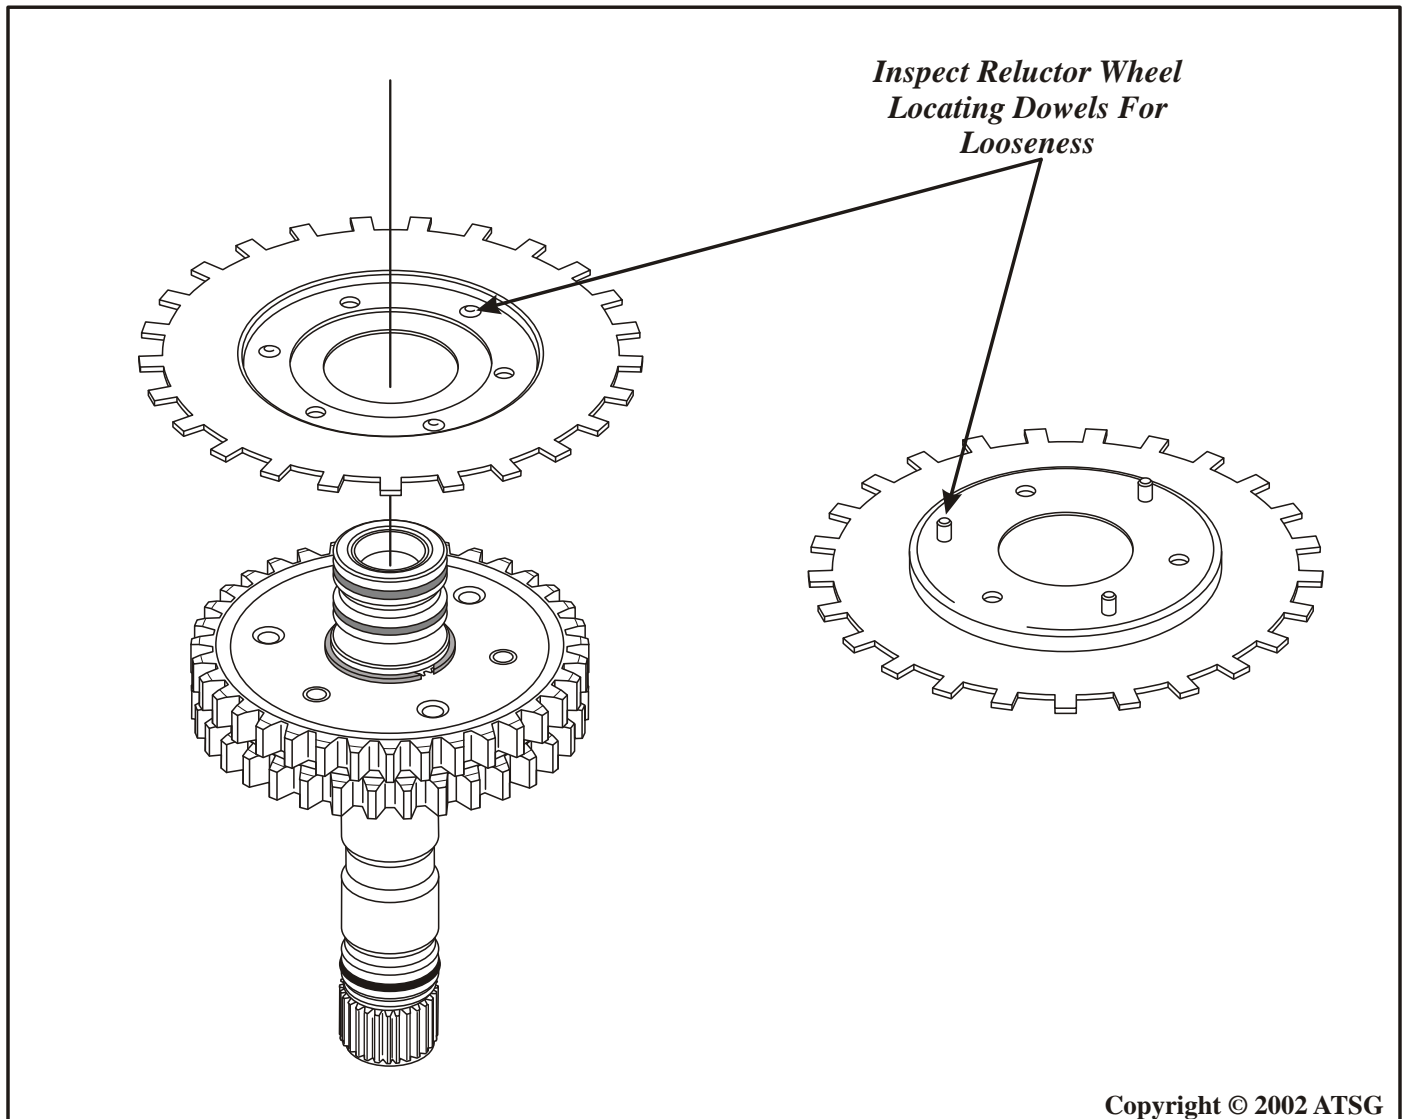
**CAUSE:** The cause may be, the locating dowels (rivets) being loose in the input speed sensor reluctor wheel. Refer to Figure 1.

**CORRECTION:** Replace the input speed sensor reluctor wheel with updated OEM part number 24212217.

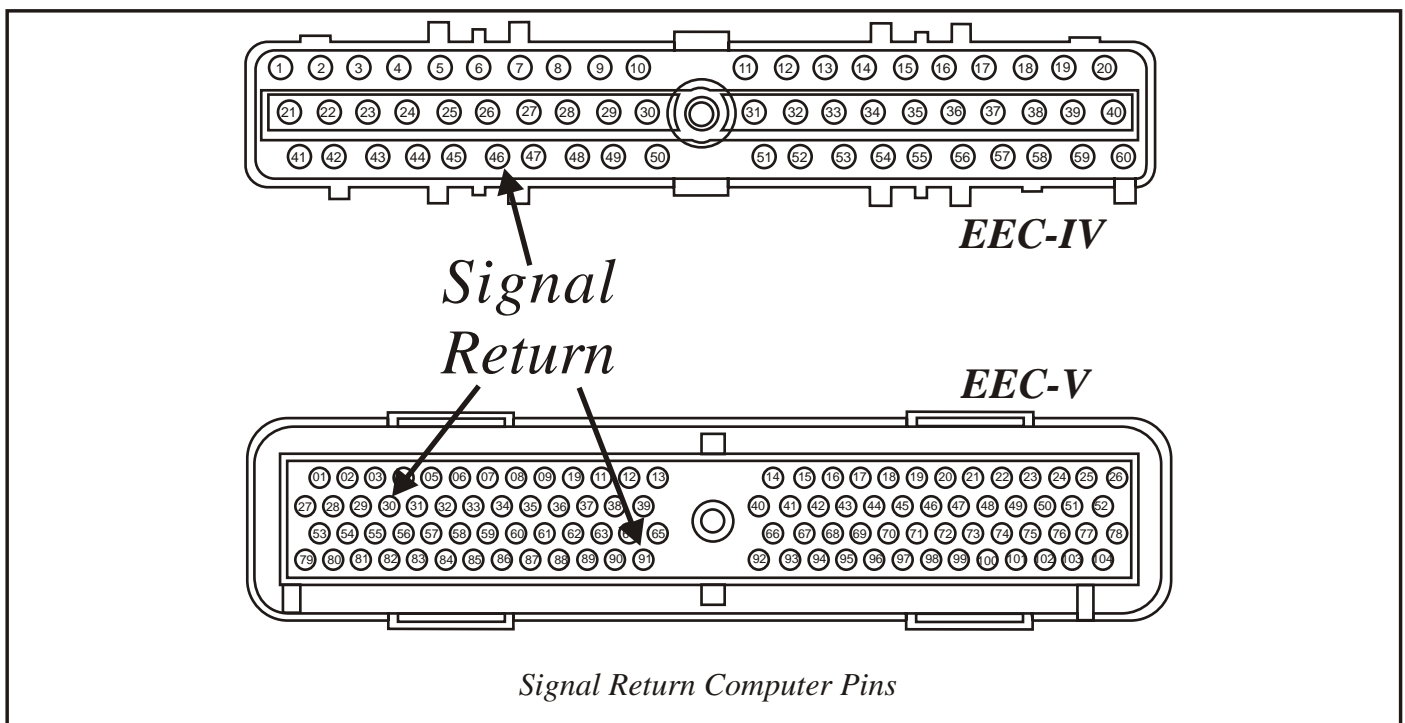
Figure 1

**CAUSE:** One possible cause for this behavior is a bad connection in the "Signal Return" circuit. The Signal Return circuit is a wire coming off of pin 46 in an EEC IV system or pin 91 and 30 on an EEC V system (See Figure 1). This "signal return" is the ground for a large number of sensors. It is routed through several splice points and connectors (See Figure 2). The route the wire takes is different for different vehicles. To further complicate matters, sensors between the poor connection and the PCM may operate normally.

**CORRECTION:** There are three possible methods to repair this problem. One is to simply ground that wire at a point past the problem. Say for example at the Transmissions Range Sensor (TRS) as seen in Figure 3. Another would be to run a bypass wire from a downstream sensor to the computer. The preferred repair method is to find the bad connection, clean or repair it, and protect it from whatever caused it to fail. Refer to the chart in Figure 4 for the color of the Signal Return wire at the Transmissions Range Sensor harness connector.
