NISSAN E/L4N71B SHIFTS TO O.D. REGARDLESS OF CANCEL SWITCH

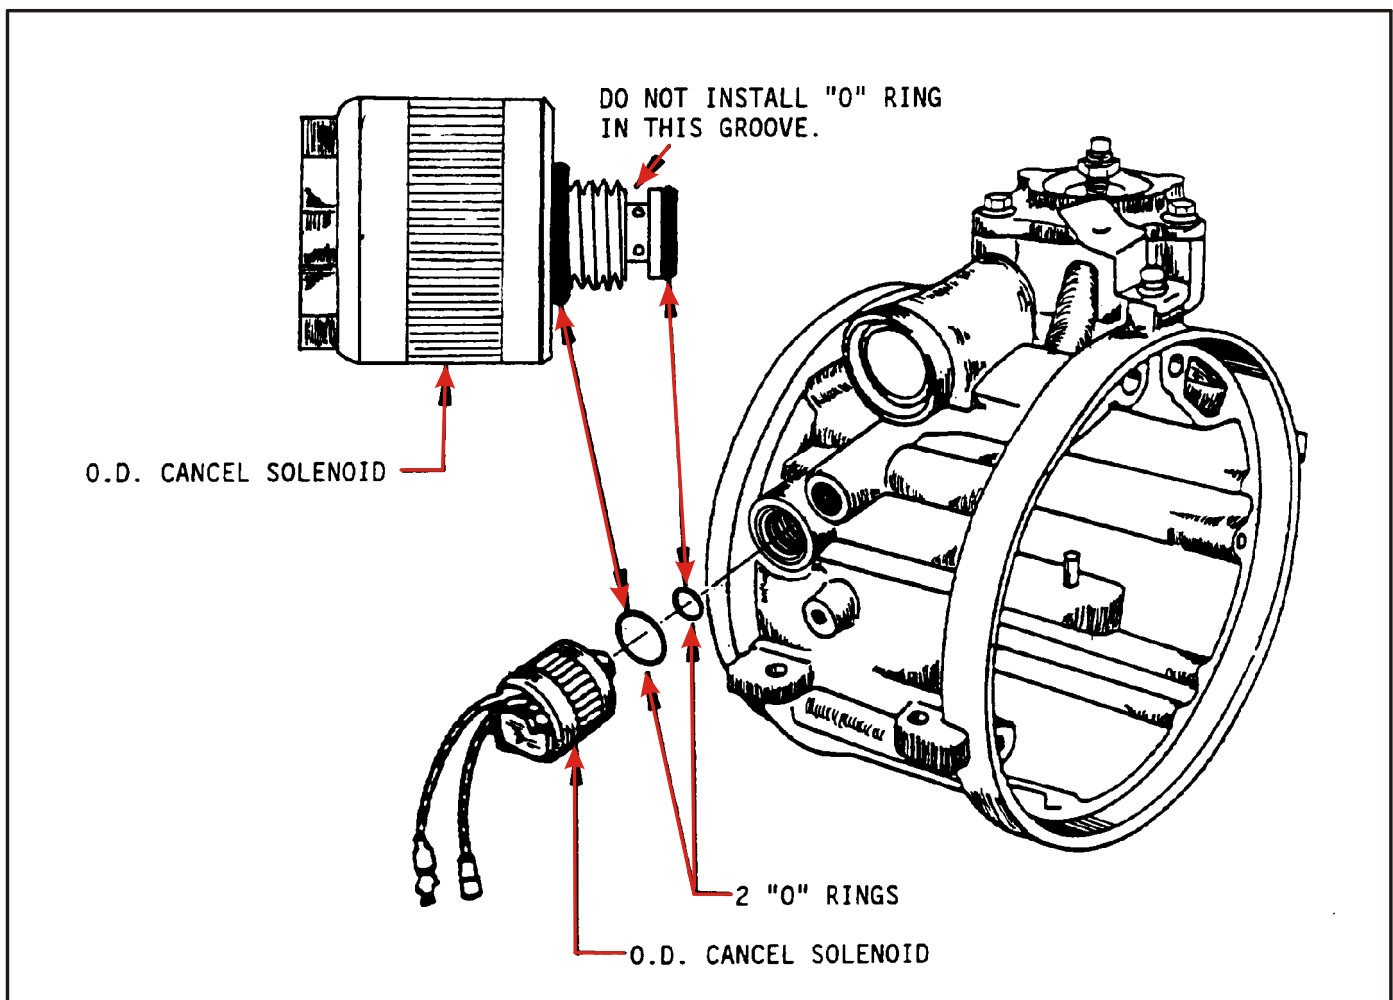
Figure 1

COMPLAINT: Transmission shifts into O.D. regardless of O.D. control switch position.

CAUSE: The cause may be the small "O" ring missing, or mis-installed in the groove of the O.D. cancel solenoid. The small "O" ring goes BEHIND the O.D. cancel solenoid, as shown in Figure 1, and seals against the bottom of the case bore (See Figure 1).

CORRECTION: Install "O" ring in proper location as shown in Figure 1.
