Technical Service Information

FORD A4LD SHIFT LEVER PRNDL ADJUSTMENT

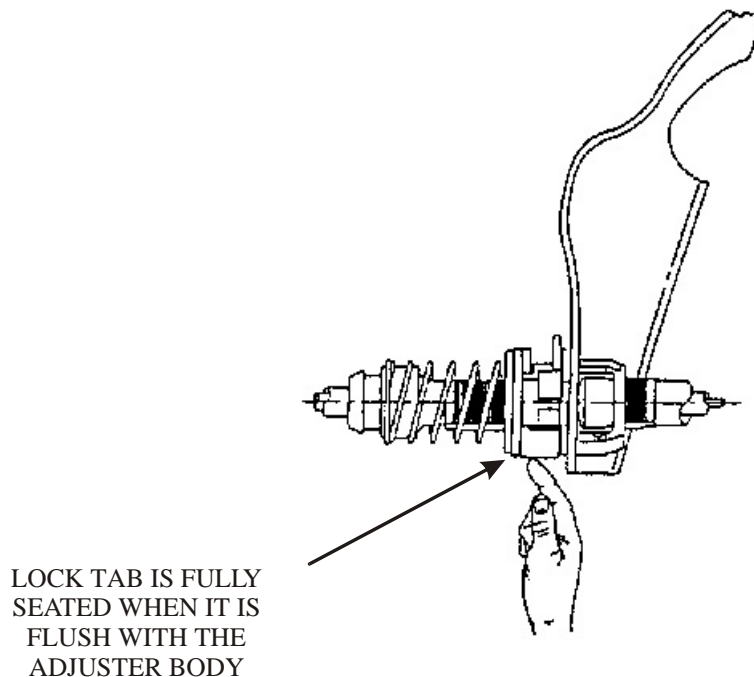
Figure 1

CAUSE: The cause may be that the transmission control cable assembly locking tab is not fully seated or secure in the cable body.

1992-93 ECONOLINE, BRONCO, F-SERIES, AEROSTAR
1993 RANGER
SHIFT CABLE ASSEMBLY LOCKING TAB POSITIONS
LOCKING TAB FULLY SEATED INTO ADJUSTER BODY

CORRECTION: If the shift lever position on the PRNDL does not correspond to the actual shift position, check the locking tab on the control cable to be sure that it is fully seated (SEE FIGURE 1). If the locking tab is not fully seated flush with the cable adjuster body, proceed as follows:

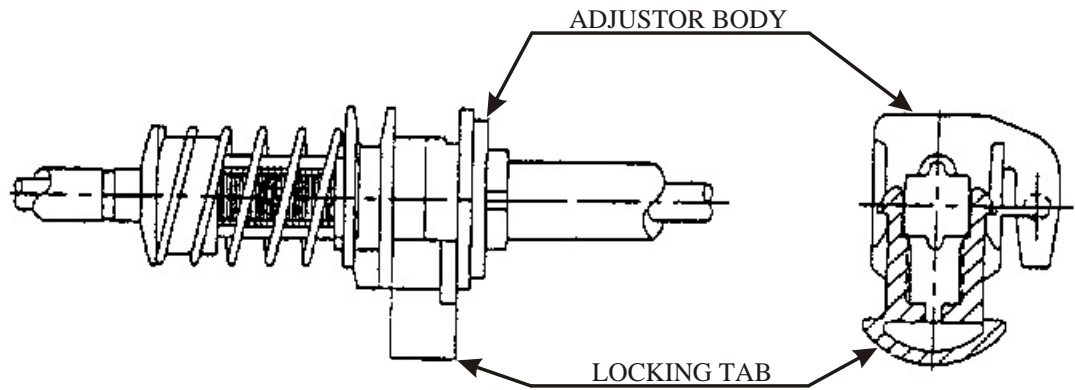
Figure 4

1989-90 BRONCO II
1888-92 RANGER
1991-92 EXPLORER
LOCKING TAB AND BODY

- 2) Replace the existing locking tab with F2TZ-7L116-A for 1993 Ranger and Explorer, and F3TZ-7L116-A for 1989 Ranger, 1991-92 Explorer, and 1989-90 Bronco II.
- 3) Push the new lock tab into the adjuster only half way (SEE FIGURES 3-4).
- 4) Adjust the shift system according to the Ford service manual before fully seating the new locking tab.
