Technical Service Information

HONDA CIVIC B4RA-M4RA-BMXA FAMILY WRONG GEAR STARTS-MULTIPLE SHIFT COMPLAINTS

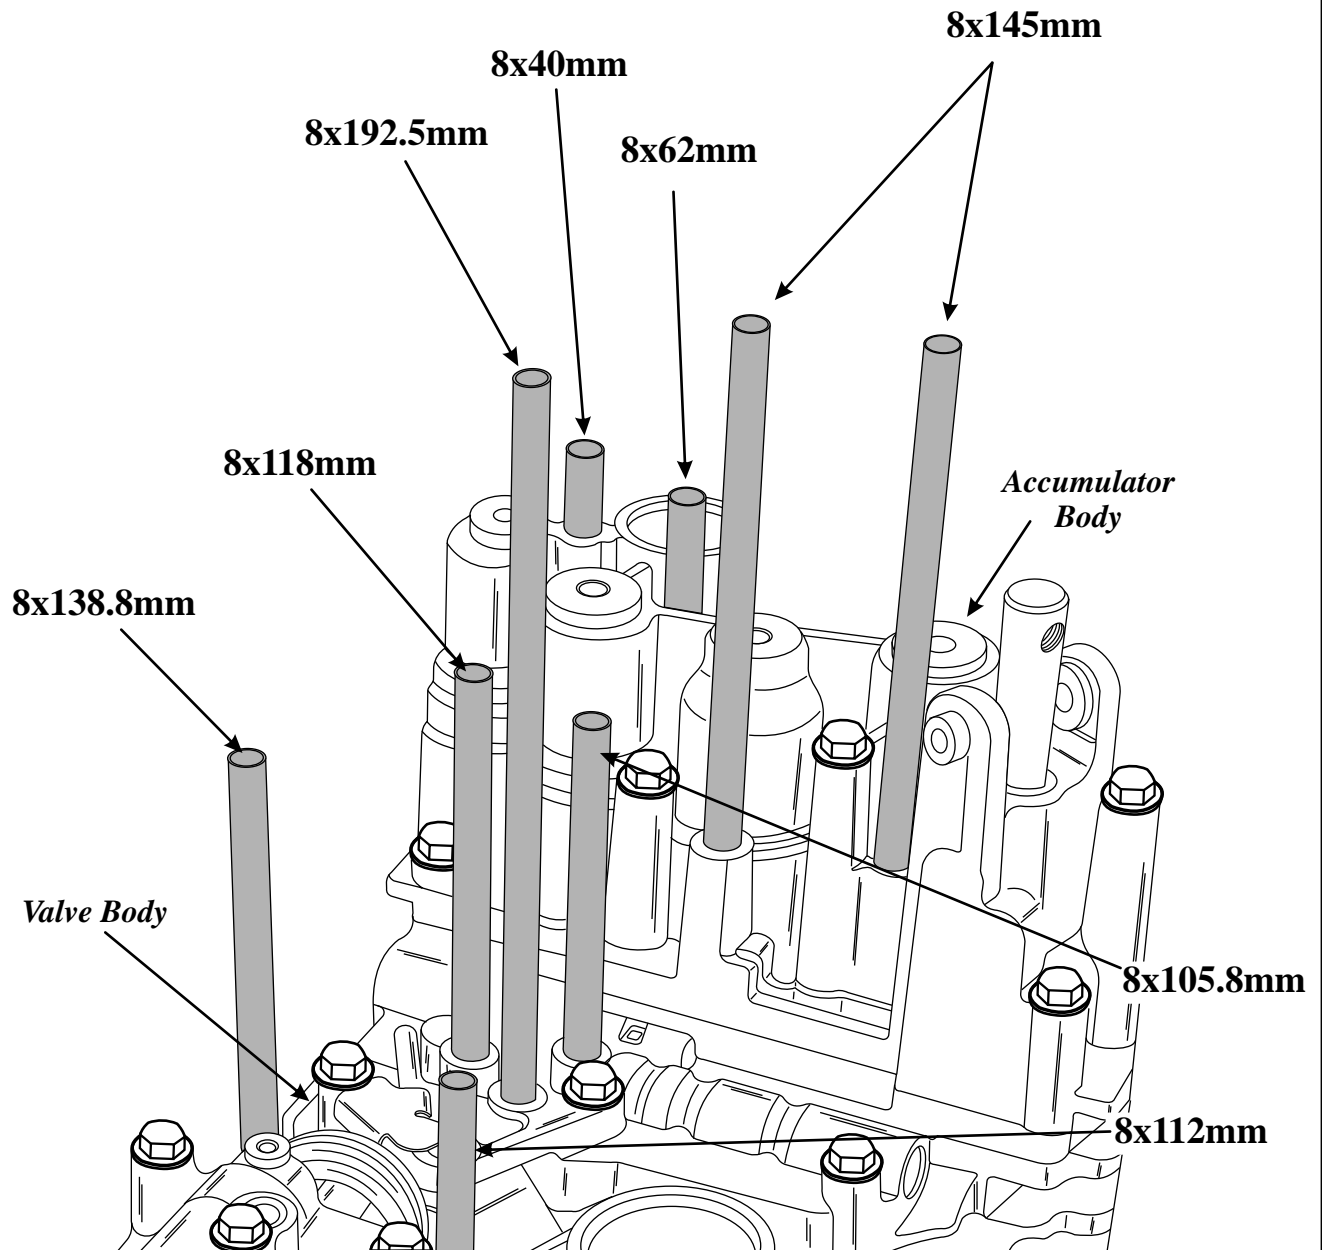
COMPLAINT: After overhaul, Honda Civics equipped with the B4RA, M4RA and or BMXA transaxle may exhibit wrong gear starts or multiple shift complaints.

CAUSE: The cause may be, that during overhaul of the valve body and re-assembly one or more of the feed tubes were placed into the wrong hole on the accumulator body or valve body, causing low modulating pressure , which is solenoid feed and or low clutch apply pressure to one or more of the clutch packs.

HONDA CIVIC B4RA-M4RA-BMXA FAMILY FEED TUBE LOCATIONS

CORRECTION: To correct this condition, refer to Figure 1 and measure the feed tube lengths to ensure that they are going into the correct locations on the accumulator body and valve body.
