Technical Service Information

THM 440-T4 HARSH REVERSE ENGAGEMENT

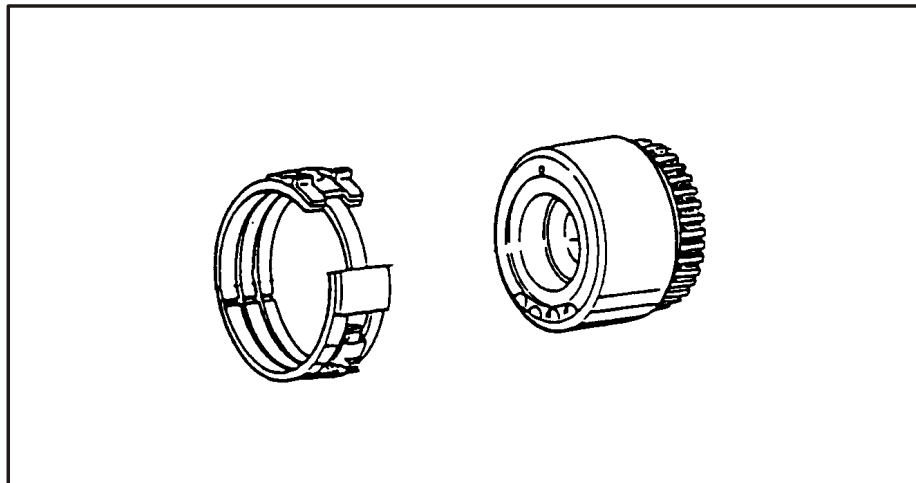
Figure 1

A harsh engagement or engagement shudder from park or neutral to reverse in a THM 440-T4 transaxle at higher mileage may be caused by one of the following items:

1. "Oxidized" fluid (the fluid may visually appear to be ok).
2. The reverse band frictional apply may have become too aggressive on the 2nd clutch housing drum assembly.

Inspect for correct engine idle speed and engine/transaxle mounts for not being loose and in good condition. If okay, drain and replace the transaxle fluid; then road test vehicle for the above condition. If the condition still exists, it may be corrected by replacing the reverse band assembly and 2nd clutch housing drum and bushing assembly with the appropriate parts listed below in "Service Parts Information".

1984-1987	8658890	Reverse Band Assembly
1987	8661912	2nd Clutch Housing Drum and Bushing Assembly
1984-1986	8646929	2nd Clutch Housing Drum and Bushing Assembly
