Technical Service Information

MAZDA MPV R4A-EL NO 3-4 UPSHIFT

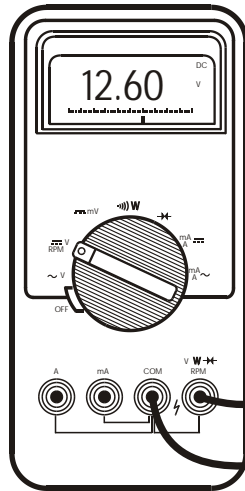
Figure 1

- STEP 1:** Probe the positive lead of the voltmeter to either terminal in the back of the inhibitor signal fuse and the negative lead to a known good ground, as shown in Figure 1, and turn the ignition switch *on*.

- The voltmeter should indicate less than 1 volt in the Park and Neutral positions and 12 volts in the Reverse, Drive, Manual 2nd and Manual 1st position. If the volt meter indicates less than 1 volt in all shifter positions go to **STEP 2**.

**VOLT METER SHOULD INDICATE 12 VOLTS
IN REVERSE, DRIVE, MANUAL 2nd AND MANUAL 1st**

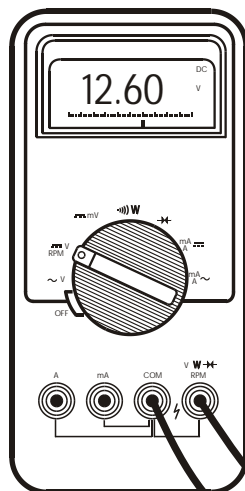
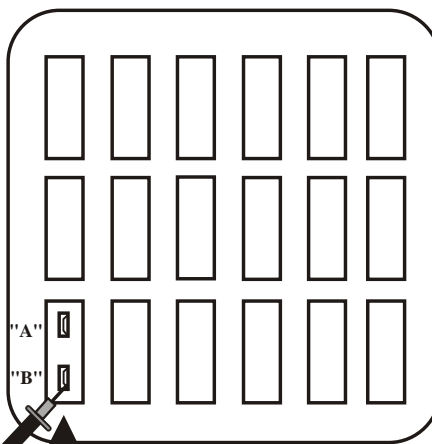
Figure 2

- STEP 2:** Remove the Inhibitor Signal fuse, as shown in Figure 2, and probe the positive lead into terminal "B," with ignition switch *on*.
The voltmeter should indicate 12 volts in all shifter positions. If the voltmeter indicates 12 volts in all ranges go to **STEP 3**.

**INHIBITOR SIGNAL
FUSE REMOVED**

VOLT METER SHOULD INDICATE 12 VOLTS IN ALL RANGES Copyright © 1998 ATSG

- If the voltmeter does not indicate 12 volts, turn ignition switch *off* and set meter to ohms. Probe terminal "B." If there is continuity to ground, repair the grounded wire or wires leading to the TCM, ECU, Instrument Cluster or Cruise Control unit.

- If there is no continuity to ground, repair the open wire from the ECU to terminal "B" at the interior fuse panel. **NOTE:** The ECU, TCM, Instrument Cluster and Cruise Control wires are spliced together before they reach the Interior Fuse Panel.

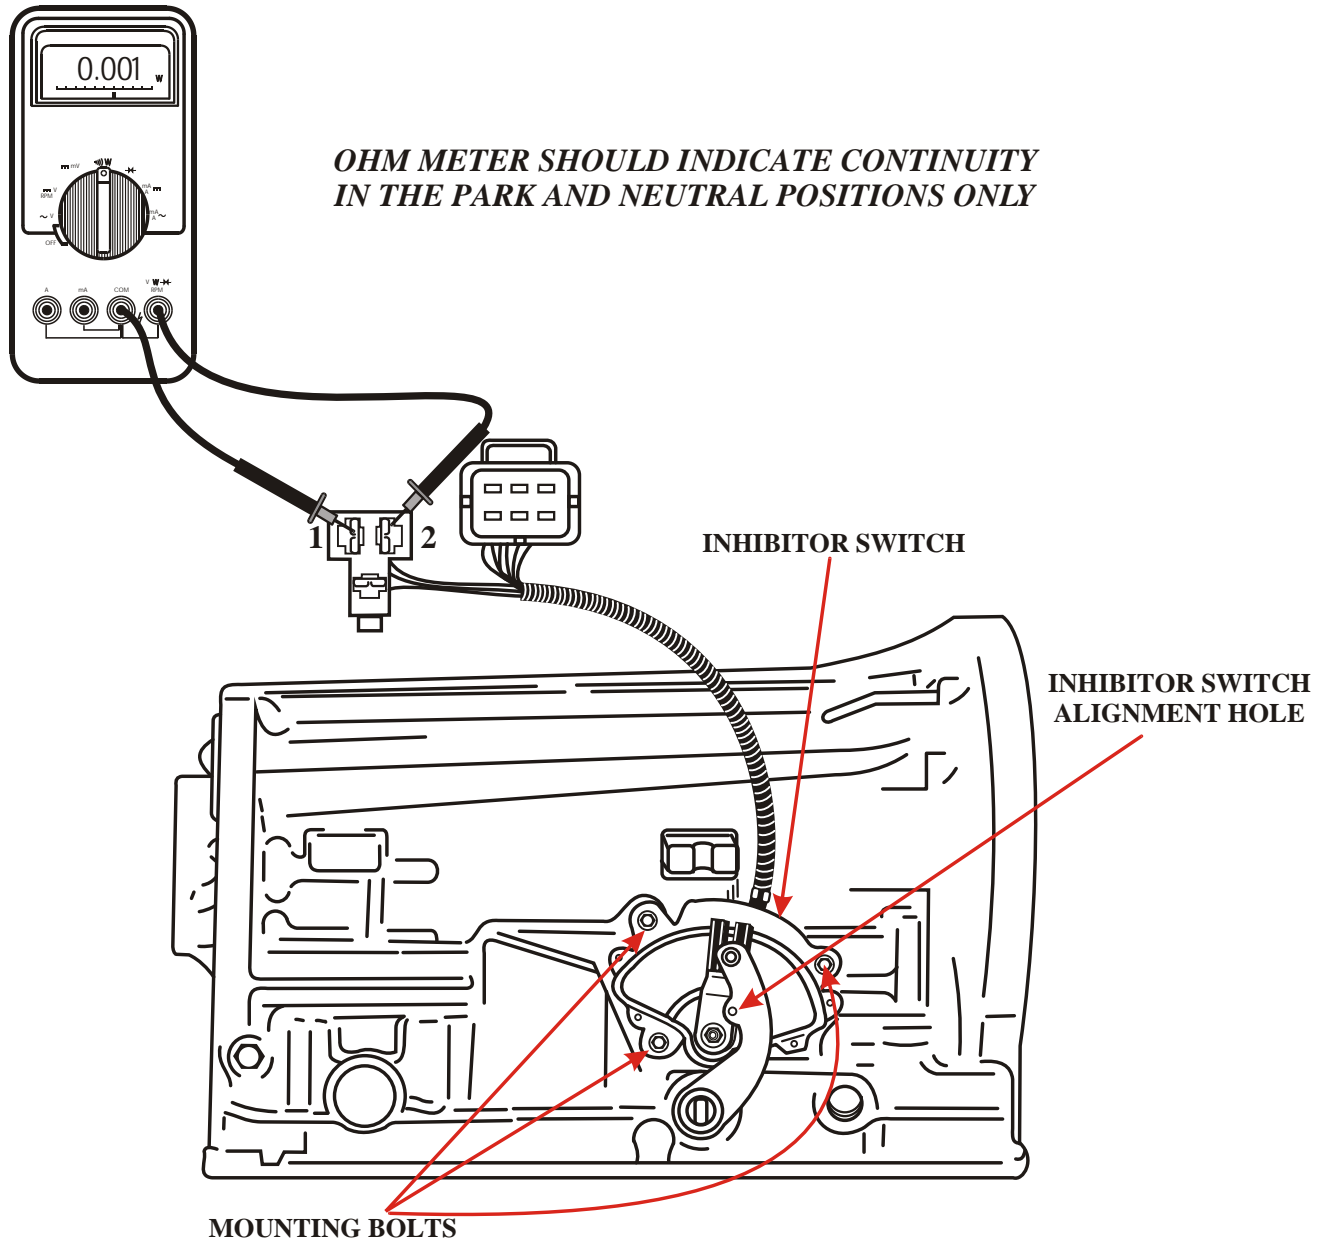
Figure 4

STEP 4: Place ohm meter across terminals 1 and 2 as shown in Figure 4. The ohm meter should indicate continuity in the Park and Neutral positions and "O.L." or open in Reverse, Drive, Manual 2nd and Manual 1 positions. If it indicates continuity in all ranges replace the inhibitor switch. If it indicates continuity in only some of the other ranges check the adjustment as shown in Figure 4.

INHIBITOR SWITCH ADJUSTMENT

Place the selector lever in Neutral. Loosen the 3 mounting bolts that attach the inhibitor switch to the case and adjust the inhibitor switch until a 5/32 drill bit will pass through the selector lever, inhibitor switch lever into the inhibitor switch guide hole.
