Technical Service Information

FORD AX4N-4F50N 1999-UP DELAYED REVERSE ENGAGEMENT-SLIPS IN REVERSE

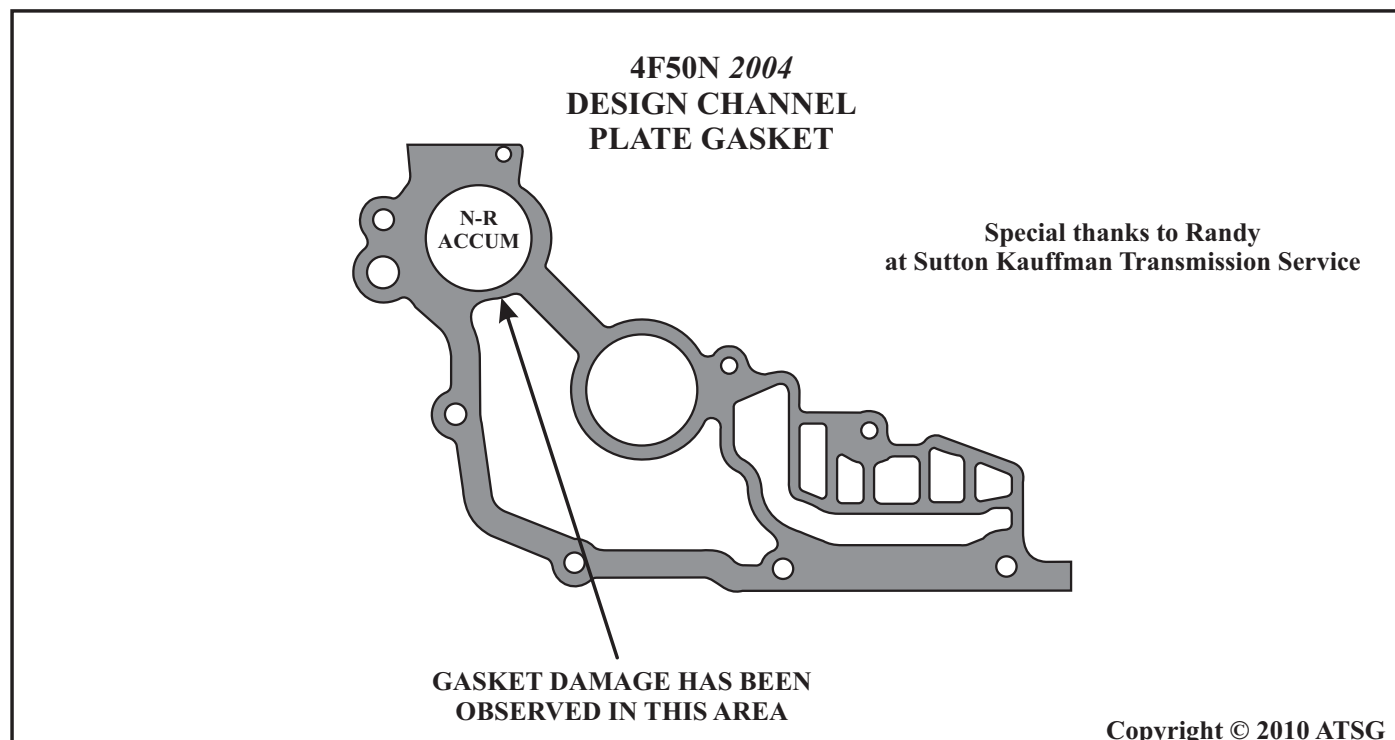
Figure 1

CAUSE: 1. Upon transaxle disassembly it may be observed that the channel plate gasket may be damaged at the N-R accumulator. (See Figure 1) This damage causes a fluid pressure loss to the reverse clutch pack resulting in either a delayed reverse engagement, or a slipping in reverse condition.

CORRECTION: 1. Currently all of the 2004-up channel plate gaskets that are now available have been updated to a new design level to prevent this problem from re-occurring. It appears that a change to the composition of the gasket material was made.

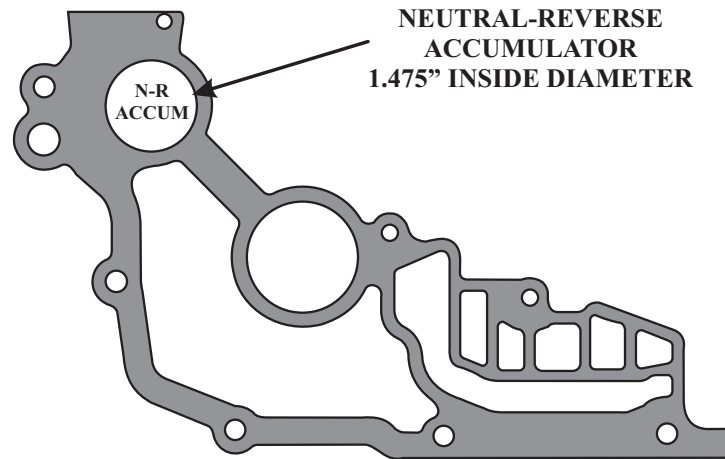
Figure 2

AX4N-4F50N 1999-2003 CHANNEL PLATE GASKET I.D.

AX4N-4F50N 1999-2003 DESIGN CHANNEL PLATE GASKET

2. During overhaul, make sure to use the proper channel plate gasket for your application. The 1999-2003 gasket is shown for identification (See Figure 2). The 2004-up gasket is shown for identification (See Figure 3).

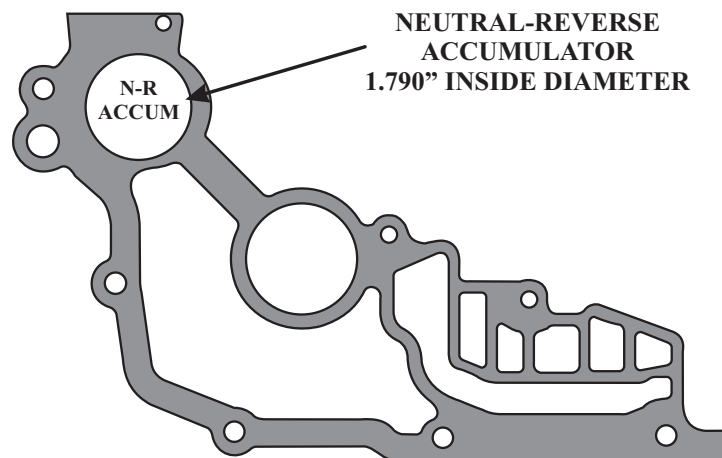
Figure 3

4F50N-2004-UP CHANNEL PLATE GASKET I.D.

4F50N 2004-UP DESIGN CHANNEL PLATE GASKET
