Technical Service Information

THM 440-T4

PREMATURE 3RD AND/OR INPUT CLUTCH FAILURE

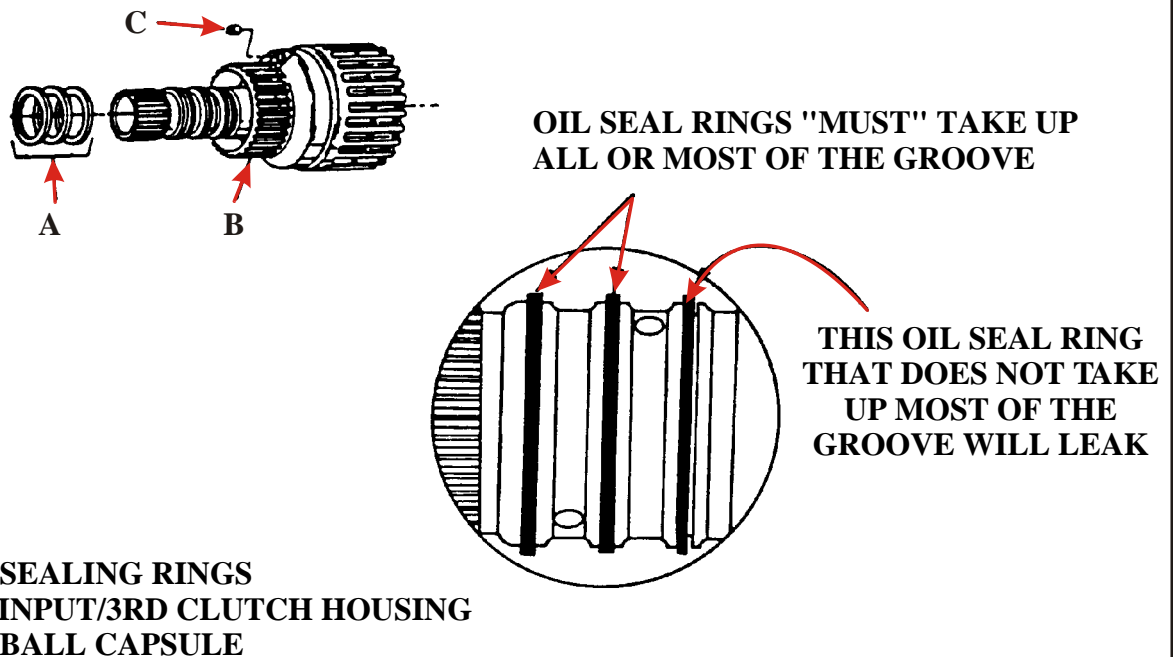
Figure 1

COMPLAINT: 1. Intermittent slip in forward and/or reverse.
2. Intermittent slip or flare on the 2-3 shift.

CAUSE: The cause may be due to one or more undersized input shaft oil sealing rings that feed both the input clutch and 3rd clutch. The sealing rings should take up most or all of the groove width (See Figure 1). Thin sealing rings may be found in any groove location, and will be about half the normal thickness. Proper width seals are .108" thick.

CORRECTION: Install proper width sealing rings on the input housing, following procedures outlined in the ATSG service manual. The sealing rings are solid and require special installation and re-sizing tools. The sealing rings are available under OEM Part No. 8656342.
