Technical Service Information

MERCEDES BENZ 722.6

TCM FLUID CONTAMINATION

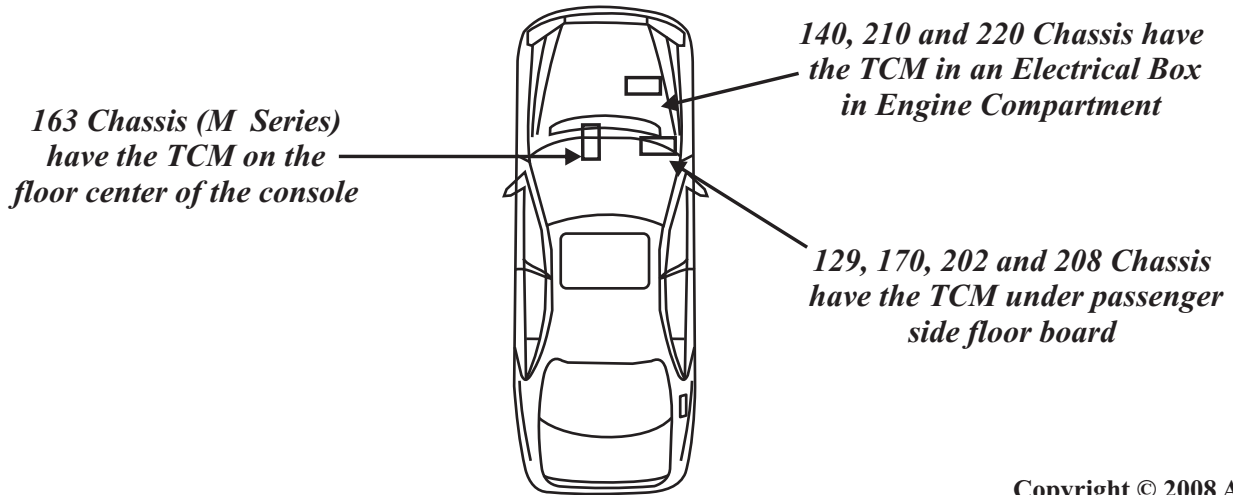
Figure 1

COMPLAINT: The vehicle may experience intermittent speed sensor or solenoid codes with reoccurring limp mode. When the technician locates the TCM, (Refer to Figure 1), to do some electrical checks, the TCM is found to be full of transmission fluid.

TCM LOCATIONS

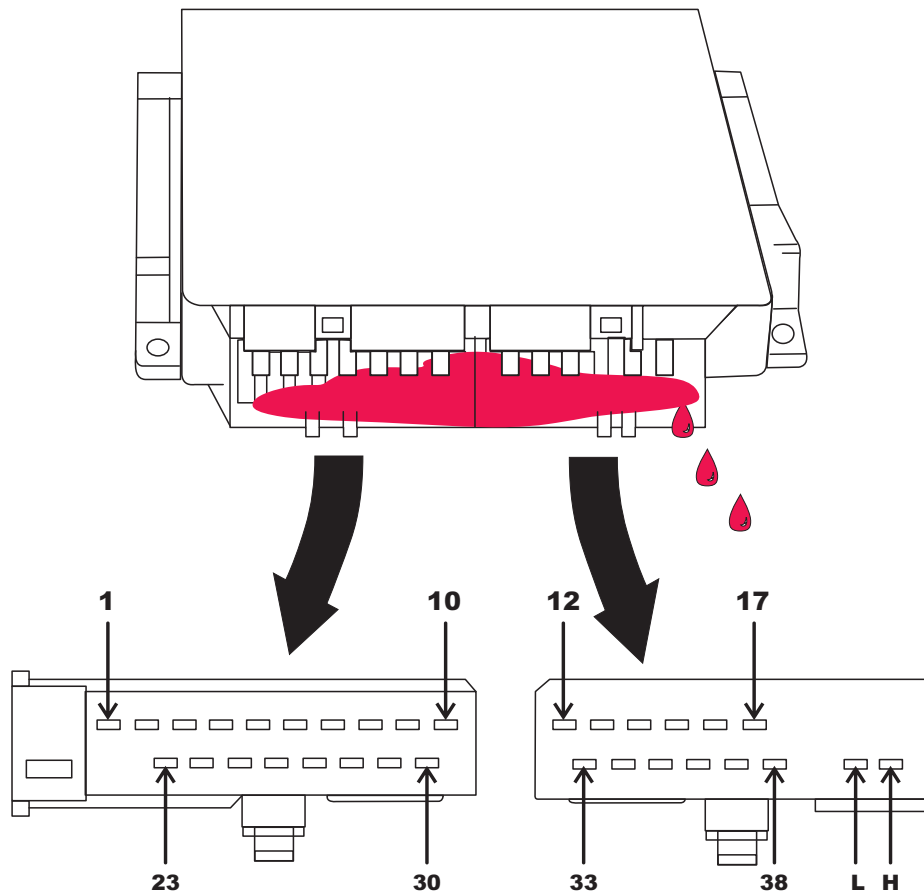
Figure 2

CAUSE: Transmission Fluid has worked its way up the wiring between the transmission case connector and the TCM through capillary action. As a result of this action, the TCM has been filled with fluid, (Refer to Figure 2).
This has nothing to do with the with seal condition on the conductor plate or the vehicle harness connector, even with good seals this will occur, (Refer to Figure 3).
