Technical Service Information

FORD 4R70W

INTERMITTENT TCIL ILLUMINATION DTCS P0741, P0750, P0755 AND P1746 MAY BE STORED IN MEMORY

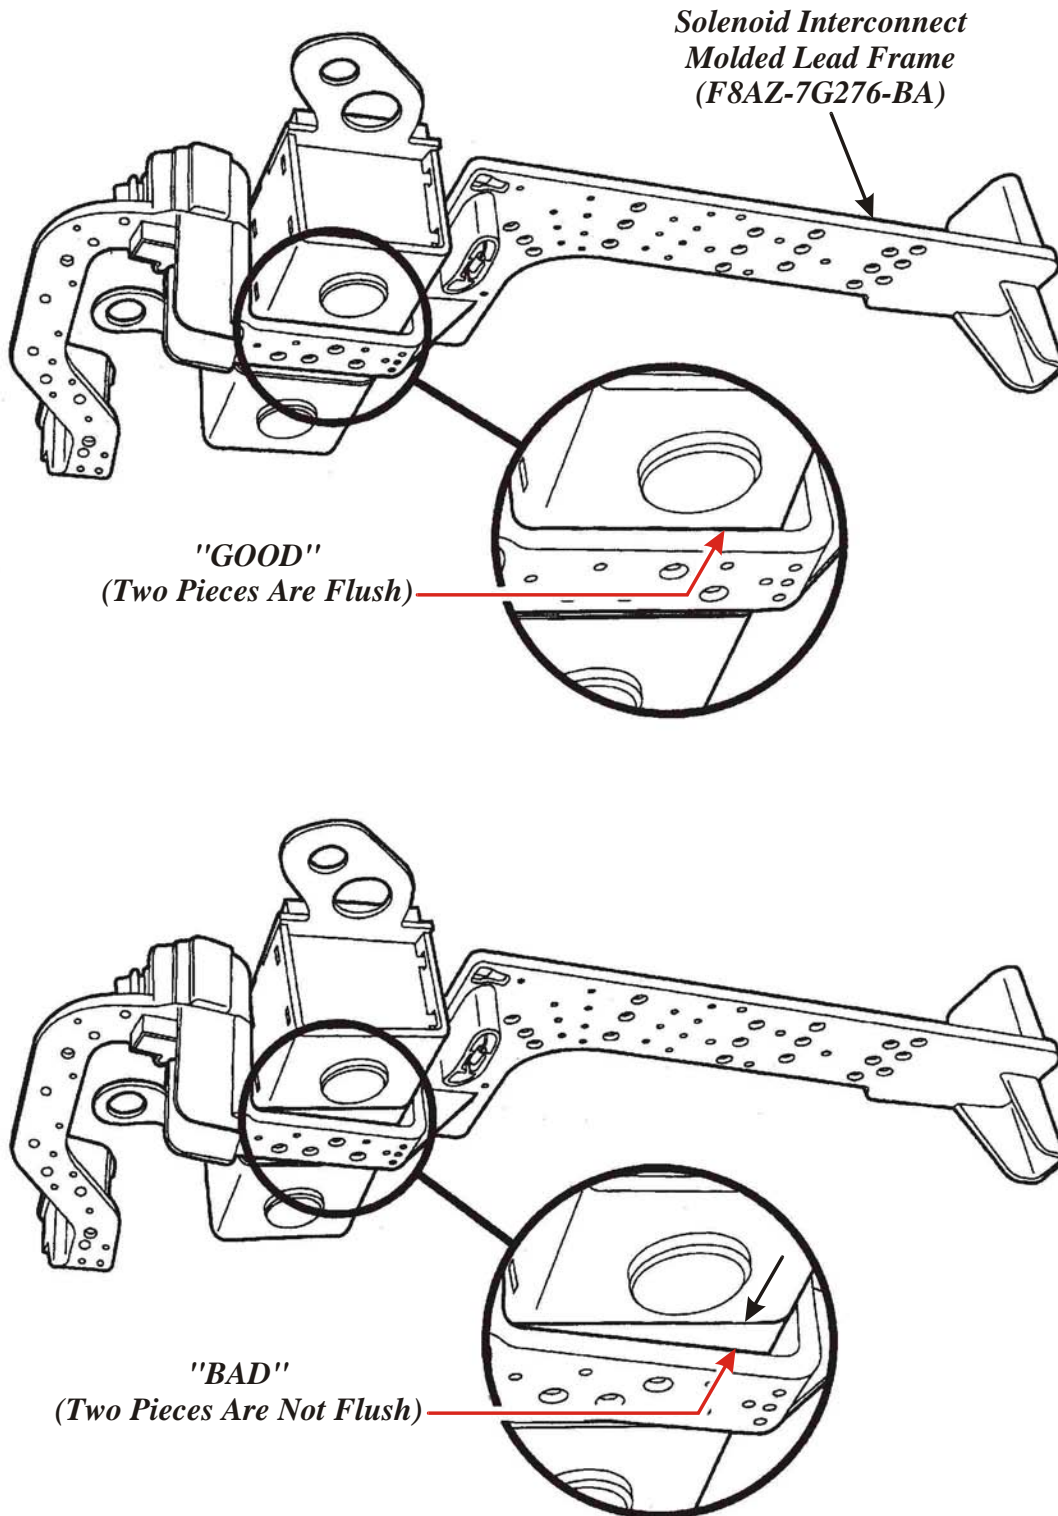
Figure 1

CAUSE: The cause may be, the solenoid interconnect molded lead frame not being fully seated on the solenoid pack or the bulkhead interconnect clips not being fully seated between the solenoid interconnect molded lead frame and bulkhead interconnect.

- (3) Verify that the solenoid interconnect molded lead frame is fully seated on all the solenoid connectors as shown in Figure 1. If the solenoid interconnect molded lead frame is fully seated, then gently remove the solenoid interconnect molded lead frame, valve body and the bulkhead interconnect.

- (5) Replace parts as necessary using the part numbers listed below and reassemble unit.

Bulkhead Interconnect (Case Connector)	F8AZ-7G276-AA
Solenoid Interconnect (Internal Molded Harness)	F8AZ-7G276-BA

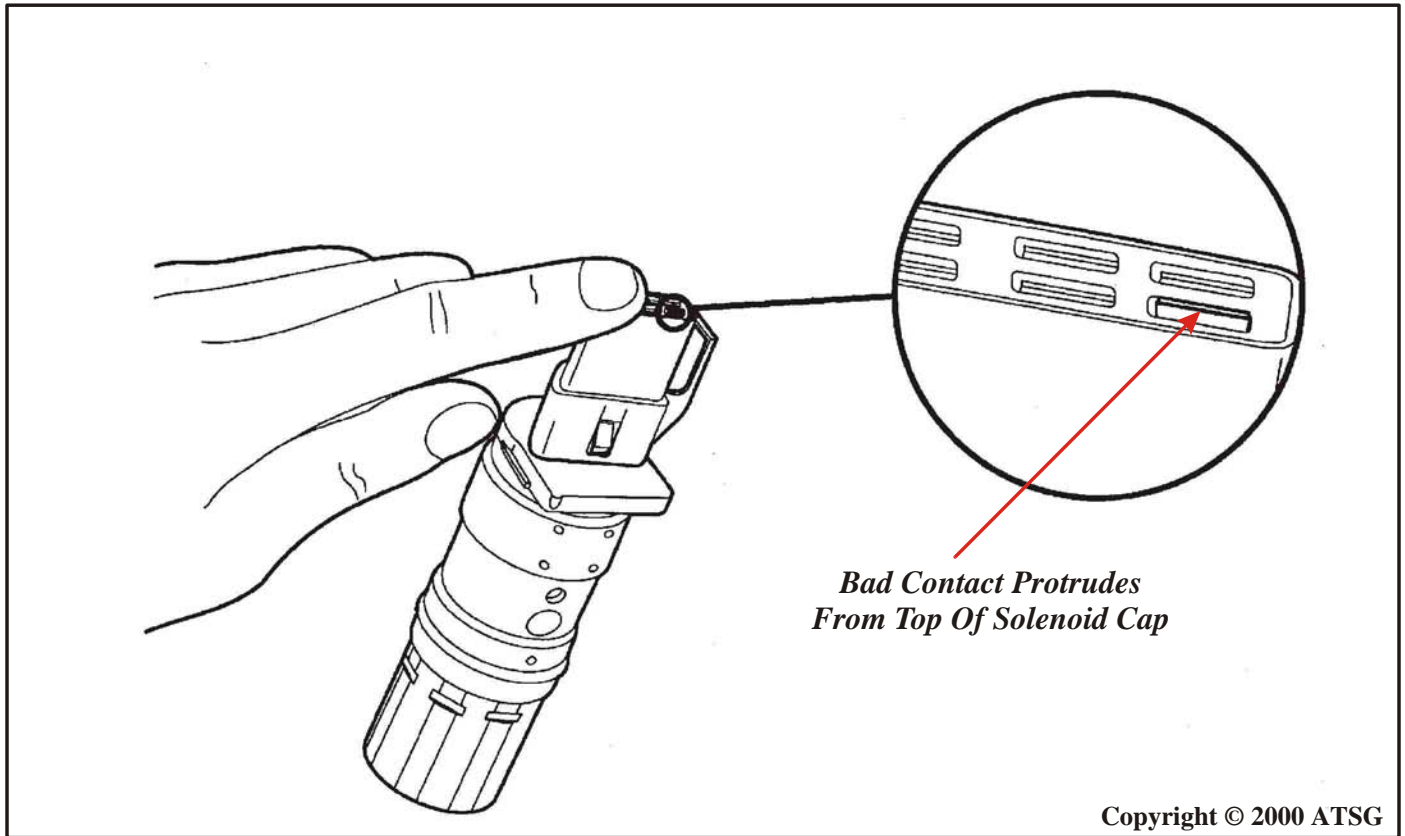
Figure 2

- (4) With the bulkhead interconnect removed, push down on the terminal cover and check to see if any of the terminals are slightly protruding above the plastic cover as shown in Figure 2. Gently pry off the terminal cover using a small screwdriver (See Figure 3). With the terminal cover off, inspect the bulkhead interconnect for spreading terminals as shown in Figure 4.
