# Technical Service Information

## **FORD E4OD 1-2 SLIDE, 2-3 FLARE, OR SLIPS FORWARD AFTER REBUILD**

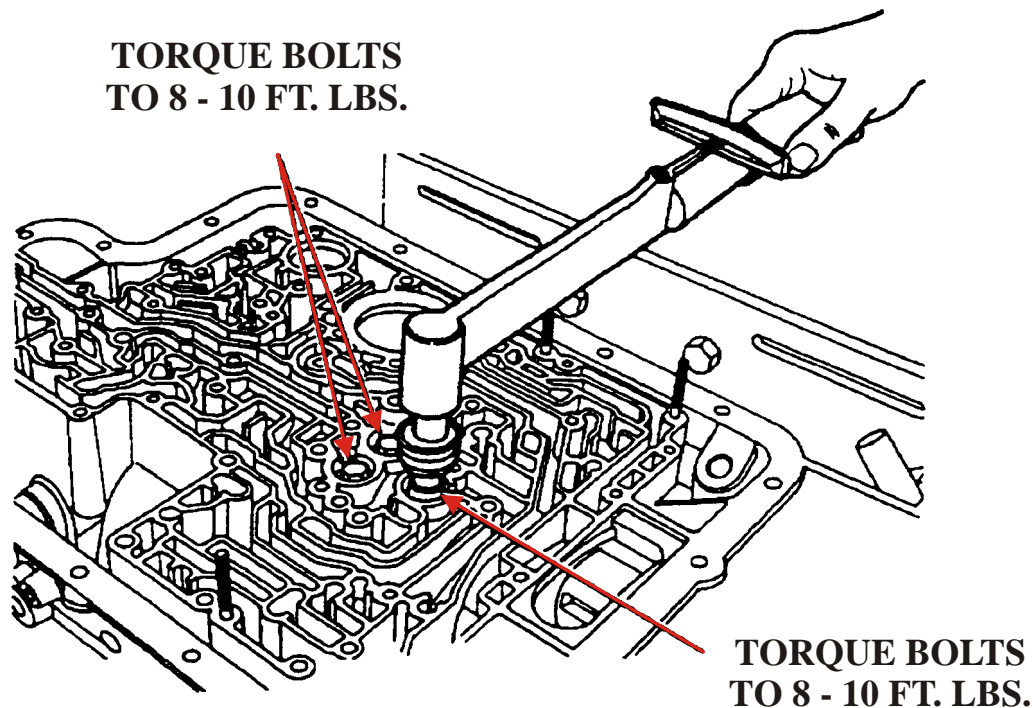
Figure 1

**COMPLAINT:** After rebuild, slips or delays in forward when hot, slides on the 1-2 shift, , or flares up on the 2-3 shift, and burns clutches especially when warm.

**CAUSE:** Over tightened center support to case bolts. This will cause leaks across oil feed passages to the clutches.

**CAUSE:** Remove valve body and re-torque center support bolts to 8 to 10 ft. lbs. In cases where distortion has been extreme, it may be necessary to use two gaskets between the spacer plate and the case.
