# Technical Service Information

## FORD 5R55E OVERDRIVE DRUM SPEED (ODS) SENSOR ELIMINATED

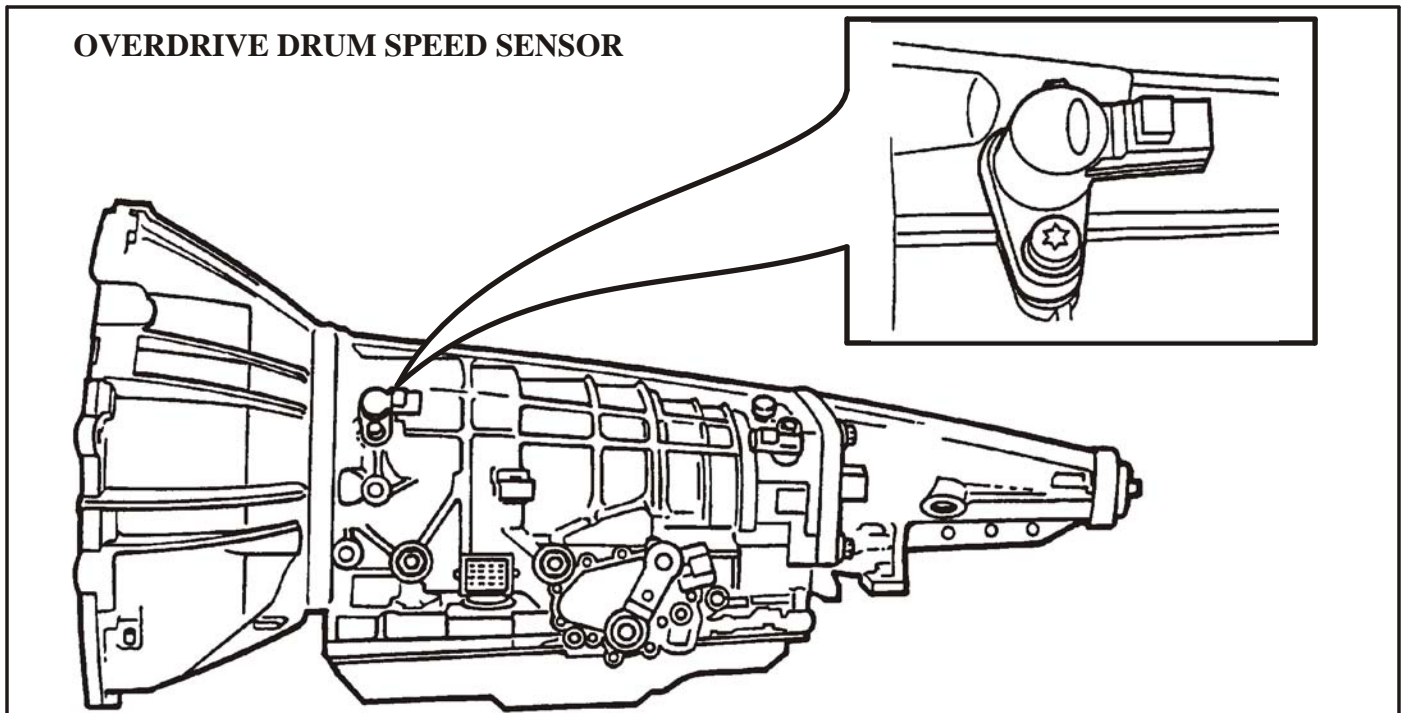
Figure 1

**CHANGE:** The Overdrive Drum Speed (ODS) Sensor, located in the transmission at the front of the case, was eliminated as a running change during the 1997 model year. Refer to Figure 1.

**REASON:** To eliminate erratic operation and malfunctions.

During the transmission rebuilding process, disconnect the ODS sensor connector, cut off the connector end and splice the wires together. Shrink wrap the wire ends and secure the wires to the harness with a tie-wrap. This should reduce the possibility of stray signals affecting the operation of the transmission. Leave the sensor installed if you are using the original case. The new service cases will not have the ODS sensor hole in the case.
