# Technical Service Information

## THM 440-T4 INTERMITTENT ENGINE STALL ON COAST DOWN

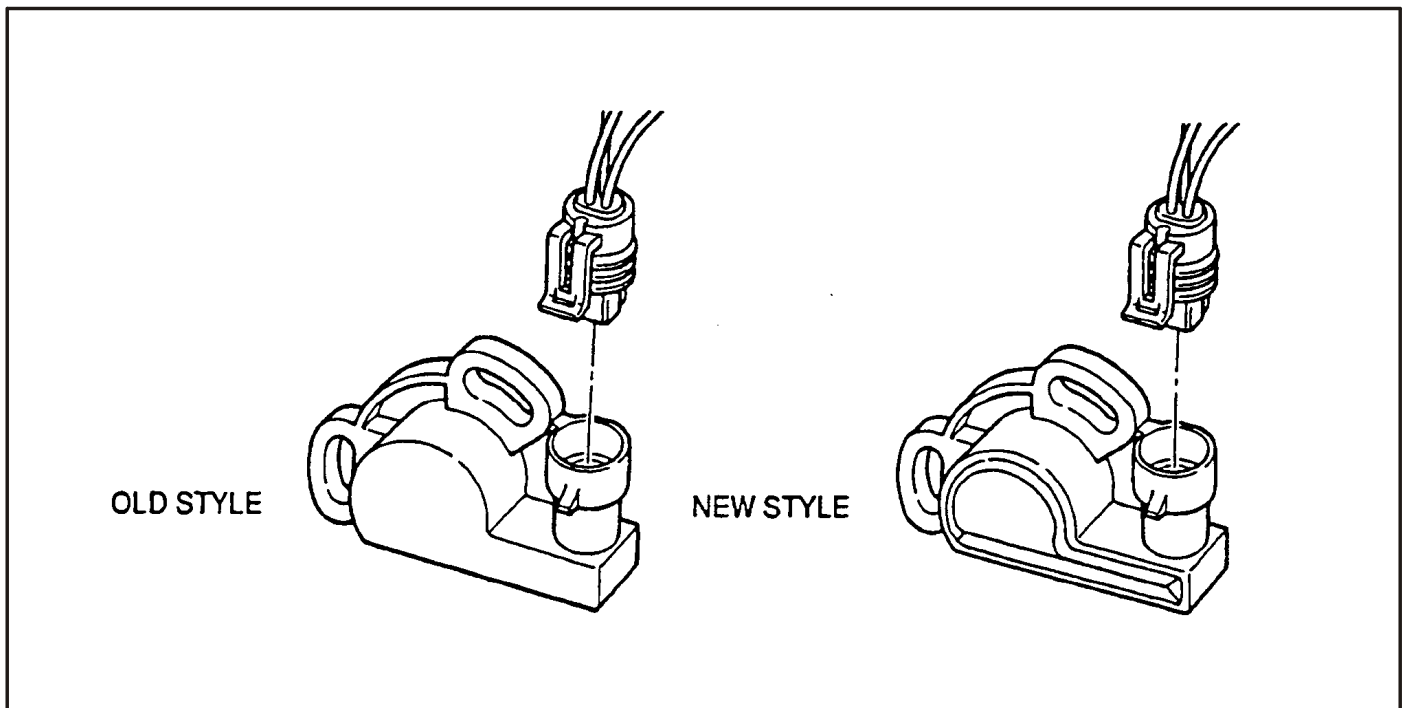
Figure 1

**CAUSE:** This condition may be caused by an erratic throttle Position Sensor (TPS) signal, a poor ground connection near the starter, and/or PCM PROM calibration.

**CORRECTION:** (1) For 1990-1991 vehicles only, visually inspect the TPS. If the TPS is the old style, replace it with Part Number 17112609 (SEE FIGURE 1).
