AUTOMATIC TRANSMISSION SERVICE GROUP

SEMINARS '88

TECHNICAL INFORMATION PACKAGE

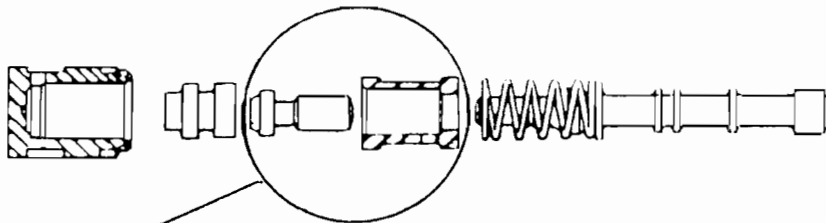
INCORRECT

REVERSE BOOST VALVE AND BUSHING CAN BE INSTALL BACKWARDS-
THIS CAN CAUSE SLIPPING IN REVERSE AND ERATIC SHIFT FEEL

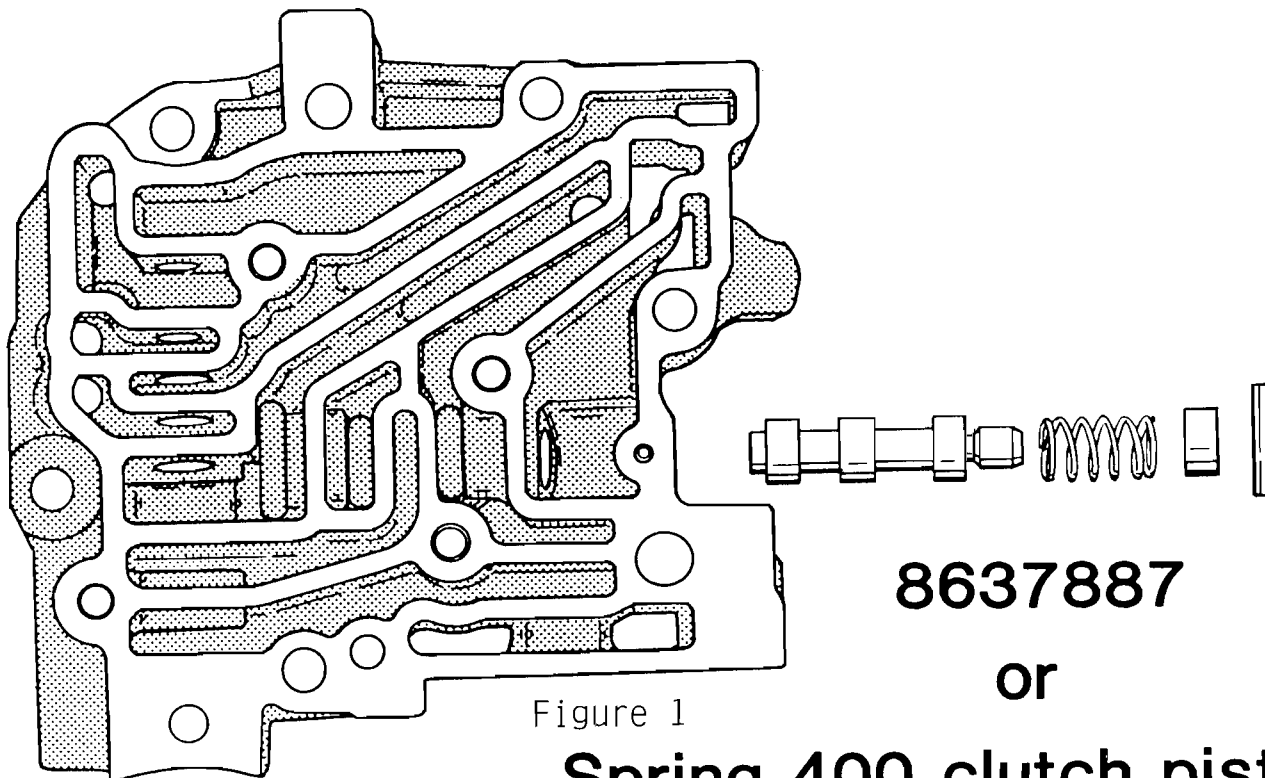
Figure 1

CAUSE: One cause can be low converter regulator charge pressure. Figure 1. Another cause can be slow drain of converter oil in front of clutch piston.

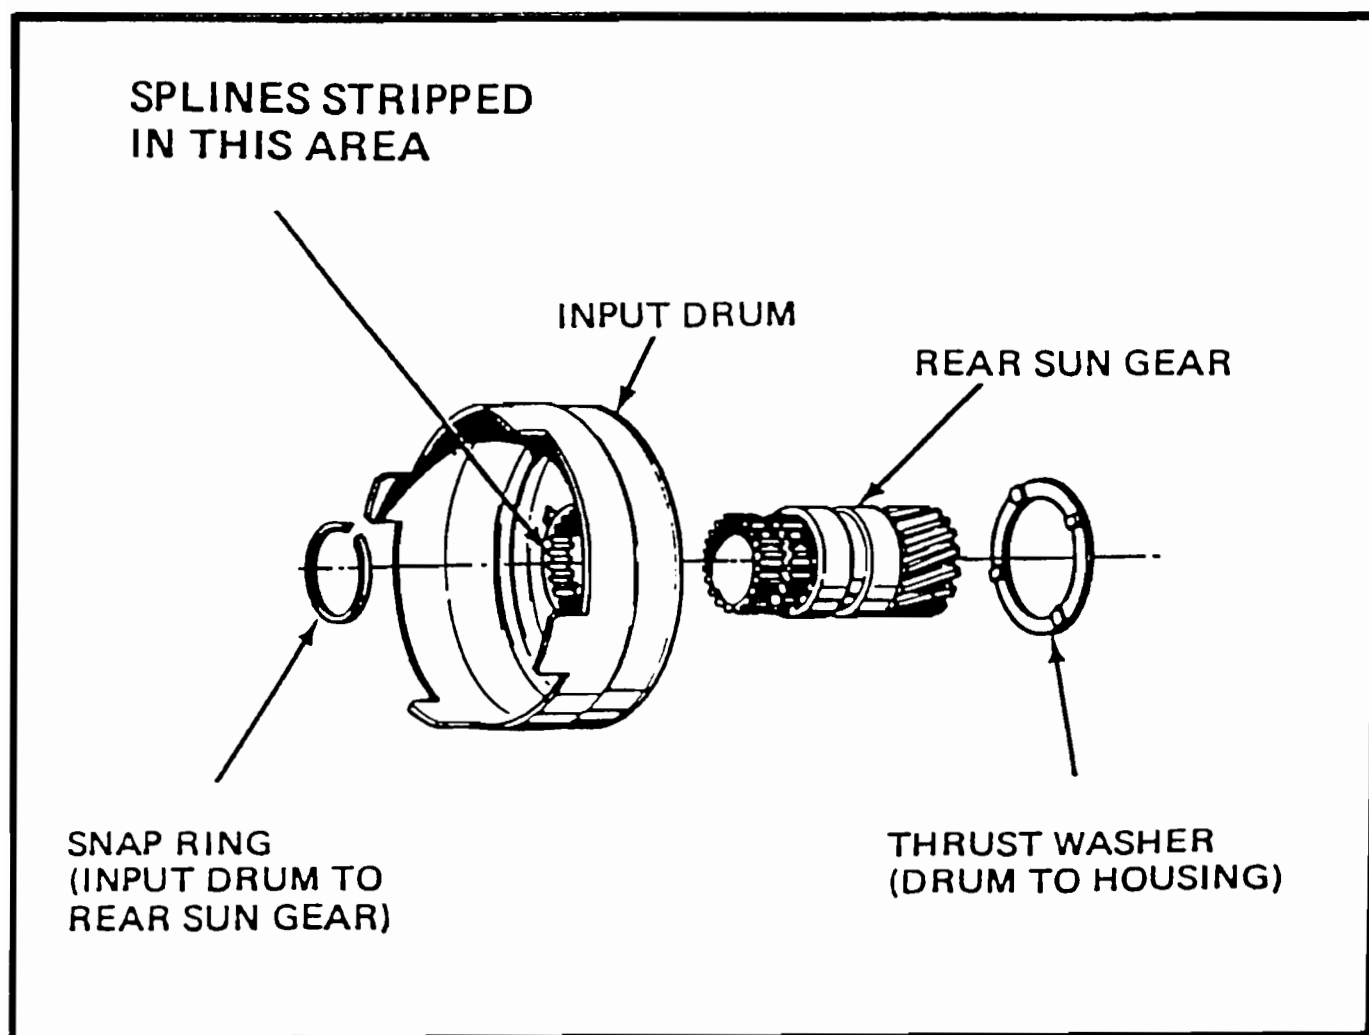
Figure 1

CAUSE: Stripped splines on the sun gear shell as shown in Figure 1.

CORRECTION: Replace the sun gear shell. If the vehicle is used in heavy duty operation (police-taxi) a new hardened shell is available. It is a flat black in color.

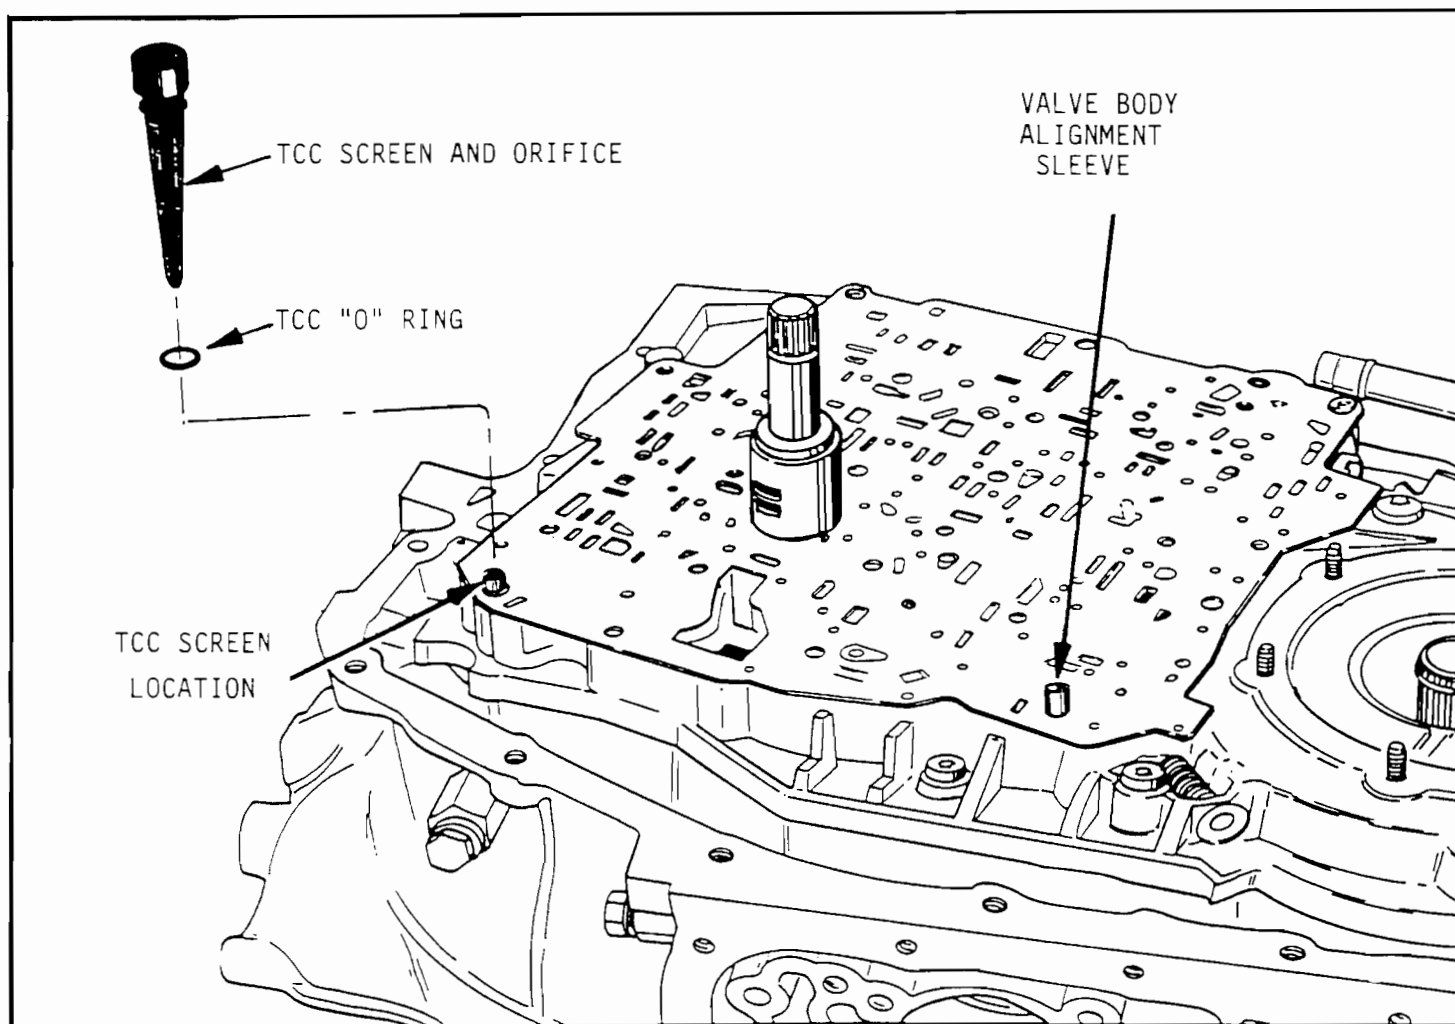
Figure 1

CAUSE: The cause may be a missing TCC screen and orifice (See Figure 1). If the TCC screen and orifice are left out of the 440-T4, the converter clutch will apply on the 1-2 shift, because of the solenoids inability to exhaust TCC signal oil there by stroking the lock-up valve. The TCC screen and orifice must be in place, as well as the "O" ring (See Figure 1).

CORRECTION: Install the TCC screen and "O" ring into spacer plate in location shown in Figure 1. First install "O" ring on TCC screen and then "Snap" into place in spacer plate. OEM Part No's as follows;
TCC Screen-----8658060 "O" Ring, TCC Screen-----8658109

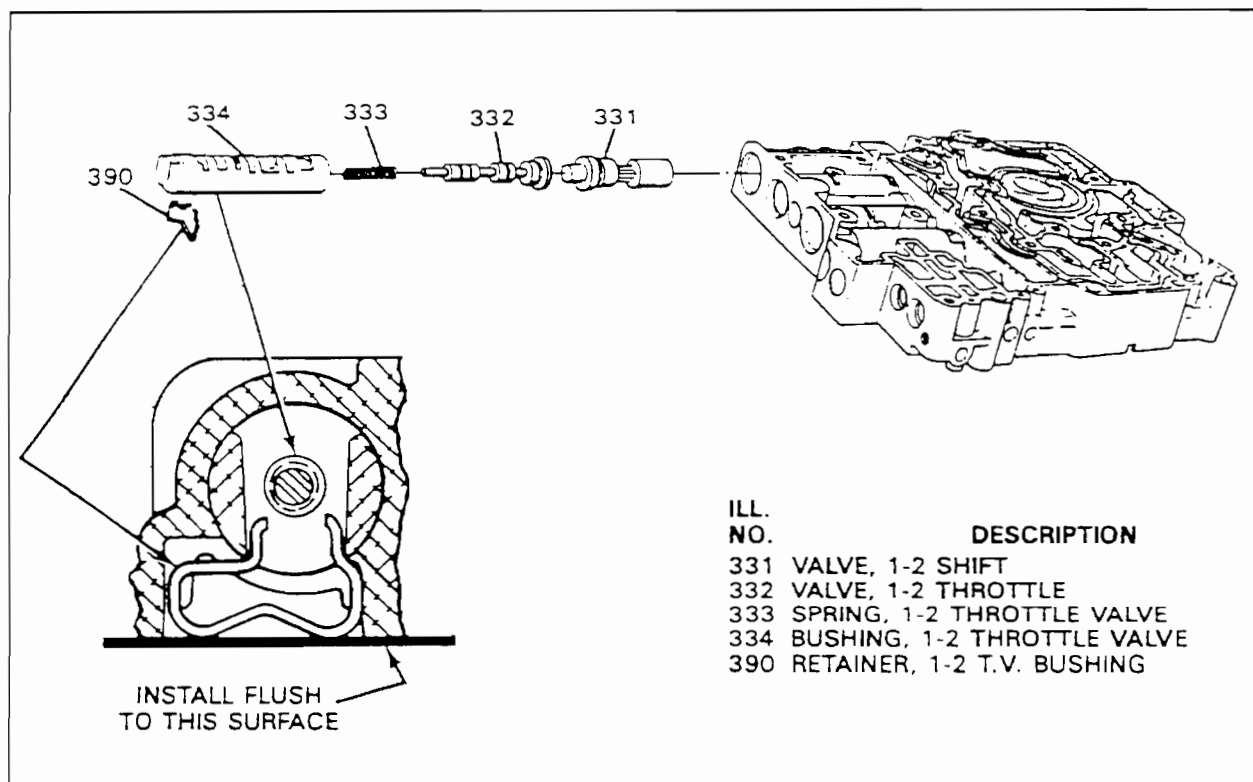
Figure 2

If governor pressure is okay, the 1-2 shift valve (331) may be stuck in the upshifted position. Remove the control valve assembly and check for a sticking 1-2 shift valve (331), 1-2 throttle valve (332), or the 1-2 throttle valve spring (333) caused by the 1-2 throttle valve bushing retainer (390) pushed in too far. The retainer should be installed flush with the machined surface of the valve body. (Figure 2)

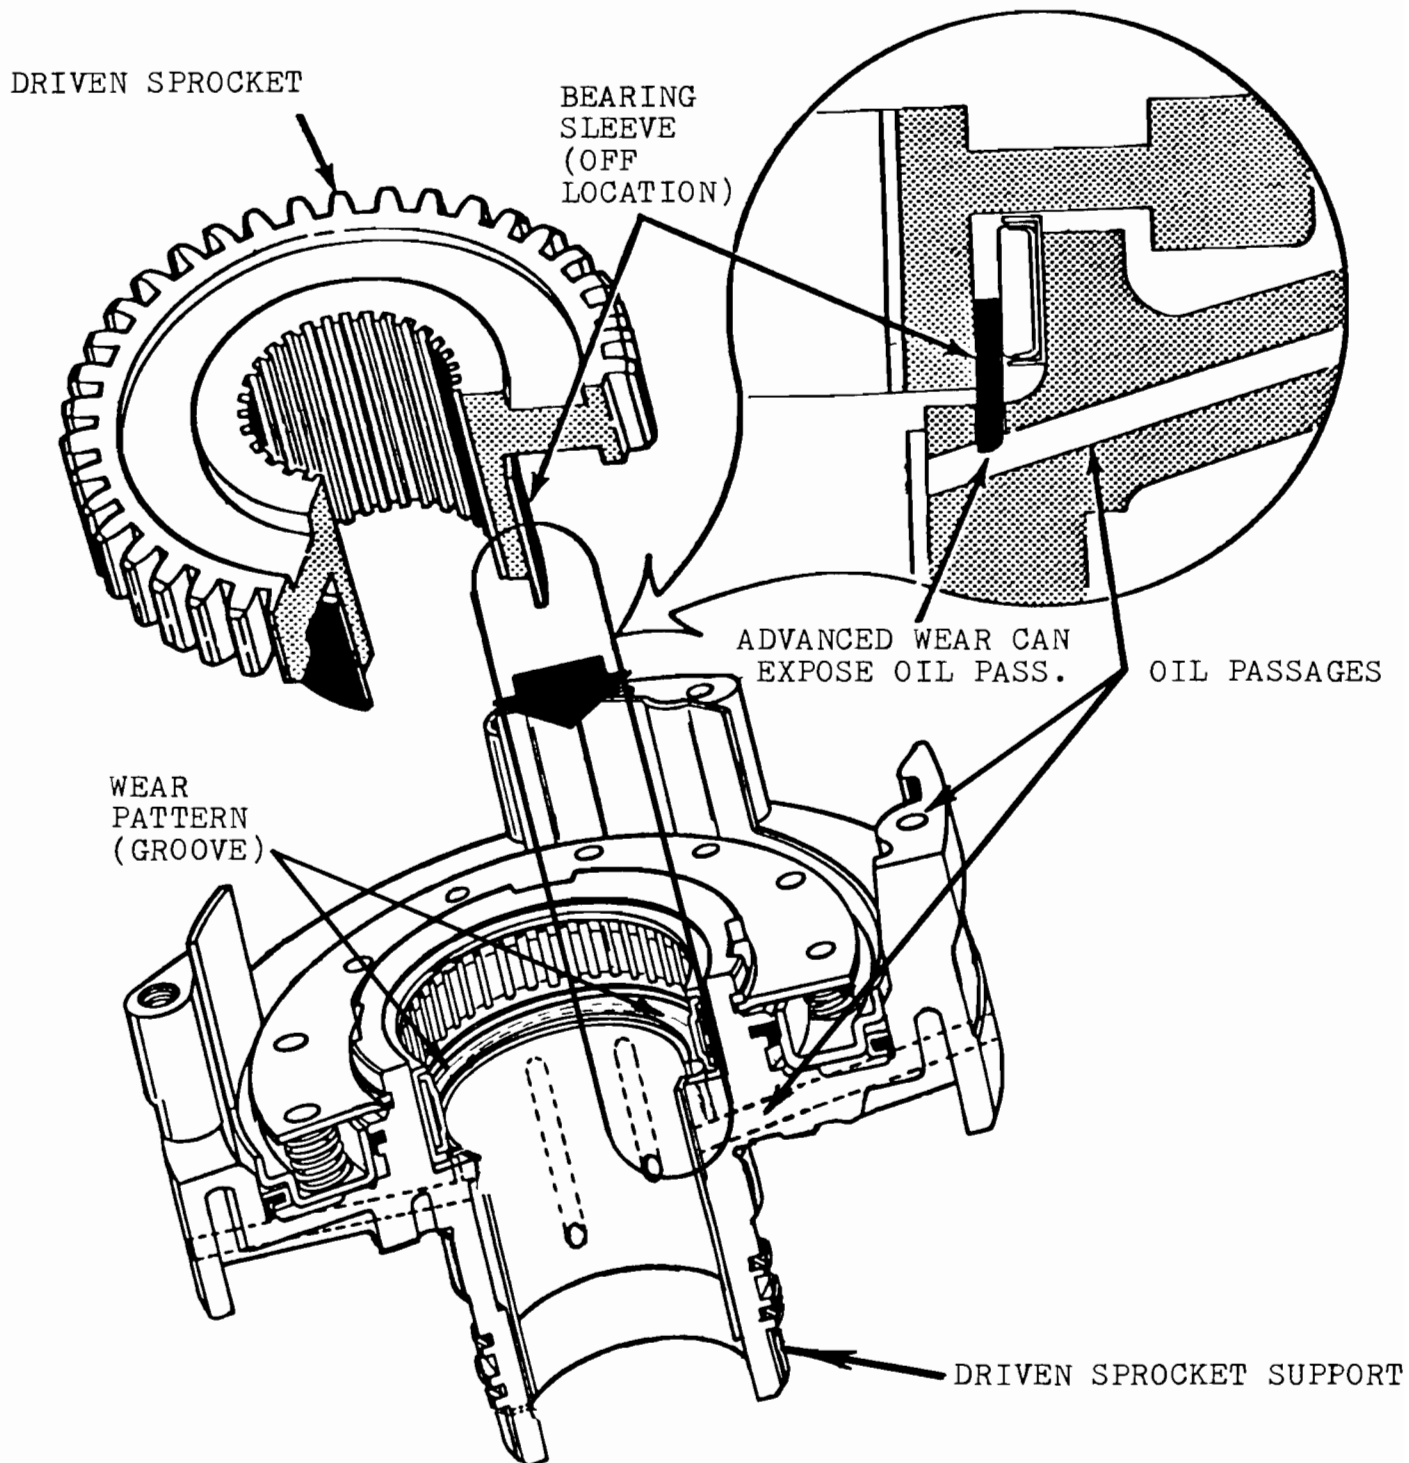
When diagnosing a THM 440-T4 transaxle for slipping shifts, or erratic shifts, check the driven sprocket support for wear as shown in illustration.

This wear pattern, if present, is caused by the bearing sleeve on the outside hub of the driven sprocket moving and wearing into the driven sprocket support. As this wear condition reaches an advanced state the oil feed passages in the driven sprocket support could be exposed, allowing an oil pressure cross leak.

The bearing sleeve on the driven sprocket may, after causing the described wear pattern (Groove), move back on to the driven sprocket and appear to be normal. If this condition is suspected, be certain to check the driven sprocket support for the wear pattern as shown in illustration.

If the above condition exists, replace the driven sprocket, driven sprocket support and any other affected parts. Be certain to check all four clutch packs in the transaxle as they are all fed through oil passages in the driven sprocket support. Repair or replace as necessary.

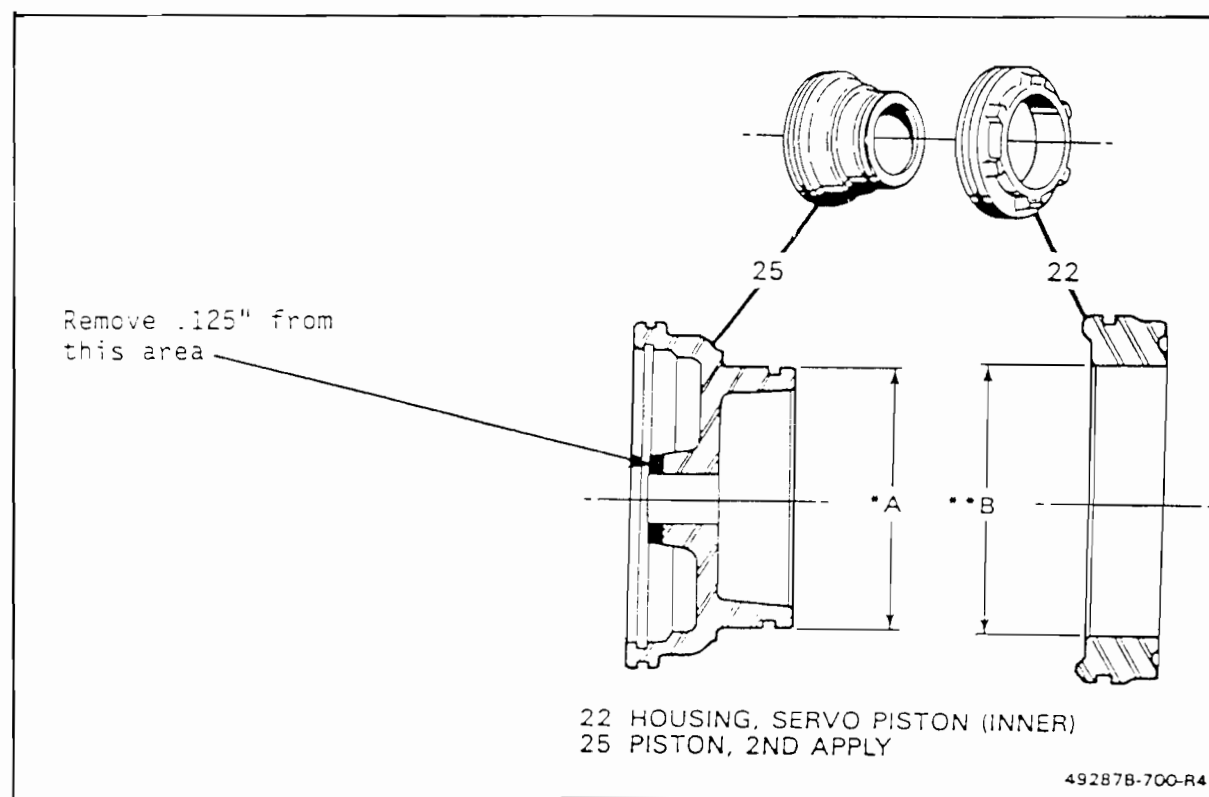
Figure 1

CAUSE: The cause could be the 2nd apply piston.

CORRECTION: Modify the 2nd apply piston by machining the inner hub and remove .125" (See Figure 1).

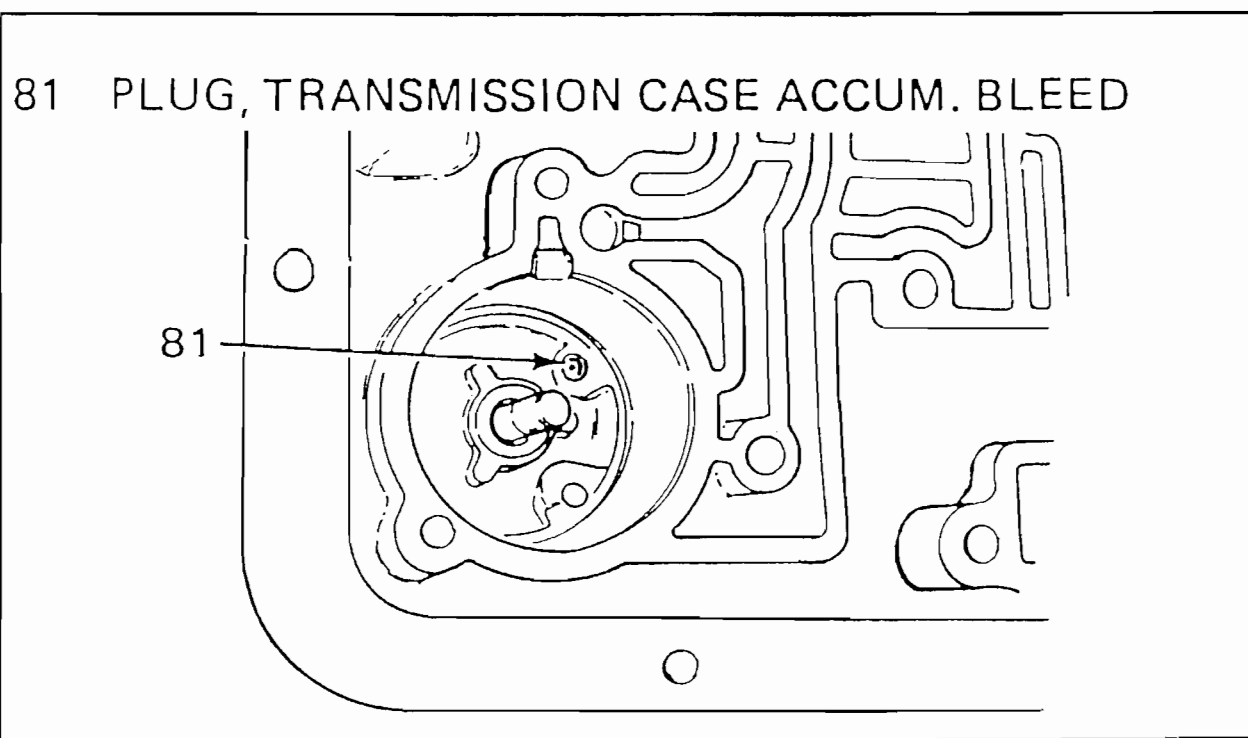
Figure 1

- COMPLAINT: No 4th gear; 2nd and 4th pressure lower than line pressure.
- CAUSE: The cause could be the bleed orifice cup plug missing from the case in the bottom of the 3-4 accumulator bore (see Figure 1).
- CORRECTION: Install bleed orifice cup plug, OEM Part Number 8628864.

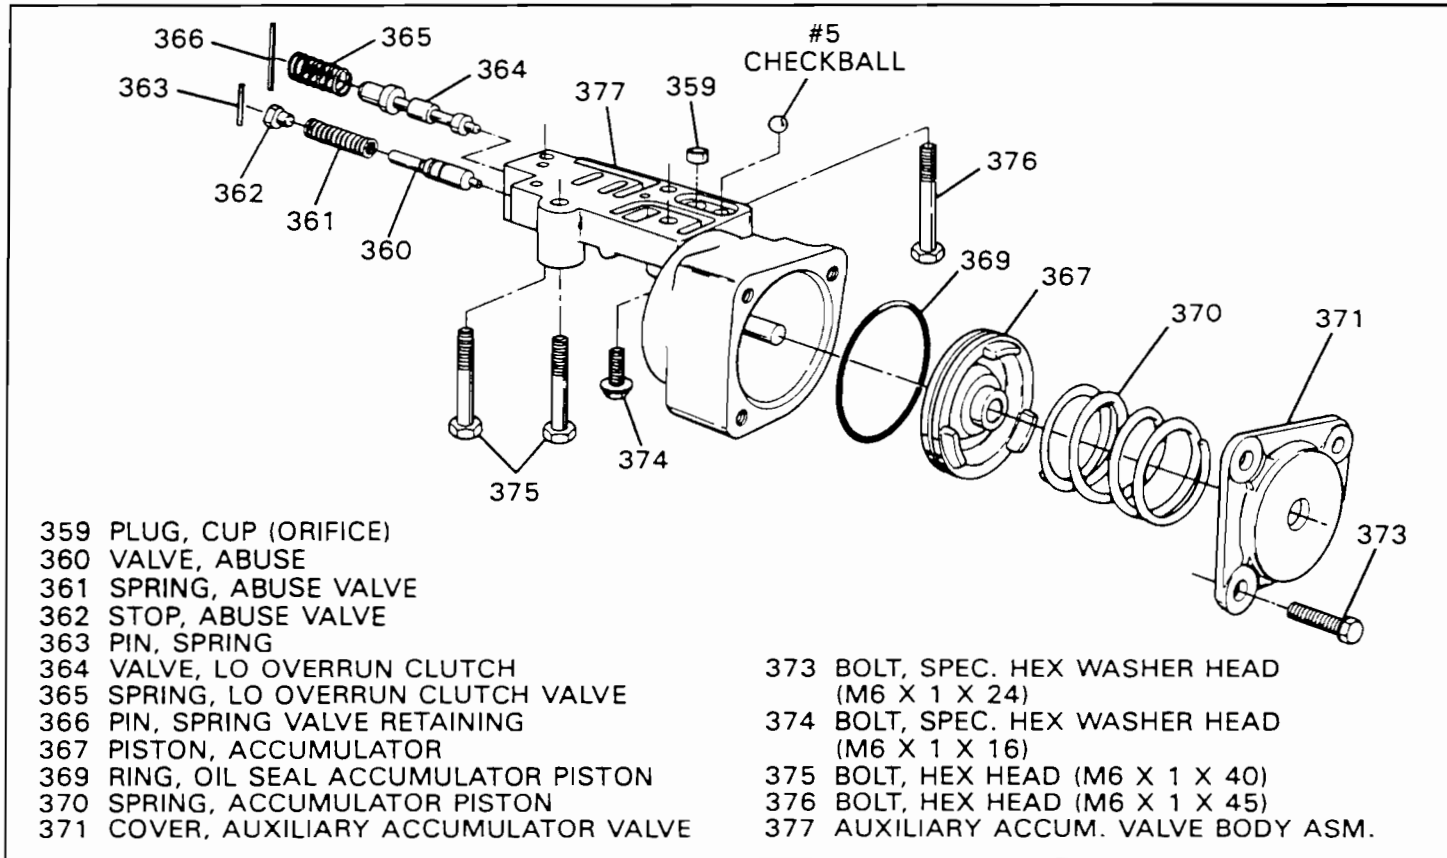
Figure 1

- COMPLAINT: Premature forward clutch failure on 1987 THM 700-R4 with auxilary valve body.
- CAUSE: The cause could be the forward clutch accumulator pin in the auxilary valve body moving out thru the hole in the center of the 1st design accumulator cover, and creating a loss of forward clutch oil. The original press fit of the pin was not sufficient to retain the pin in the auxilary valve body casting.
- CORRECTION: If you have the 1st design cover, braze shut the hole in the center of the cover and drill a 3/16" hole off center. (See Figure 1). The 2nd design cover with the oblong hole in the center is OK to use as is. If the pin has moved out the back side of the auxilary valve body, a simple "staking" process will prevent it from moving that direction again. The 2nd design auxilary valve body casting has a step machined in that area to prevent the pin from moving.

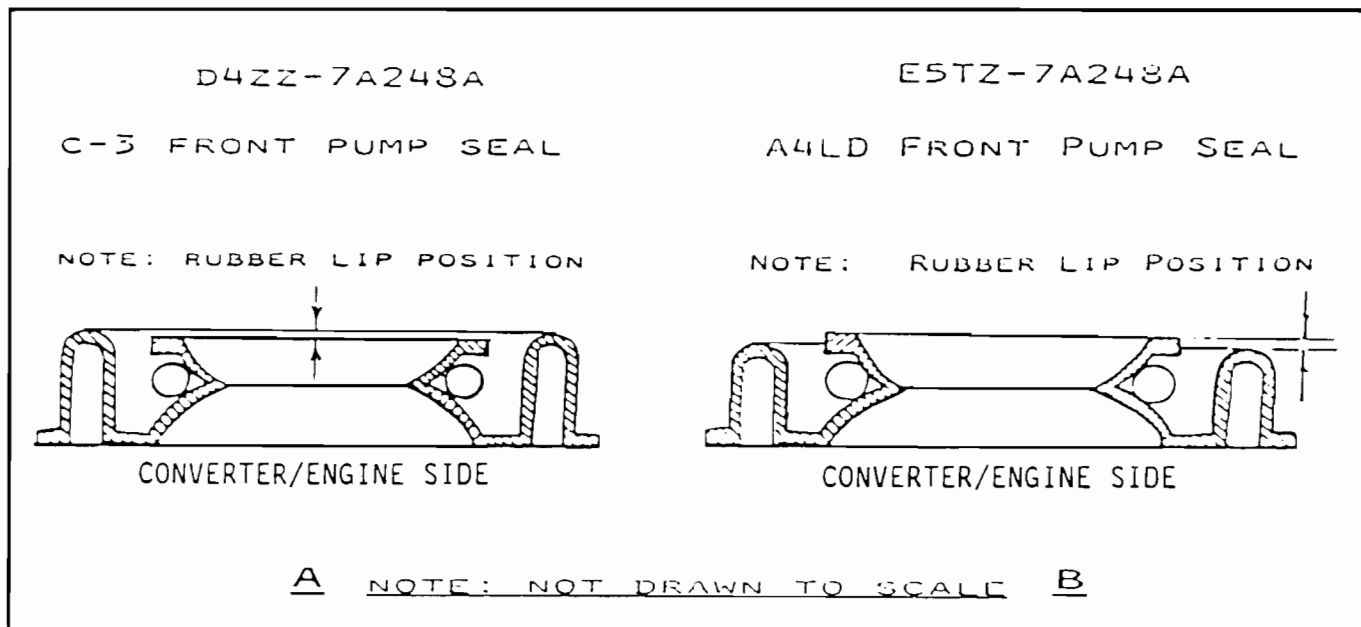
- COMPLAINT: C-3 front seal pops out after overhaul or seal replacement.
- CAUSE: One cause can be the use of an A4LD front seal used in place of the C-3 front seal. See Figure 1 B (A4LD seal). Note that the lip of the seal protrudes past the metal base of the seal housing. When the seal is installed, the rubber portion of the seal restricts the drain passage behind the seal. In Figure 1 A (C-3 seal), the seal lip is below the metal base of the seal.
- CORRECTION: Install a C-3 front seal (D4ZZ-7A248A) in C-3 transmissions.

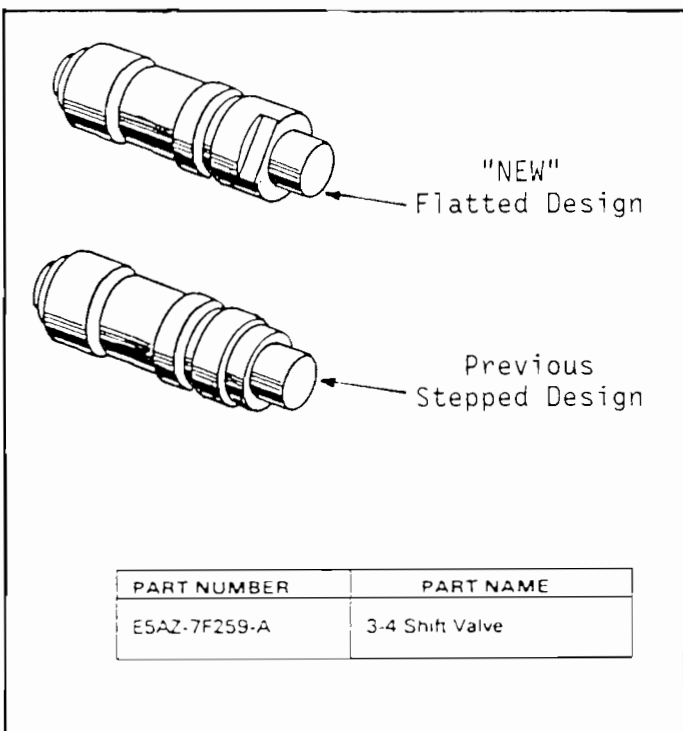
Some AOD-equipped vehicles with transmissions built between March, 1983 and April 19, 1985 may exhibit a no forward drive condition after coast down from fourth gear. This condition may occur if a small particle of contamination causes the 3-4 shift valve to stick in the forward clutch exhaust position.

To service this condition, install a new 3-4 shift valve that has a design with flats on the valve. This will allow contamination to pass and be trapped in the main control filter assembly. The new valve was incorporated in production April 19, 1985. Refer to Figure 1 for visual differences between 3-4 shift valve design levels.

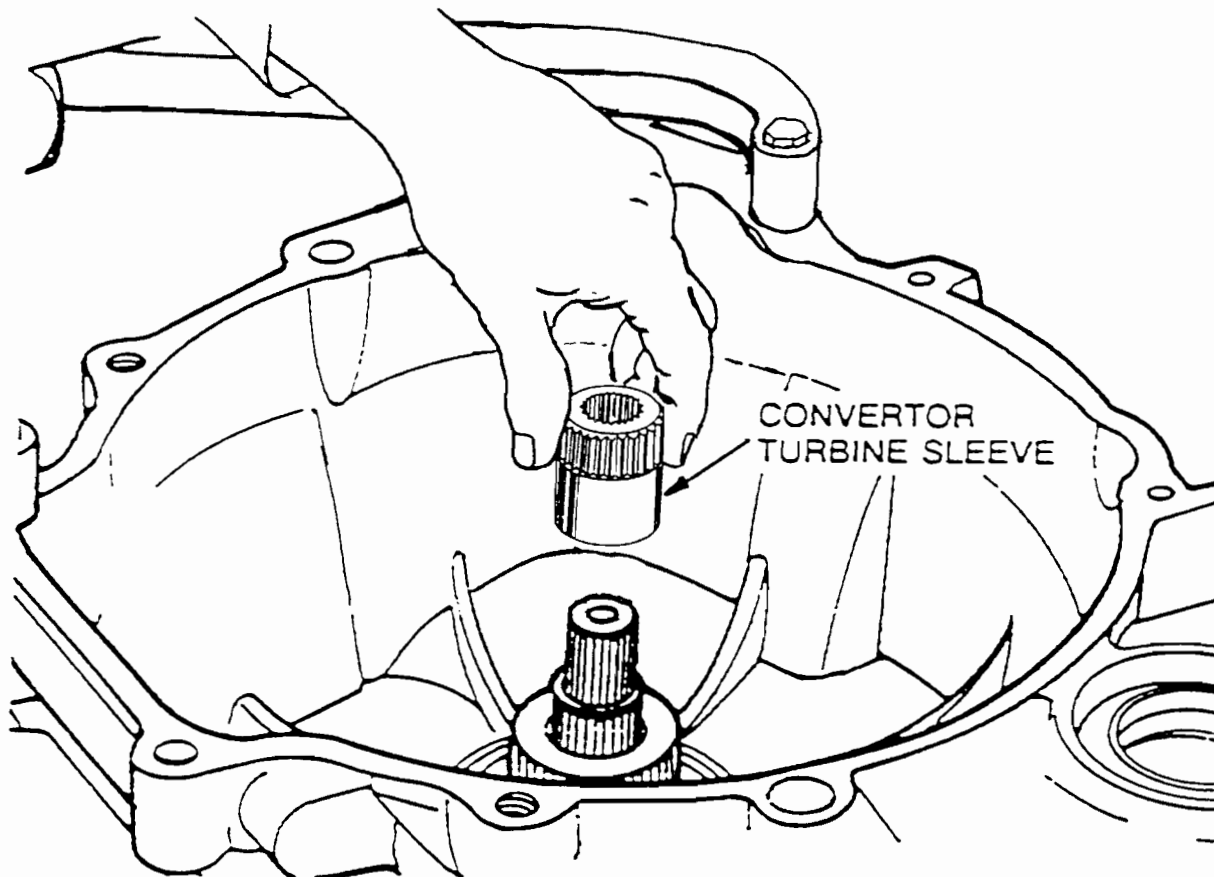
Figure 2

1987-88 Tempo Topaz only use a converter adapter sleeve, Part Number E7FZ-7A878-A. This sleeve has two internal splines and one external spline. (See Figure 1) Since this is a slip on adapter, it can stay engaged in the torque converter turbine hub upon removal of the converter from the transmission. If this adapter IS NOT reinstalled on the transmission (turbine and intermediate shafts), a NO DRIVE CONDITION WILL BE THE COMPLAINT AFTER INSTALLATION. (See Figure 2)
