Technical Service Information

THM 3T40 (125C) FINAL DRIVE WEAR

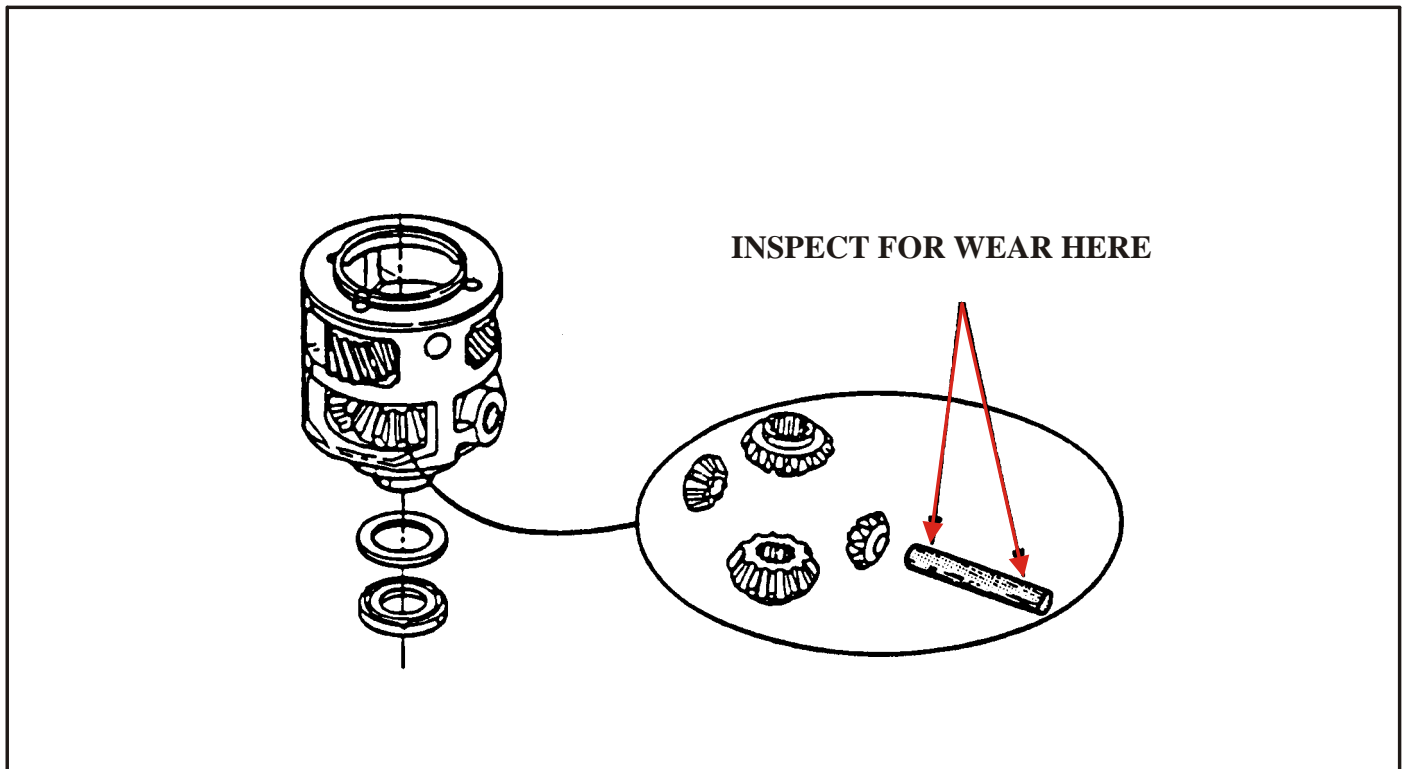
Figure 1

COMPLAINT: On 1989 models only, a garage shift clunk when selecting any gear from park or neutral, and/or, noise when turning especially in tight turns. In severe cases it will “Resemble” limited slip differential that needs additive, and sometimes breaks the transaxle case in the final drive area.

CAUSE: The cause may be a worn or gaulded differential pinion shaft that supports the two pinions in the final drive (See Figure 1). The black coating flakes off of the pinion shaft because of improper hardening at the manufacturer.

CORRECTION: Inspect the differential pinion shaft for wear in the pinion gear area (See Figure 1). If the pinion shaft is worn (Black Coating Cone), replace the pinion shaft and both pinion gears. The pinion shaft and pinion gears in the 1989 models are different dimensions than the previous models and will not interchange. If the pinions are seized to the pinion shaft, then the entire final drive assembly should be replaced. Make certain that you select the same final drive ratio.
