# Technical Service Information

## HONDA/ACURA BAXA/B7XA FAMILY TIE UP IN REVERSE WHEN HOT

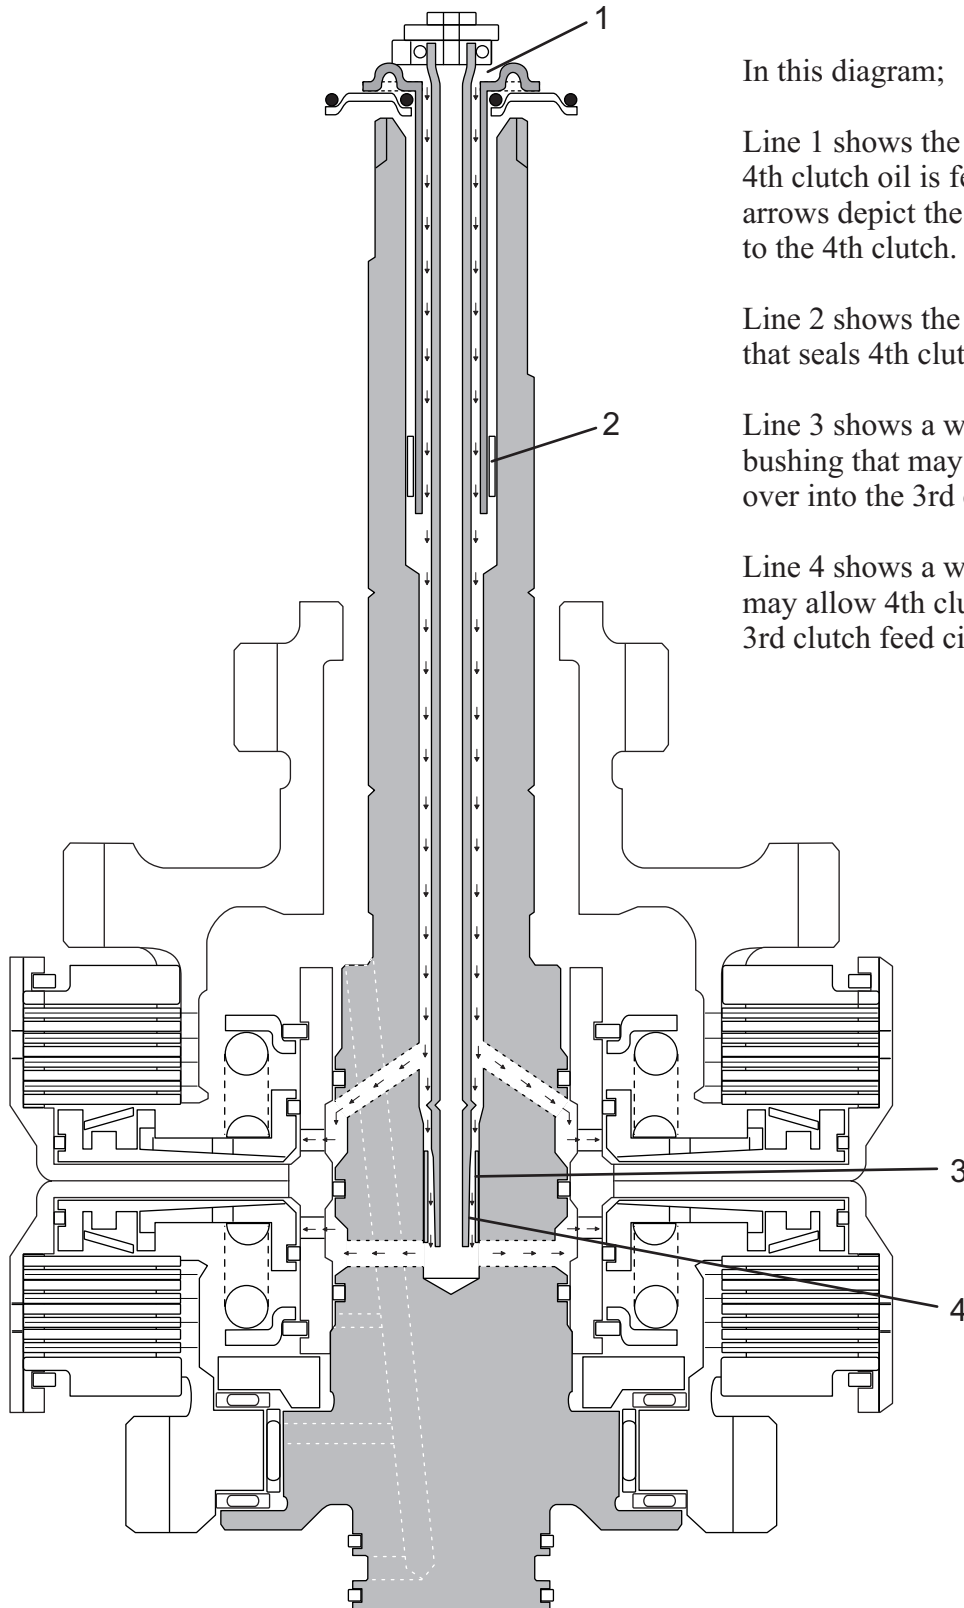
Figure 2

**CAUSE:** One cause may be a worn bushing in the main shaft, or a worn 3rd clutch feed tube in the back cover allowing 4th clutch oil to cross over into the 3rd clutch circuit partially applying the 3rd clutch and causing the tie-up.

## HONDA/ACURA BAXA/B7XA FAMILY PARTIAL CUTAWAY CROSS LEAK AREAS

Line 1 shows the area of the mainshaft where 4th clutch oil is fed into the mainshaft. The arrows depict the direction in which oil flows to the 4th clutch.

Line 2 shows the 4th clutch feed tube bushing that seals 4th clutch oil.

Line 3 shows a worn 3rd clutch feed tube bushing that may allow 4th clutch oil to cross over into the 3rd clutch feed circuit.

Line 4 shows a worn 3rd clutch feed tube that may allow 4th clutch oil to cross over into the 3rd clutch feed circuit.

If any pressure is present on the 3rd clutch tap when the selector is placed in the reverse position, it will be necessary to remove the transmission from the vehicle and disassemble so the mainshaft can be replaced. It will be necessary to also inspect the tubes located in the transaxle rear cover. If any wear is present on the 3rd or 4th clutch feed tubes, the rear cover will need to be replaced since the tubes are not serviced separately. Refer to figure 3 for illustration of the mainshaft and the location of the 3rd and 4th clutch feed tubes in the transaxle rear cover.

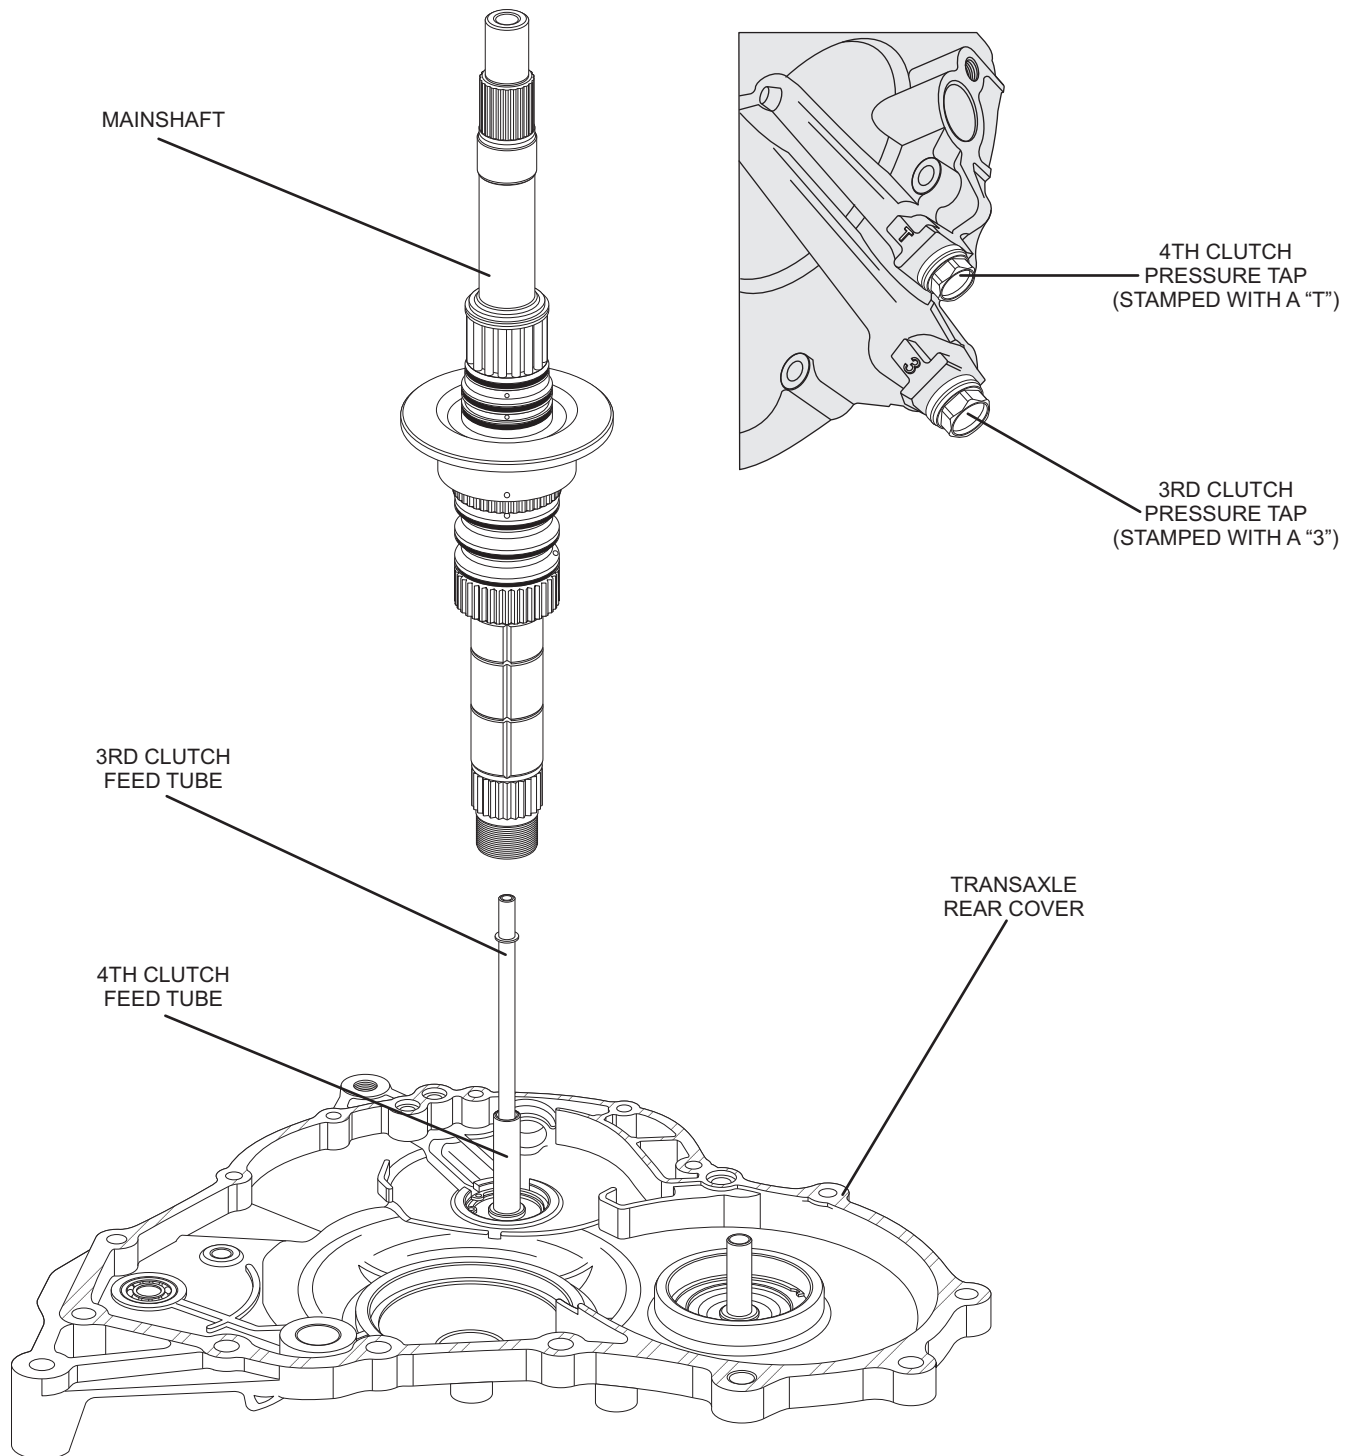
Figure 3

## HONDA/ACURA BAXA/B7XA FAMILY REAR COVER/MAINSHAFT ILLUSTRATION AND PRESSURE TAP LOCATIONS

**CORRECTION:** The best way to check for this condition is to conduct a pressure test on the 3rd clutch pressure tap when the vehicle is “HOT” and the selector is placed into reverse. Refer to figure 3 for pressure tap locations on the transaxle rear cover.
